Model: Aries-C1.5	Date: 04-Oct-10	No.: RD095001h
-------------------	-----------------	----------------

Subject: Firmware Release Note: Engine		Prepared by: T. Miyamoto	
From: 1st PP Tech Service Sect., PP Tech Service Dept.			
Classification:	<input type="checkbox"/> Troubleshooting	<input type="checkbox"/> Part information	<input type="checkbox"/> Action required
	<input type="checkbox"/> Mechanical	<input type="checkbox"/> Electrical	<input type="checkbox"/> Service manual revision
	<input type="checkbox"/> Paper path	<input type="checkbox"/> Transmit/receive	<input type="checkbox"/> Retrofit information
	<input type="checkbox"/> Product Safety	<input checked="" type="checkbox"/> Other (Firmware)	<input checked="" type="checkbox"/> Tier 2

This RTB has been issued to announce the firmware release information for the **Engine**.

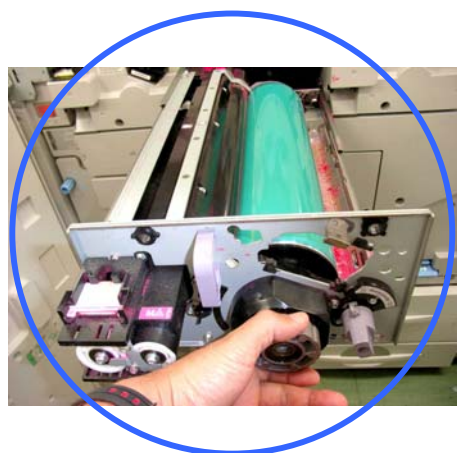
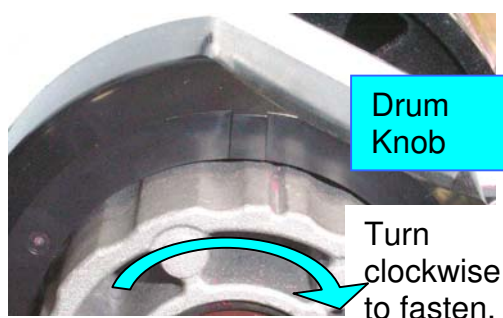
Keep the developer unit drawn out when fastening the drum knob.

Do NOT fasten the drum knob when the developer unit is installed.

Do NOT fasten the drum knob when the drum cleaner is installed.

If the drum knob is loosened while the drum cleaner is installed, make sure to remove the drum cleaner before fastening the drum knob.

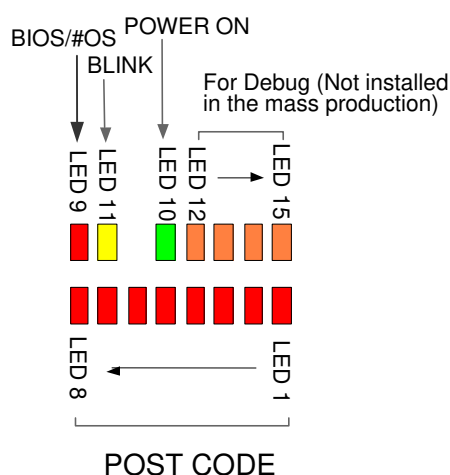
LED Configuration

The diagram below shows the LED configuration. The controller status can be checked by observing the sequence of the LED turning on, off, or flashing.

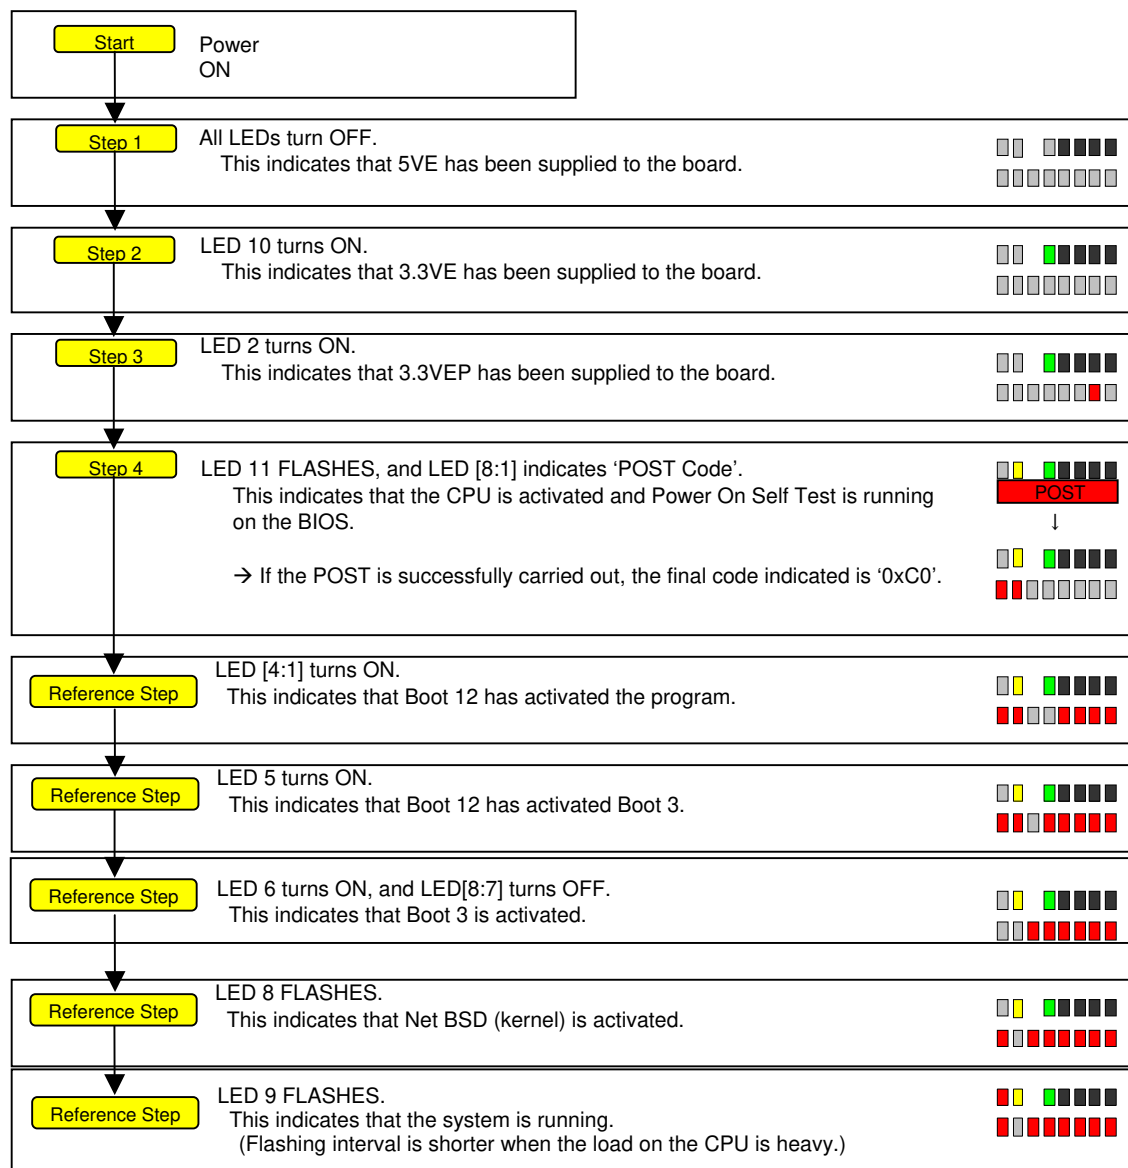
LED Indication Sequence (POST Code)

The LEDs will turn OFF, turn ON, or FLASH in the following order when powering on the machine.

→ System activation up to Step 4 is expected to complete in 15 seconds after powering on the machine.

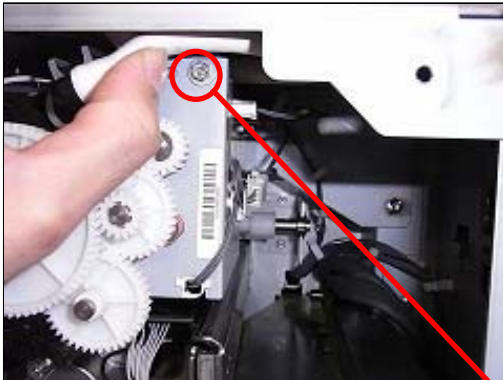
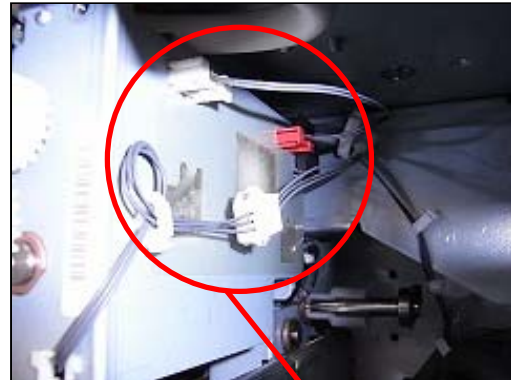
Variations in the precision of assembly of the bushing/holders that fix the sub-hopper units' drive shaft apply stress and causes wear on the drive shaft. (Abrasion of the drive shaft occurs at the bushing closest to "Holder-A".)

5. Disconnect 3 connectors, remove the snap ring, and remove 1 screw fixing the Yellow sub-hopper and 2 screws fixing the Holder-A.

5-1. Disconnect 3 connectors here.

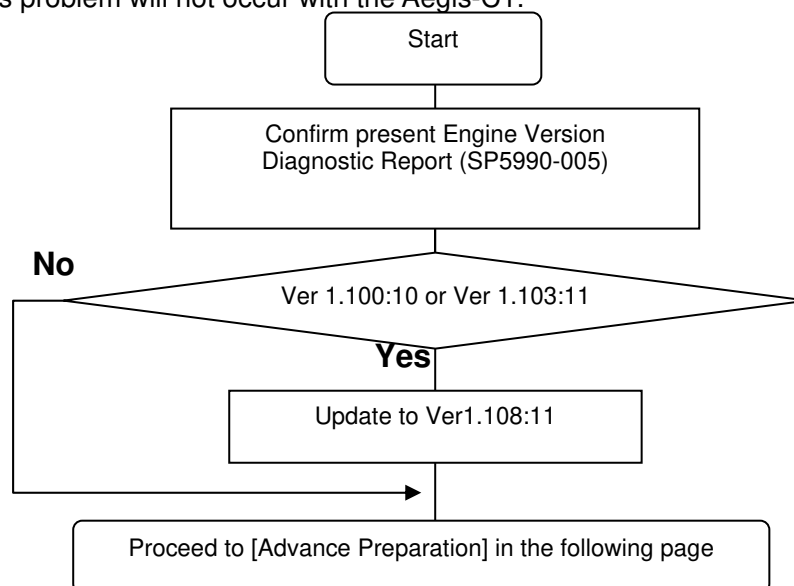
When a direct update to the latest version is attempted from either Version1.100:10 or 1.103:11, WatchDogTimeOut ERROR(*1) could occur resulting in a non-functioning of the operation panel, and the machine will stop. As replacement of the BCU board will be required to resolve this error, please ensure to follow this correct procedure.

While the software timer resets the hardware timer in a certain interval, WatchDogTimeOut error occurs when this reset is not executed after a lapse of time specified and the hardware timer reaching a time-out state. This problem has been confirmed with versions 1.100:10 and 1.103:11 and has been resolved from 1.108:11. Hence firmware is updated in the particular order mentioned in above.

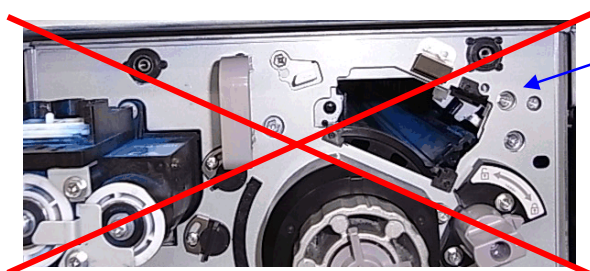
The development unit will be positioned incorrectly when operated without the Inner Cover and the screws, causing scratches on the drum surface and uneven image density.

Confirm complete fastening of the 3 screws.

Never operate the machine without the Inner Cover or the screws.

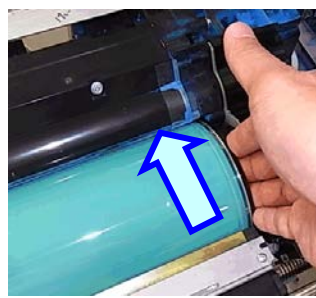
Do not attempt to forcefully fasten the (cross-shaped) drawer stop knob by shoving in the unit. Doing so will NOT help install the unit completely but will only damage the teeth of the internal gear.

When the gears are not engaged properly, the drum cleaning unit pushes the drum towards the direction in which the PG is narrowed. Printing in this condition will cause toner to adhere to the development rollers and generate scratches on the drum surface.

If the development unit is not correctly installed, pull out the PCDU and slightly reposition the drum so that the internal and external gears are engaged properly.

If the above SC occurs and heavy scratches are observed on the drum surface, replace the drum with a new one.

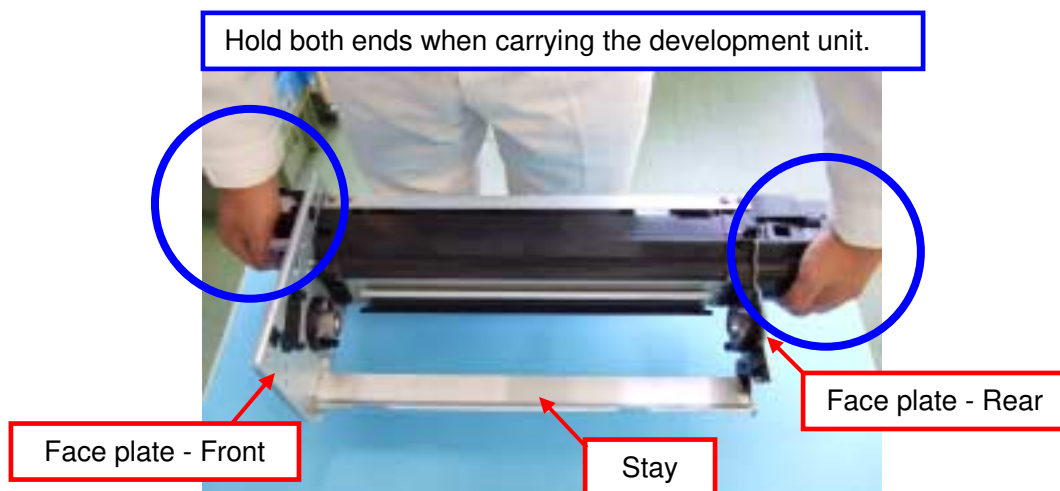
Do not grip the face plates or the stay.

Applying external pressure will deform the front and rear plates in vertical and horizontal directions, resulting in fluctuation of the PG.

- Always hold the prescribed locations when handling the development unit.
- Never apply external pressure to the front and rear plates and the stay.
