Model: Aries-P1.5	Date: 04-Oct-10	No.: RM077001h
-------------------	-----------------	----------------

Subject: Firmware Release Note: Engine		Prepared by: T. Miyamoto	
From: 1st PP Tech Service Sect., PP Tech Service Dept.			
Classification:	<input type="checkbox"/> Troubleshooting <input type="checkbox"/> Mechanical <input type="checkbox"/> Paper path <input type="checkbox"/> Product Safety	<input type="checkbox"/> Part information <input type="checkbox"/> Electrical <input type="checkbox"/> Transmit/receive <input checked="" type="checkbox"/> Other (Firmware)	<input type="checkbox"/> Action required <input type="checkbox"/> Service manual revision <input type="checkbox"/> Retrofit information <input checked="" type="checkbox"/> Tier 2

This RTB has been issued to announce the firmware release information for the **Engine**.

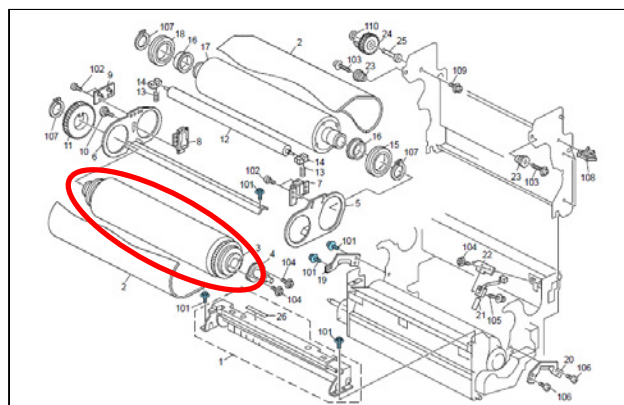
The Hot Roller installed in the fusing unit of the Aries was found with a defect in which the rubber covering the hot roller was shifted. (See the photo below)

The defect was caused by a fault in the manufacturing process where the rubber was not heated to the prescribed time and was not hardened enough.

Photo showing the "shift of the rubber" of a defective Hot Roller

- The defective Hot Rollers were installed **ONLY** in the fusing units stocked as spare service parts, which have all been replaced with the proper hot roller.
- Aries machines in stock are all installed with the proper hot roller regardless of the hot roller p/n. (The hot roller p/n could be the former M0774105 but is not defective.)
- Please **DO NOT USE** the hot roller registered with the p/n M0774105 if procured separately as a service part.

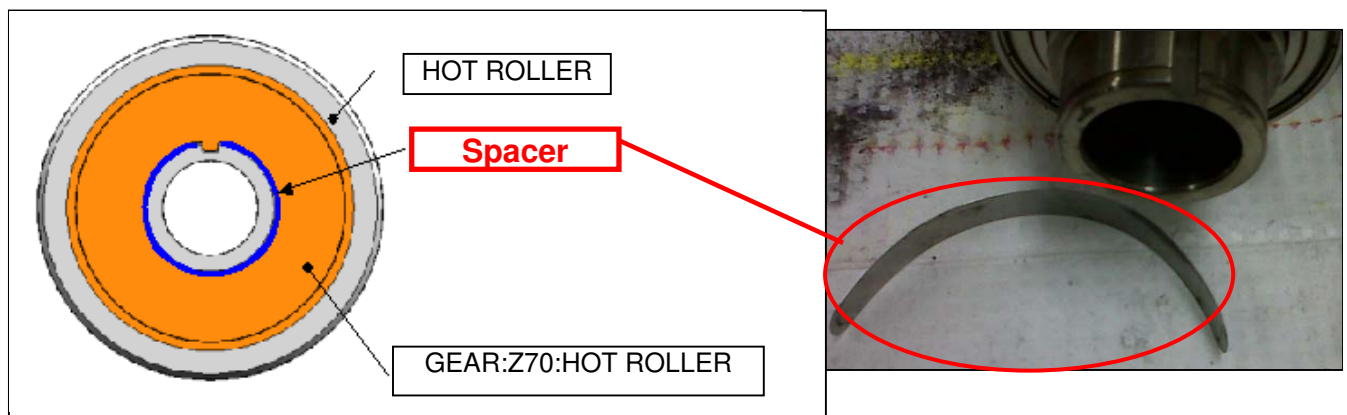
Some of the old Hot Rollers (M0774105) installed in the Pro C901/C901s of the initial production could be found with a “spacer” attached to the core to compensate for the deviation in the core size.

Please dispose of this spacer, if found, together with the Hot Roller when replacing this old hot roller with a new Hot Roller.

The spacer is not needed for the new Hot Roller (M0774160) because the core size of the new Hot Roller is precise.

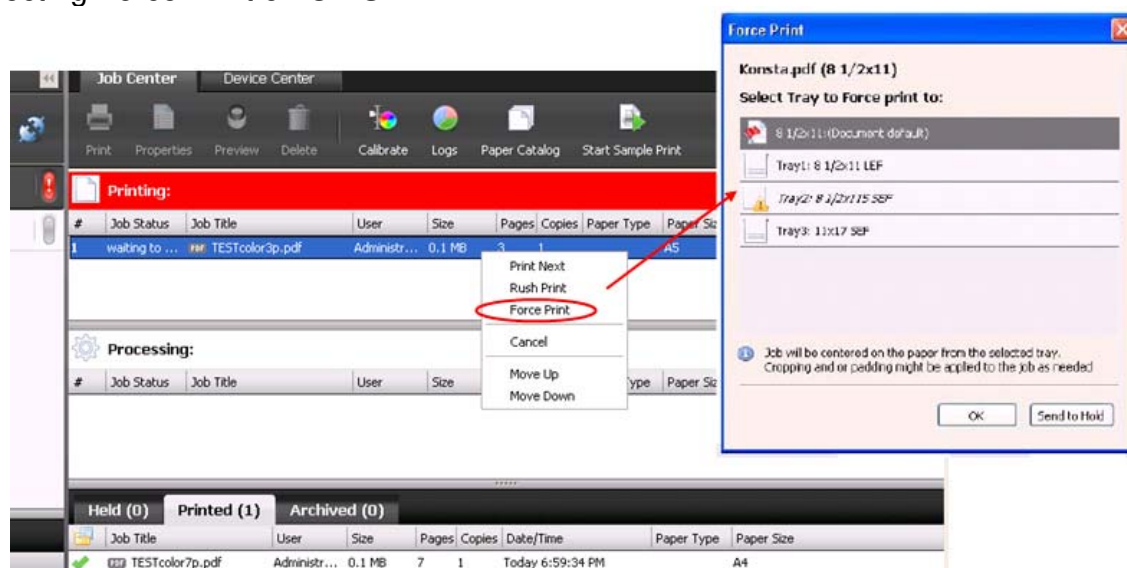
However, when operated from Command Work Station (CWS) the Force Print dialog box (Figure 1) will open but will result in another dialog box (Figure 2), and disables completion of the process.

Figure 1 below shows the dialog box that displays the mis-matching error jobs when selecting Force Print on CWS.

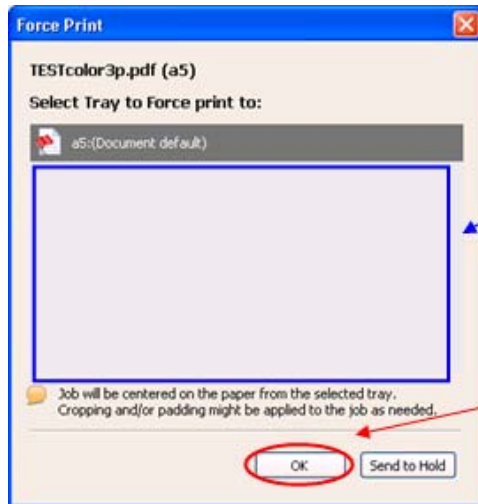
Figure 2 below shows the actual error:

- Paper Tray information does not appear in the blue box under “Document default”.
- The “OK” button is invalid.

To close the dialog box, click “X” or “Send to Hold”.

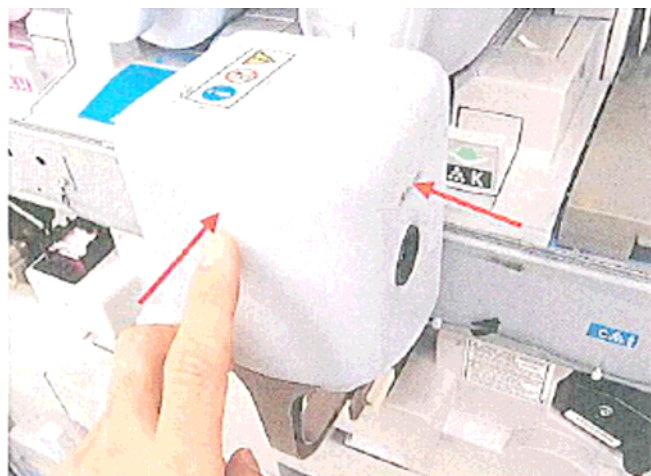
developer bottle moves about 3mm either side of the bottle as shown below.

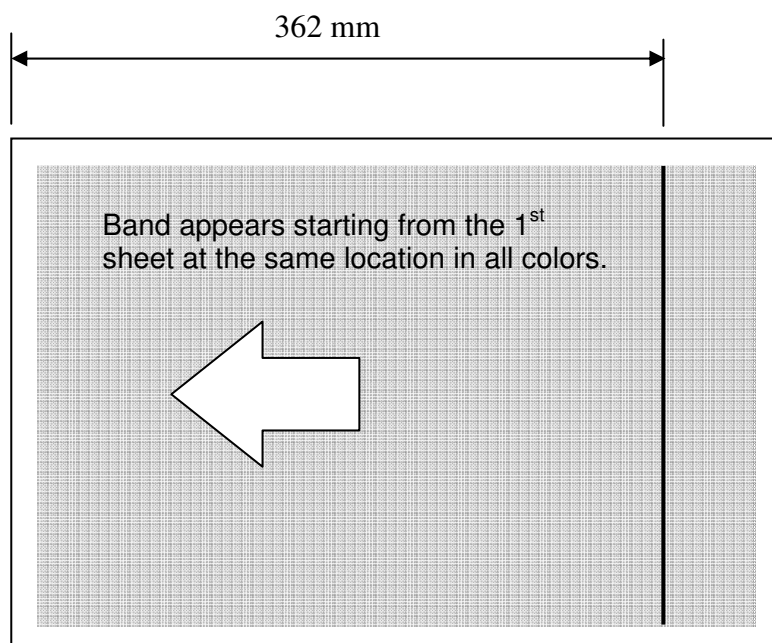
Location of the band by color and paper size

362 mm from the leading edge in all colors and paper sizes

1. Register the paper that is now being used into the Paper Library.
2. In Advanced Settings, adjust **No15: Paper Transfer Feed Speed Adjustment** to a value +/- 0.2% in relation to the current value.

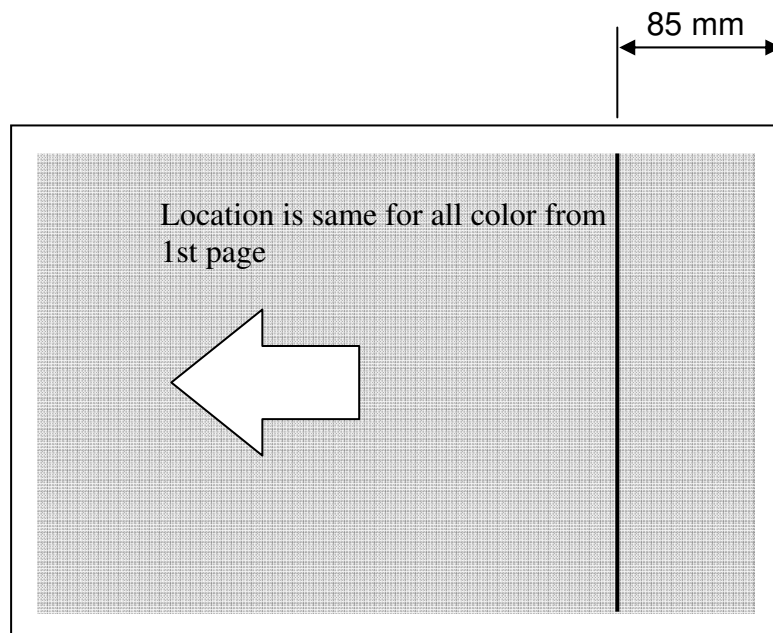
Location of the band by color and paper size

85 mm from the trailing edge in all colors and paper sizes

1. Register the paper that is now being used into the Paper Library.
2. In Advanced Settings, adjust **No15: Paper Transfer Feed Speed Adjustment** to a value +/- 0.2% in relation to the current value.

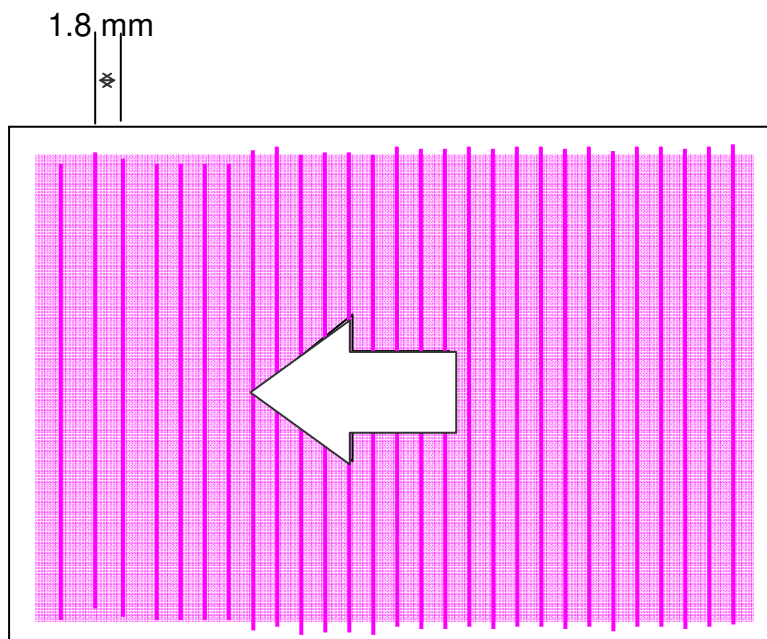
Location of the band by color and paper size

Across the entire page in all or specific color(s)

Action
Change the Dither to "dot".

- 200 Dot + Fine Text & Graphic
- 150 Dot
- 175 Dot

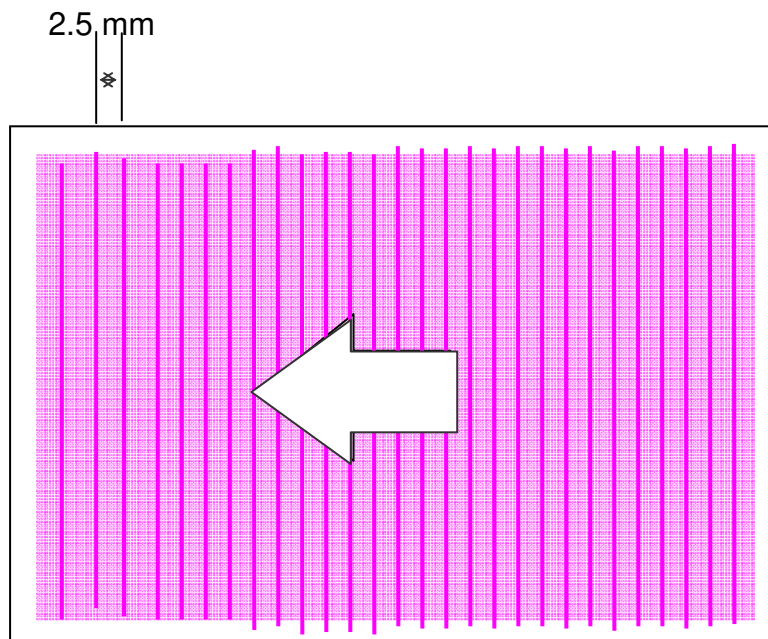
Location of the band by color and paper size

Across the entire page in all or specific color(s)

Action
Change the Dither to "line"

- a. 175 Line + Fine text
- b. 200 Line + fine text

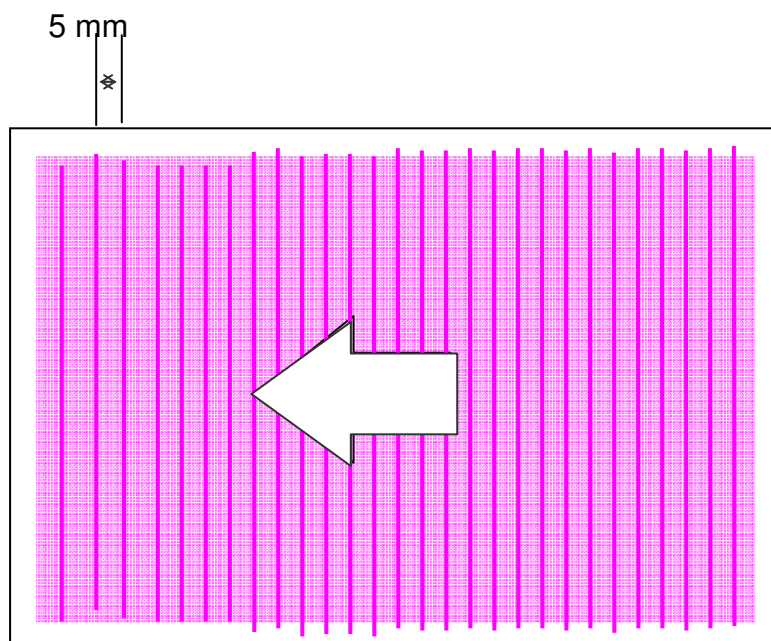
Location of the band by color and paper size

Across the entire page

1. Register the paper that is now being used into the Paper Library.
2. In Advanced Settings **No15: Paper Transfer Feed Speed Adjustment**, reduce the paper feed speed to -0.1% or -0.2% from the current speed.

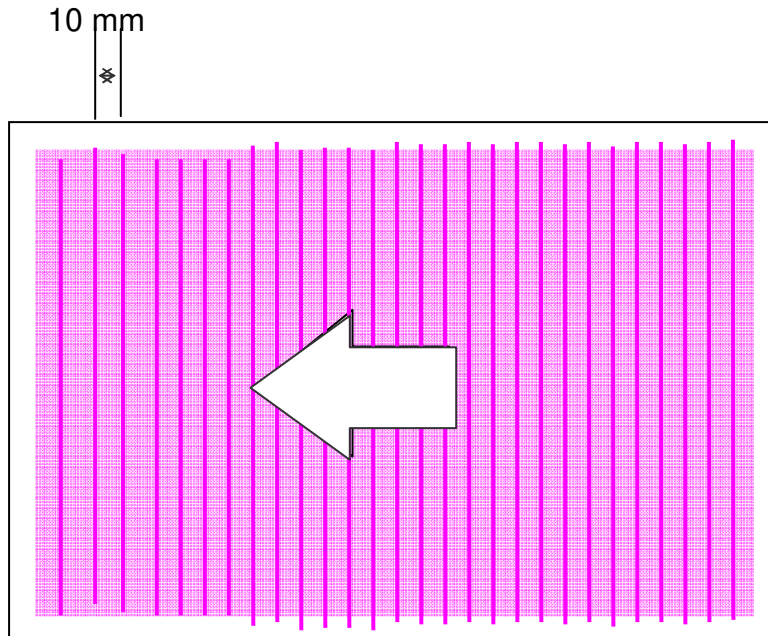
Location of the band by color and paper size

Across the entire page

Remove one of the two modified fly wheels (P/N: M0771294), and secure one original fly wheel and one modified fly wheel with TAPPING SCREW:4X12.

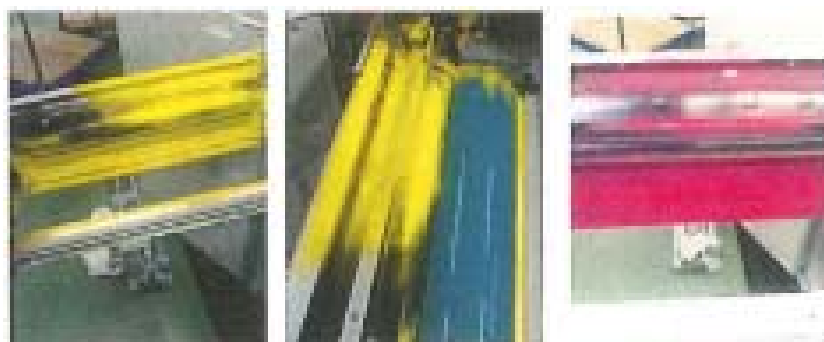
Toner scattering (refer to the diagram below) may occur, if the toner coverage is extremely low.

(Reference value: Toner coverage is less than 2.0 %)

1. **At the next visit** to the customer's site or during **installation**, please change the following SP.

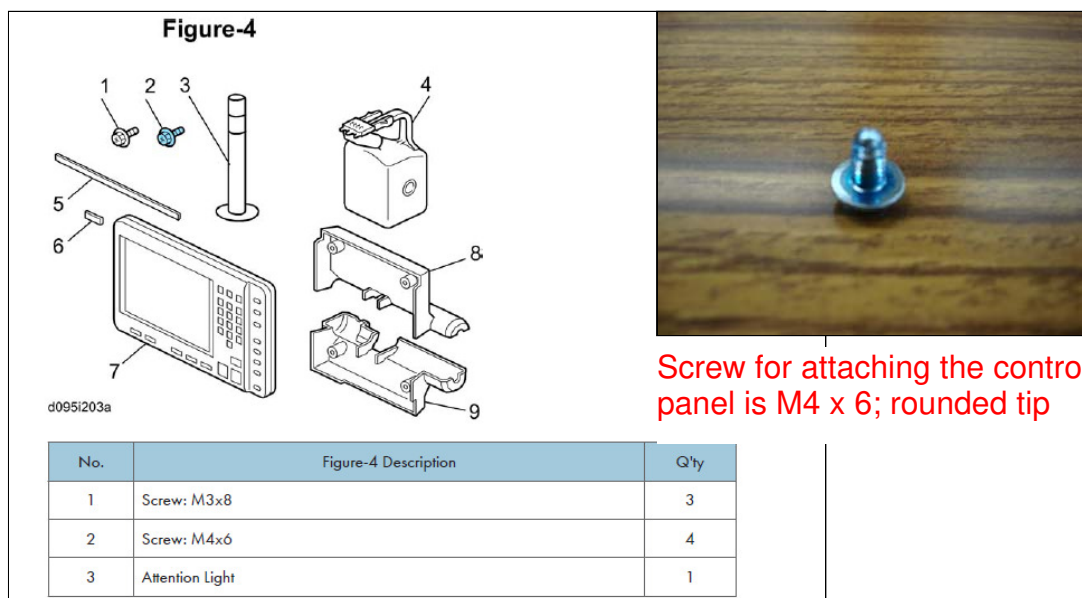
If the operation panel is attached using the M4x8 screws and fastened completely, the screw may contact the control board of the operation panel due to the narrow gap between the control board and the bracket. Although the M4x6 screws are included as accessories, the service manual does not mention that we should use these screws to fasten the operation panel.

Please make sure the control panel is fastened with **M4 x 6** screws for machines in the field.

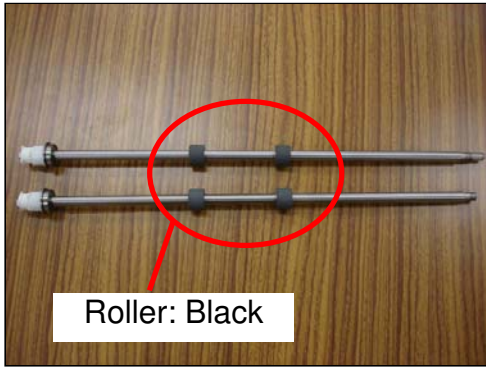
Roller Marks on Paper Edges caused by toner contaminated Transport Rollers

<p>Roller: Black</p>

Please replace the Transport Rollers, Spring, and Guide Plates at your next service visit (or for a new site installation) by ordering the following replacement kits.

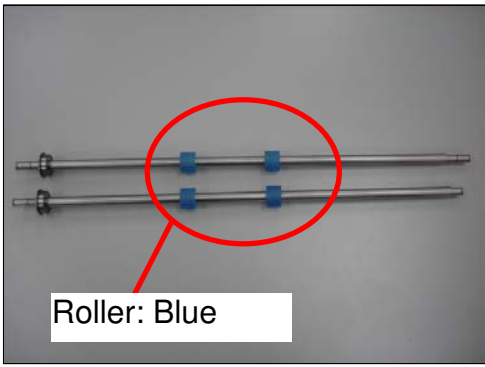
<p>Roller: Blue</p>	
Spring

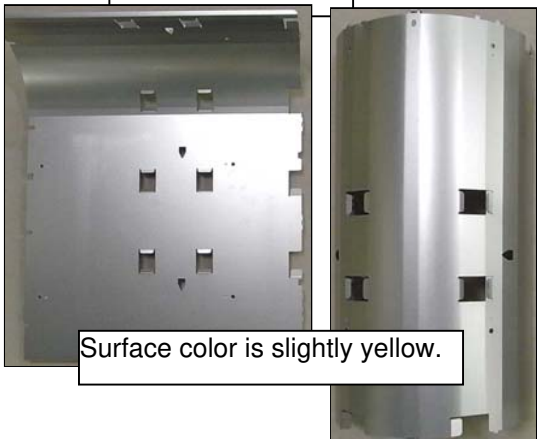
Vertical White Streaks caused by toner contaminated Guide Plates

<p>Surface color is slightly yellow.</p>

M3799902 --- The Guide Plates have been coated to reduce friction and prevent toner contamination.

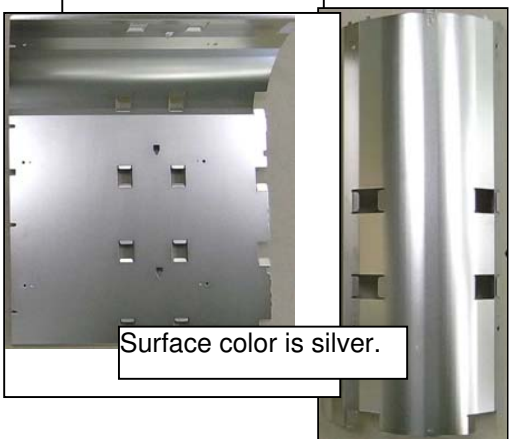
<p>Surface color is silver.</p>

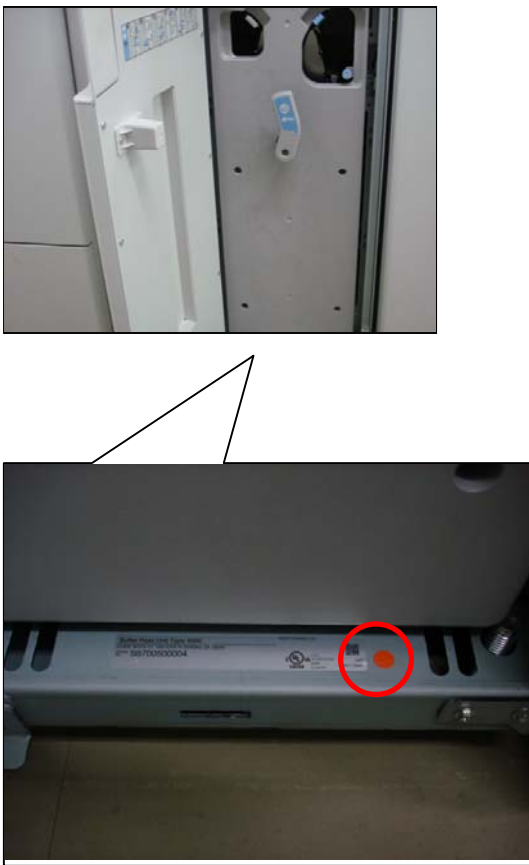
NA	Units of the serial numbers below M379-17S6701100001 and connected to the C901/C901s
EU	<p>Units of the serial numbers below M379-27S6701200007 and connected to the C901/C901s</p> <p>NOTE (Only EU): Units attached with a sticker on the bottom frame (See the photo below) have already been implemented of the modification. Modification is not required for these units. First of all, make sure to open the front door and check for this sticker.</p>

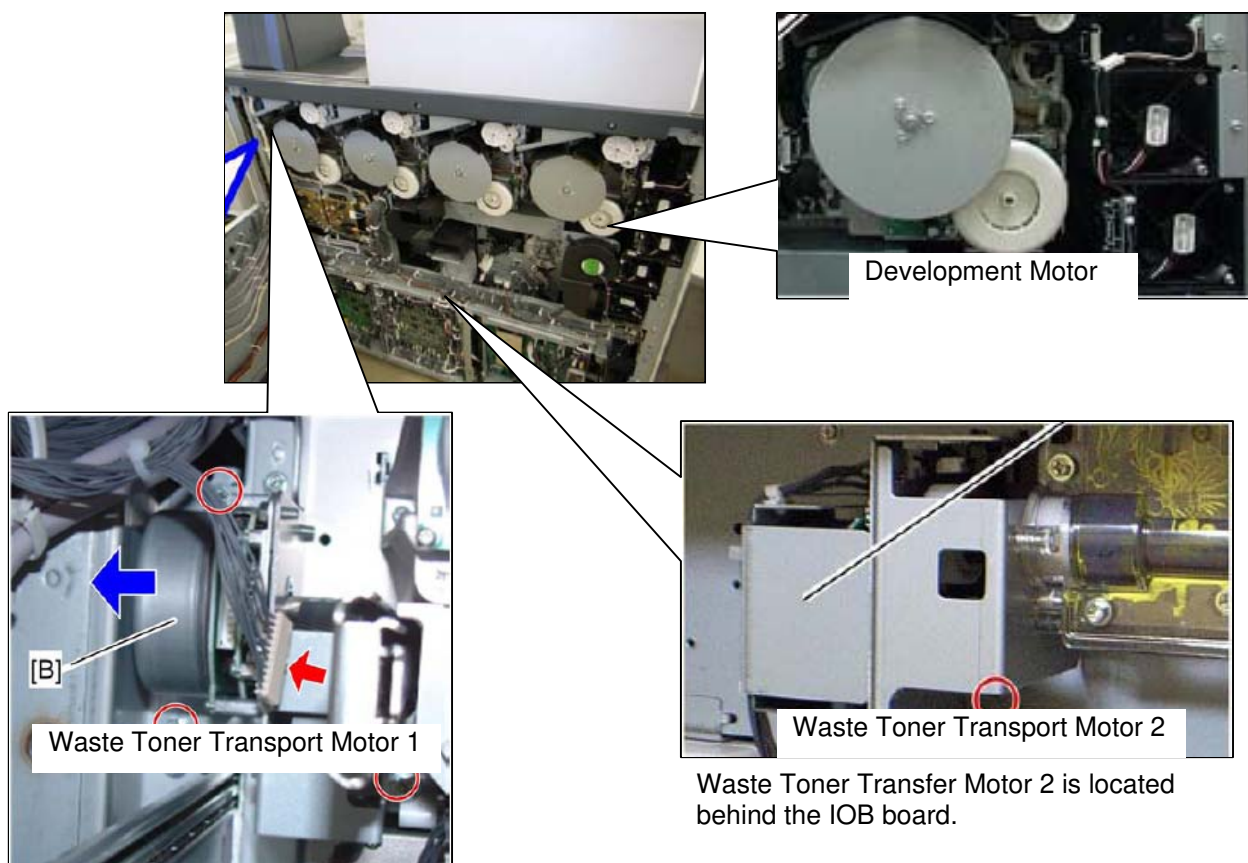
If the output check for the Development Motor is run independently, toner could clog between the Development Motor and the Waste Toner Transport Motor 1.

If the output check for Waste Toner Transport Motor 1 is run independently, toner could clog between Waste Toner Transport Motor 1 and Waste Toner Transport Motor 2.

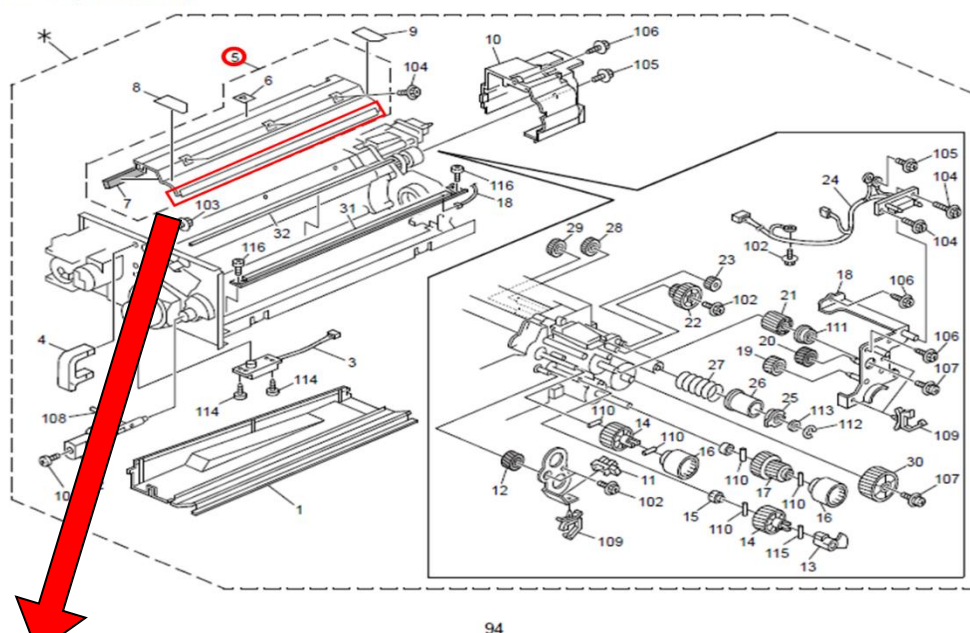
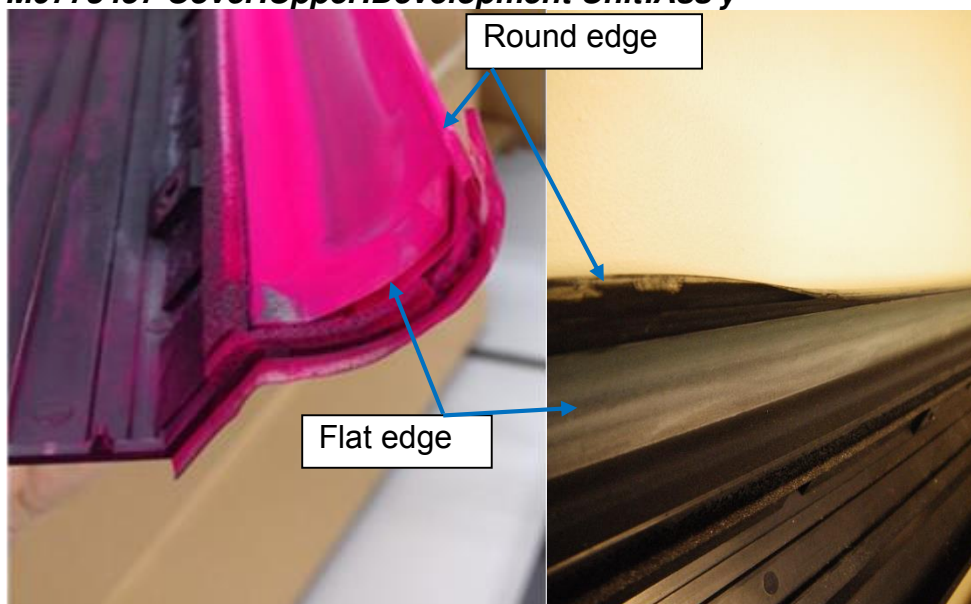
Figure 1 (Index #5: p/n M0773457 Cover:Upper:Development Unit:Ass'y)

1. To identify the color causing the lines, print 3 sheets of the halftone pattern (SP2-106-002-16) in each color.
2. **Check if the edge of the mylar attached to M0773457 is torn or not. If torn, replace M0773457 and print a halftone pattern in the color causing the line. Confirm the line has disappeared to complete the procedure. If the mylar is not torn, do the next step.**

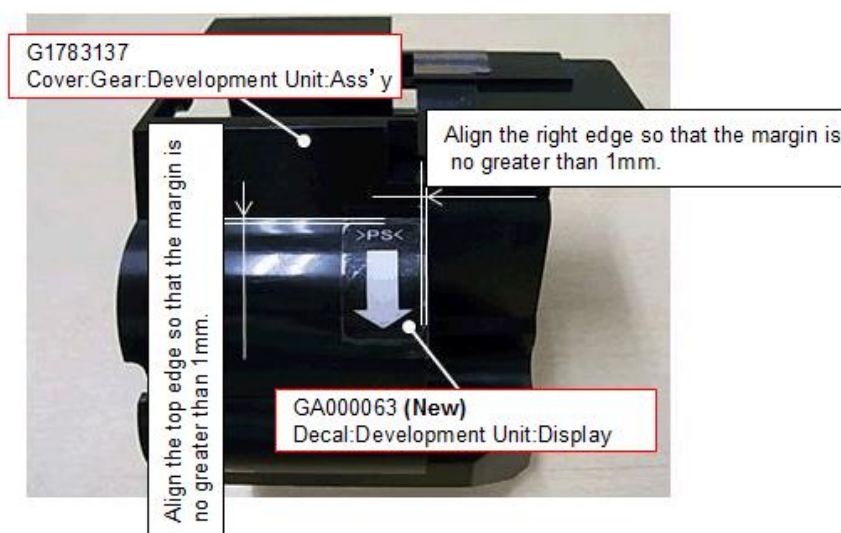
Note 2: *Rotating the development roller in the opposite direction may wear the mylar and entrance seal of the development unit and cause adverse effects. Rotate the development roller only in the direction indicated with the seal. See RTB RM077054 for more detail.*

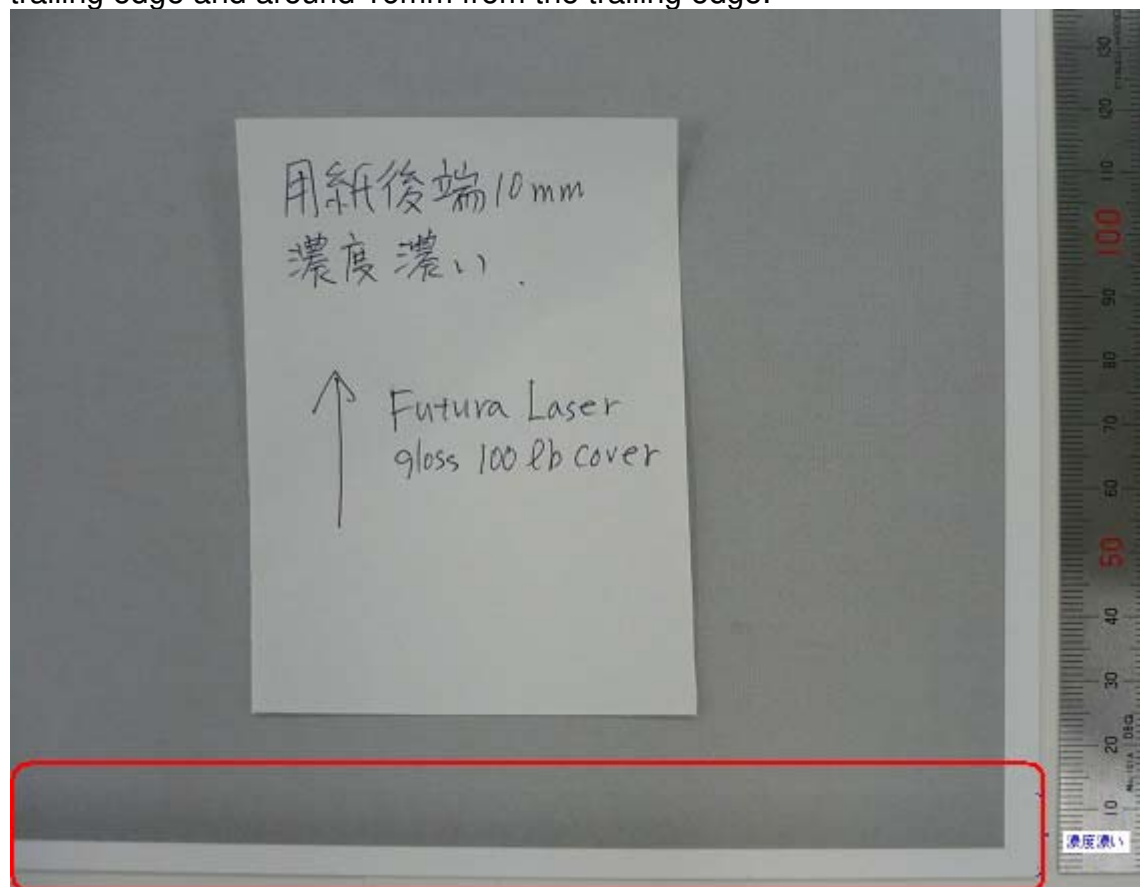
Reduced color density or a white band appears in an area between the trailing edge and around 16mm from the trailing edge.

In halftone areas, a colored band (high color density) appears in an area between the trailing edge and around 16mm from the trailing edge.

After the trailing edge passes the ITB entrance guide, the paper becomes closer to the ITB, and paper transfer current leaks due to high paper resistance; therefore, the image does not transfer to the paper.

After the trailing edge passes the ITB entrance guide, the paper become closers to ITB, and paper transfer current leaks and toner scatter appears, which looks like a colored band. If the paper resistance is high, paper transfer current leaks more and becomes a white band.

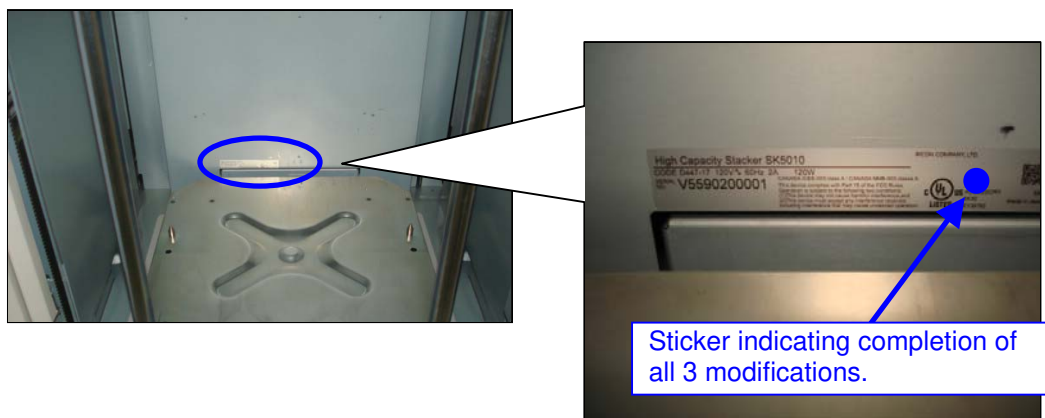
Sticker indicating completion of all 3 modifications.

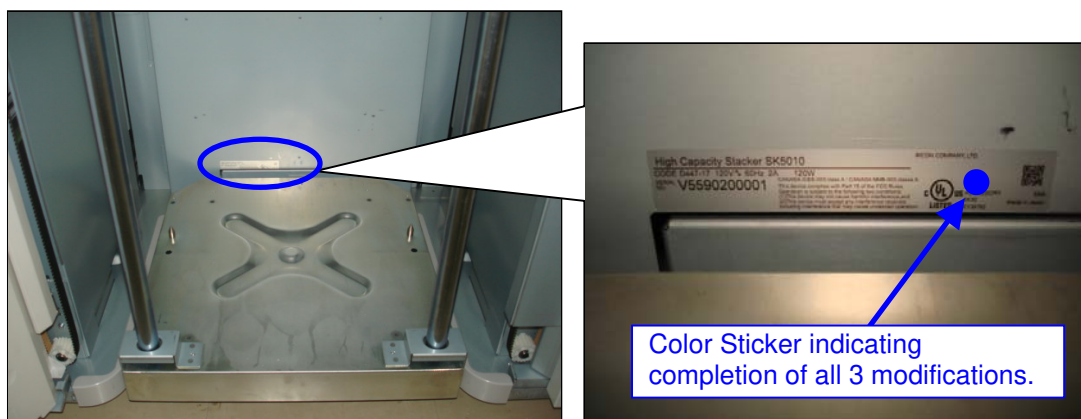
Units with the sticker attached on the bottom frame (see the photo below) have already received all 3 modifications "A", "B", and "C", and therefore, will not require the modification.
(The color of the sticker is not determined.)

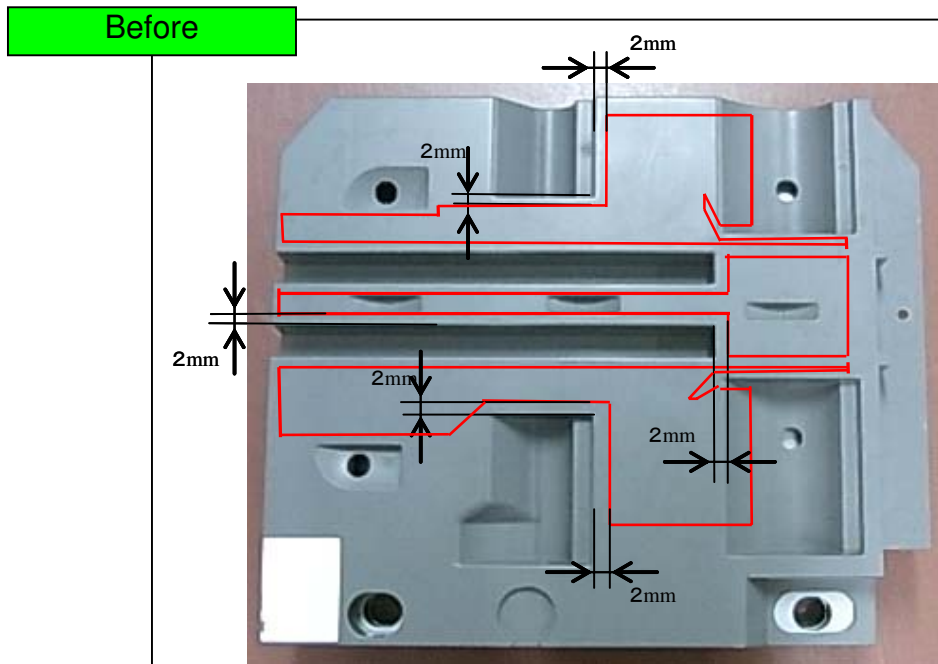
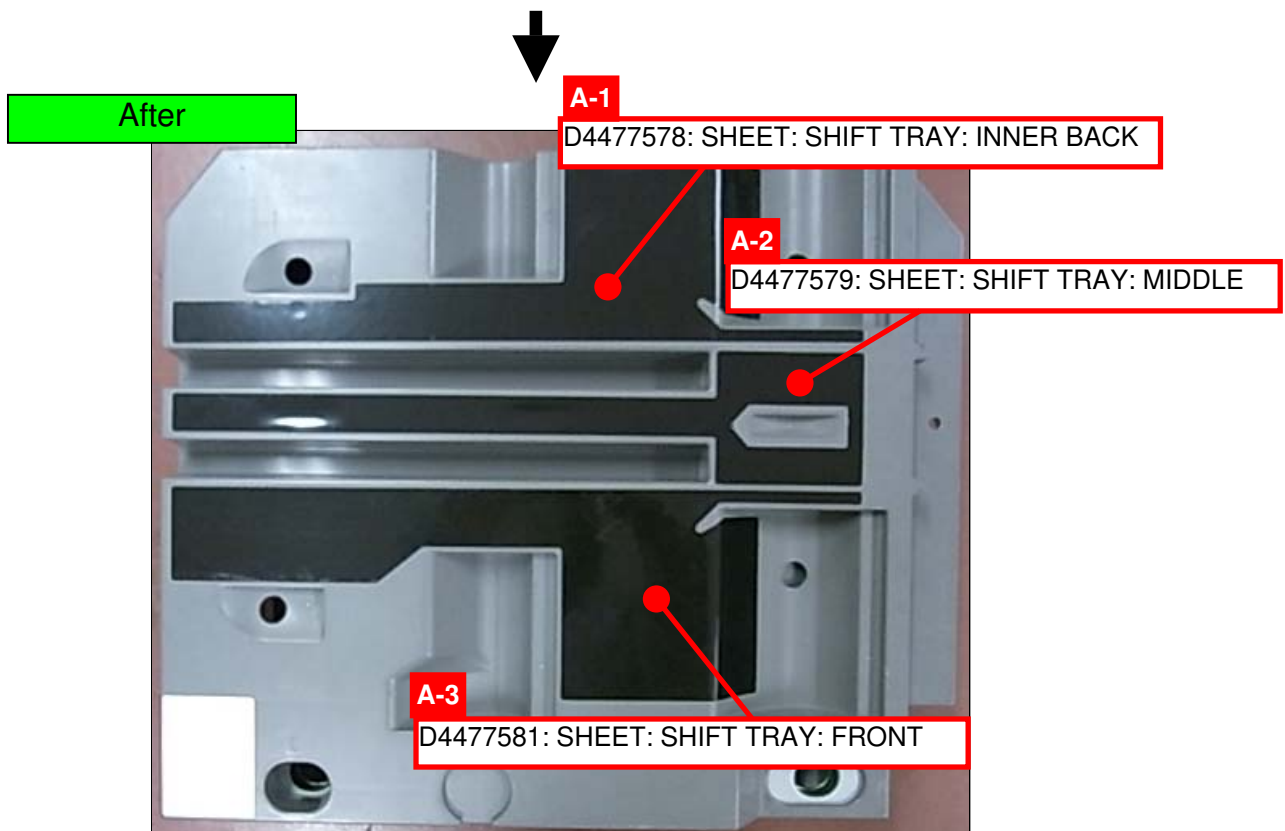
Static electricity causes the first sheet to stick to the shift tray in low humidity & low temperature environments, especially with coated paper.

Attach the 3 Mylars to the position outlined in red in the photo below: 2mm inside the black line.
Maker sure the Mylars do NOT protrude against the lines and do NOT have air-bubbles.

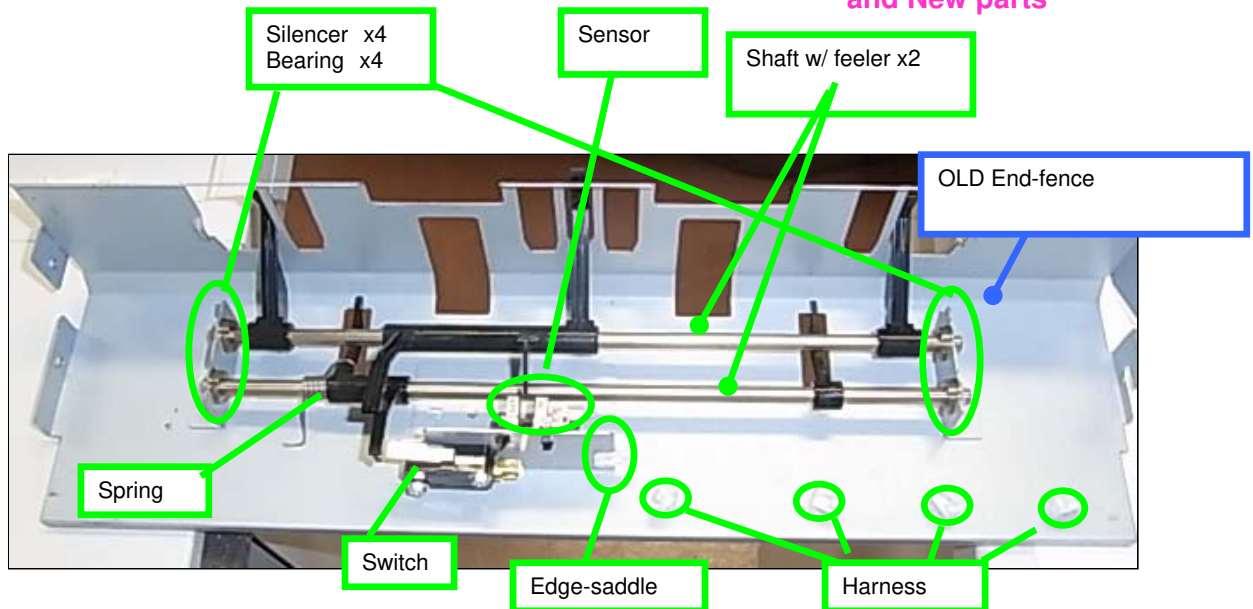
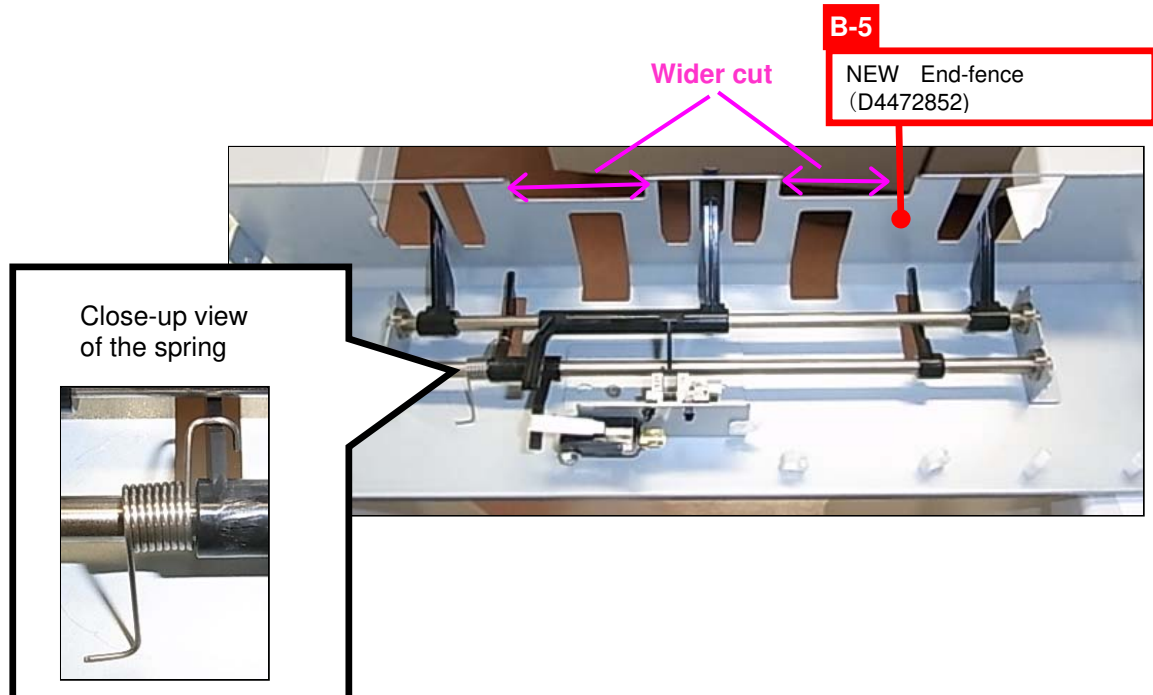
Replacement of the Shift Tray related parts

Red: Newly added

Pink: Differences between Old and New parts

Step B-27. Replace with the modified end-fence.

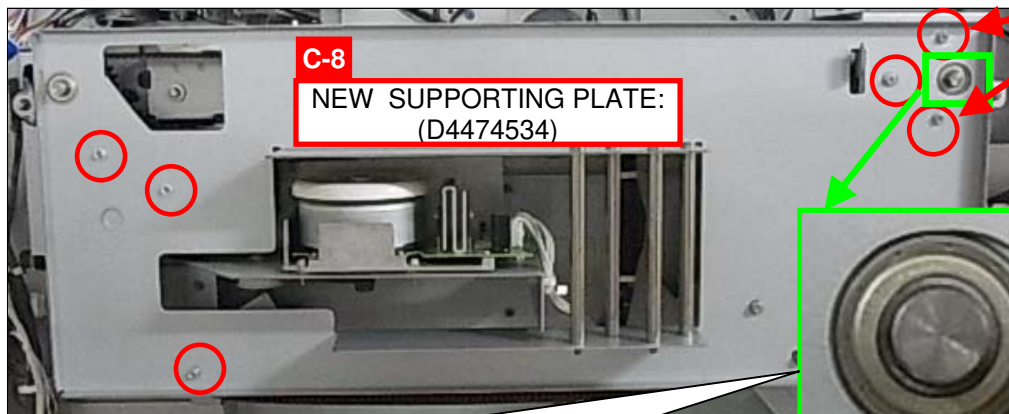
C-8

NEW SUPPORTING PLATE:
(D4474534)

Step C-8. Install the new SUPPORTING PLATE and fix it with 6 screws (M4x8).

Make sure the bearing is aligned correctly to the whole when installing the SUPPORTING PLATE.

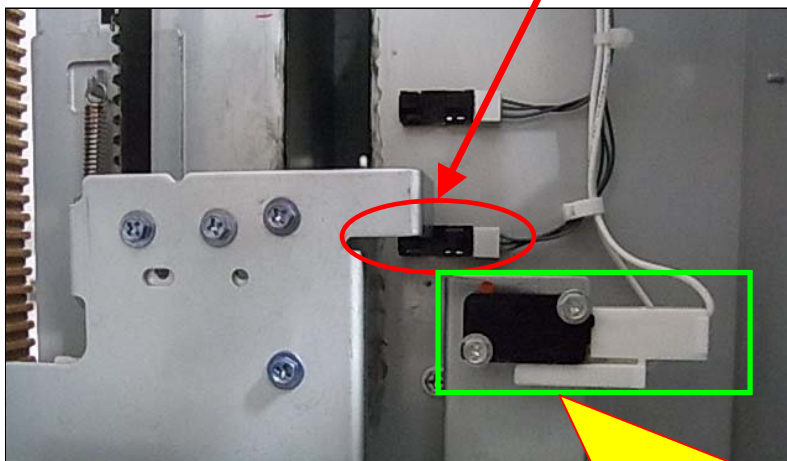
The curved part of "Bracket B" must not reach this microswitch.

Step C-17 Again, manually rotate the DC Brushless Motor until the curved part of "Bracket B" reaches the sensor.

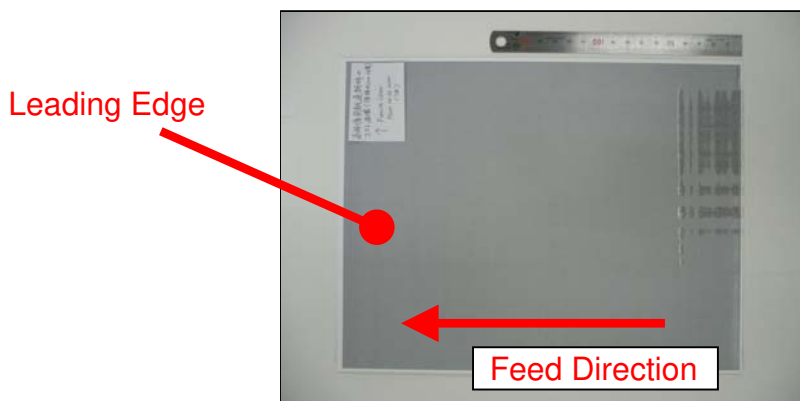
Printed images could appear as if “scratched” as shown in the photo below when feeding highly stiff paper stocks.

Feeding stiff & thick paper causes the paper to lift up the Guide Plate as the paper enters the PTR nip. Due to the small gap between the tip of the Guide Plate and the ITB, the lifted Guide Plate contacts the ITB and brushes the toner, resulting in a “scratched” image.

Replace with the modified Guide Plate (ITB GUIDE PLATE TYPE AX, p/n M0776514) if the symptom described is observed when feeding stiff & thick paper stocks.

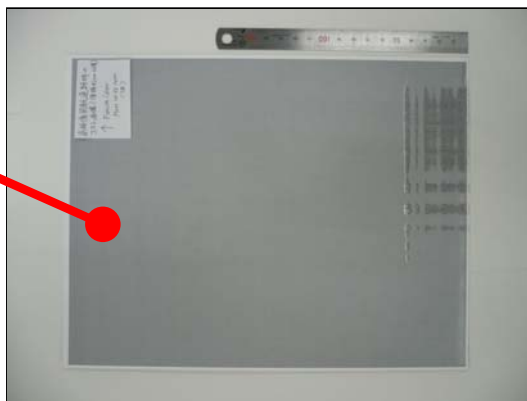
Leading Edge

The modified Guide Plate "AX" is to be used when scratched image appear in the trailing edge as shown in the photo below.

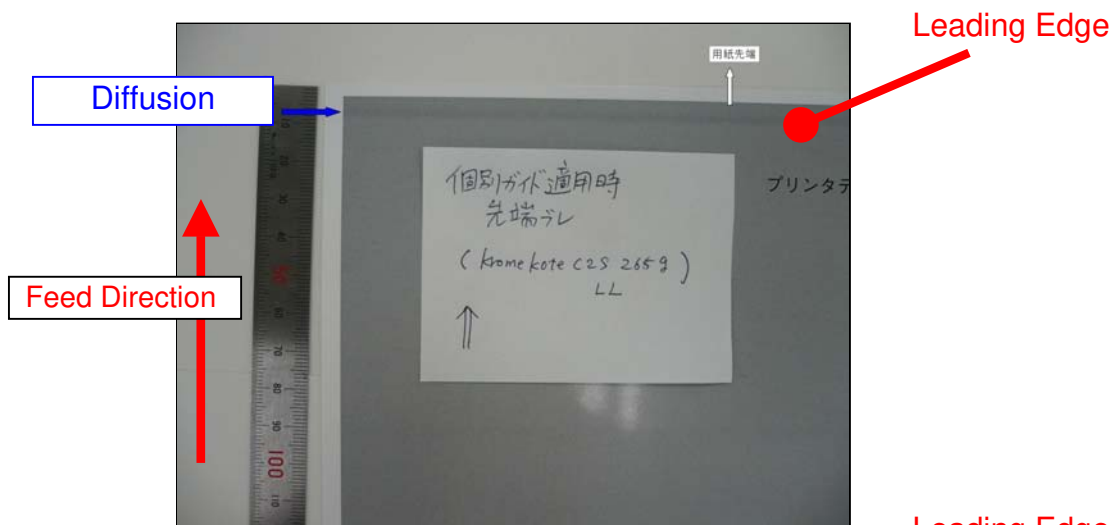
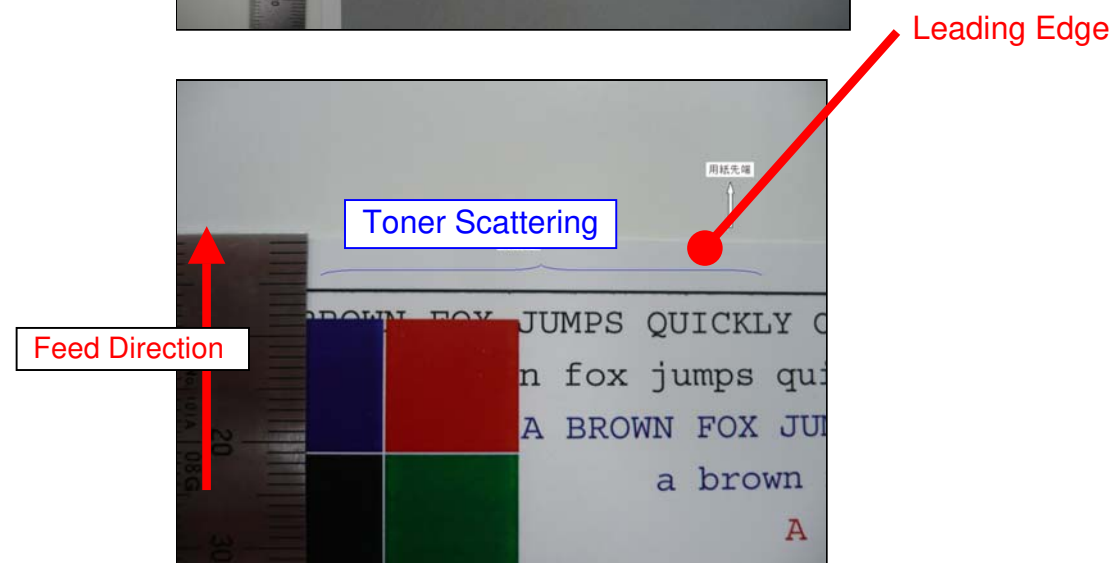
The guide plate should be switched back to the original Guide Plate Type AD if toner scattering/diffusion appears in the leading edge as shown in the photo below.

If replacement with the modified Guide Plate results in the trade-off described above, switch the guide plate back to the original Guide Plate.

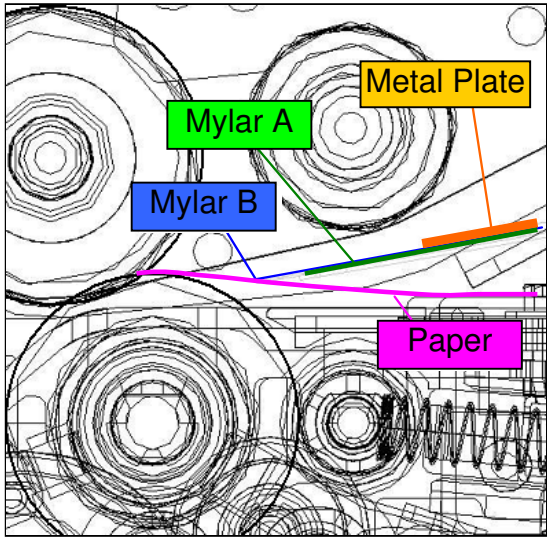
<p>Distance between ITB and Guide Plate: 2.1mm Distance between nip and Guide Plate: 11.7mm</p> <p>Length of Mylar A (green): 12mm Length of Mylar B (blue): 16mm</p>

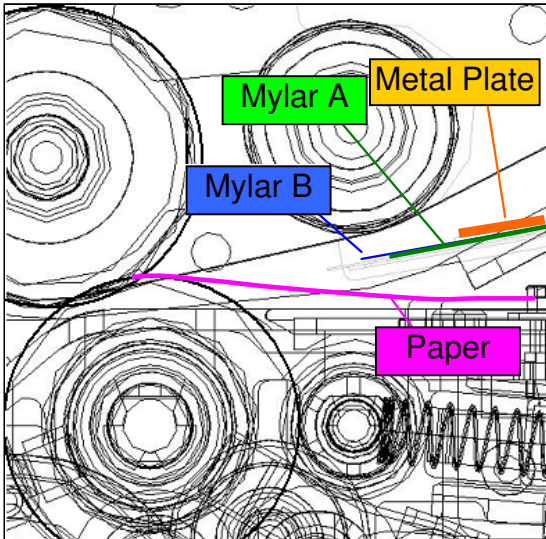
<p>Distance between ITB and Guide Plate: 2.5mm Distance between nip and Guide Plate: 21.9mm</p> <p>Length of Mylar A (green): 10mm Length of Mylar B (blue): 12mm</p>

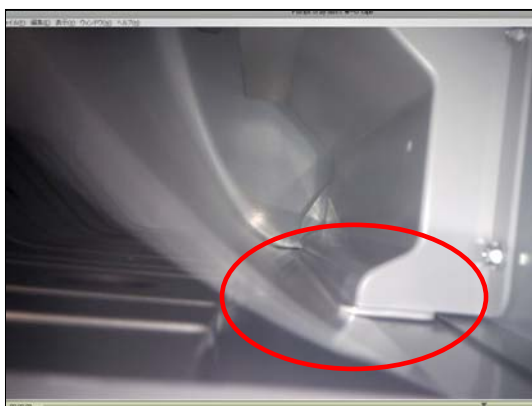
The trailing edge of the sheet gets caught in the gap between the plate and the cooling duct during switchback operation.

Check the purge tray if the following part is attached. If not, procure the part and attach it to cover the gap.

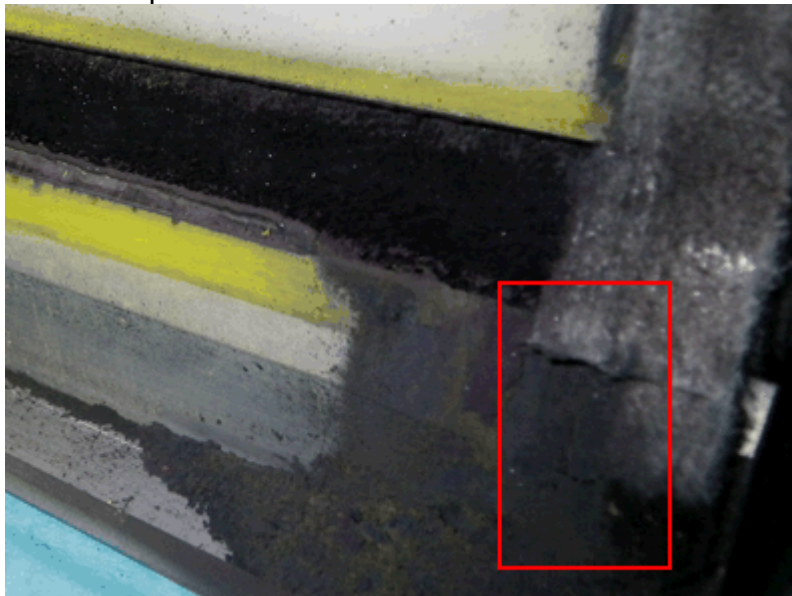
Bad example

The "Entrance Seal:Belt Cleaning" is positioned **underneath** the "Seal: Belt Cleaning: Entrance: Side".

When servicing the ITB belt cleaning unit, make sure the "Seal: Belt Cleaning: Entrance: Side" is NOT lapping over the "Entrance Seal: Belt Cleaning".

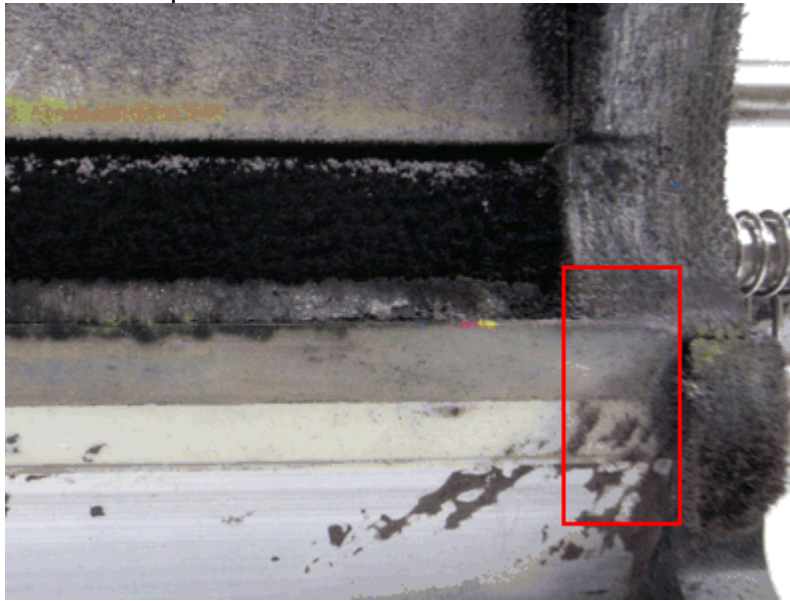
Good example

The "Entrance Seal: Belt Cleaning" is positioned **above** the "Seal: Belt Cleaning: Entrance: Side".

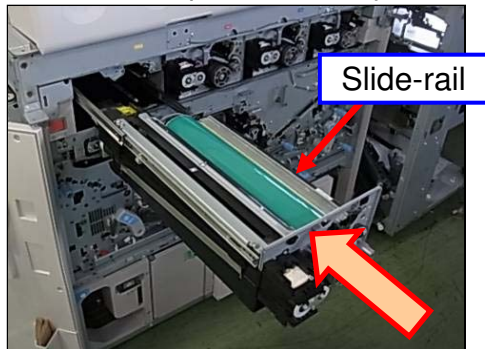
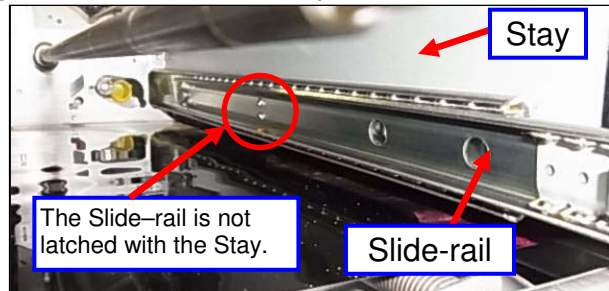
Slide-rail could drop from the Stay when setting the C, M, and Y development units.

Mold used for creating the Stay was damaged and fixed but the dimensions of the fixed mold were incorrect.

Replace the current slide-rails with the modified slide-rails for C, M, and Y stations either on new installs or a service visit for the affected units shown on the following page.
