Model: Aries-P1.5	Date: 04-Oct-10	No.: RM077001h
-------------------	-----------------	----------------

Subject: Firmware Release Note: Engine		Prepared by: T. Miyamoto	
From: 1st PP Tech Service Sect., PP Tech Service Dept.			
Classification:	<input type="checkbox"/> Troubleshooting <input type="checkbox"/> Mechanical <input type="checkbox"/> Paper path <input type="checkbox"/> Product Safety	<input type="checkbox"/> Part information <input type="checkbox"/> Electrical <input type="checkbox"/> Transmit/receive <input checked="" type="checkbox"/> Other (Firmware)	<input type="checkbox"/> Action required <input type="checkbox"/> Service manual revision <input type="checkbox"/> Retrofit information <input checked="" type="checkbox"/> Tier 2

This RTB has been issued to announce the firmware release information for the **Engine**.

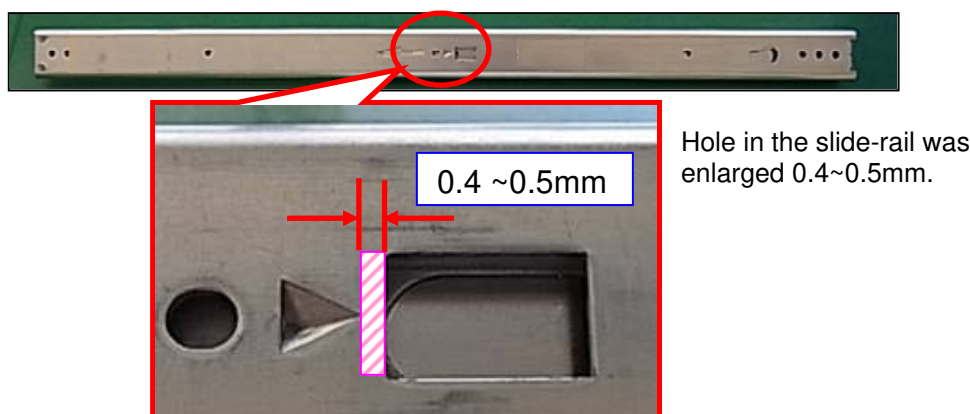
The hole in the Slide-rail was enlarged to allow the latch on the Stay to reach the projection.

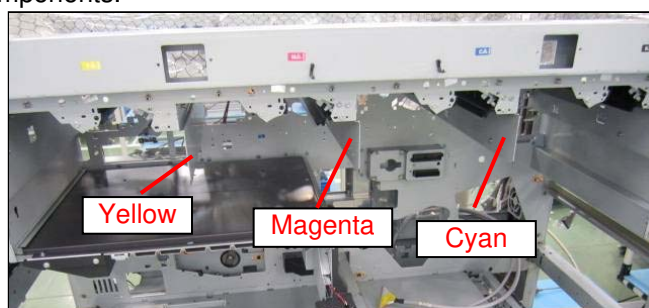
Cause

Mold used for creating the Stay was damaged and fixed but the dimensions of the fixed mold were incorrect.

Instead of modifying the Stay which had the incorrect dimensions, the Slide-rails were modified because replacement of the Stay is complex and is inappropriate to carry out in the field. Replacement with the modified Slide-rails will have no adverse affect on the durability of the Stay and enables proper latching of the two components.

Replace the current slide-rails with the modified slide-rails for C, M, and Y stations either on new installs or a service visit for the affected units shown on the following page.

Replace the 3 slide-rails installed in the right hand side of Cyan, Magenta, and Yellow stations.

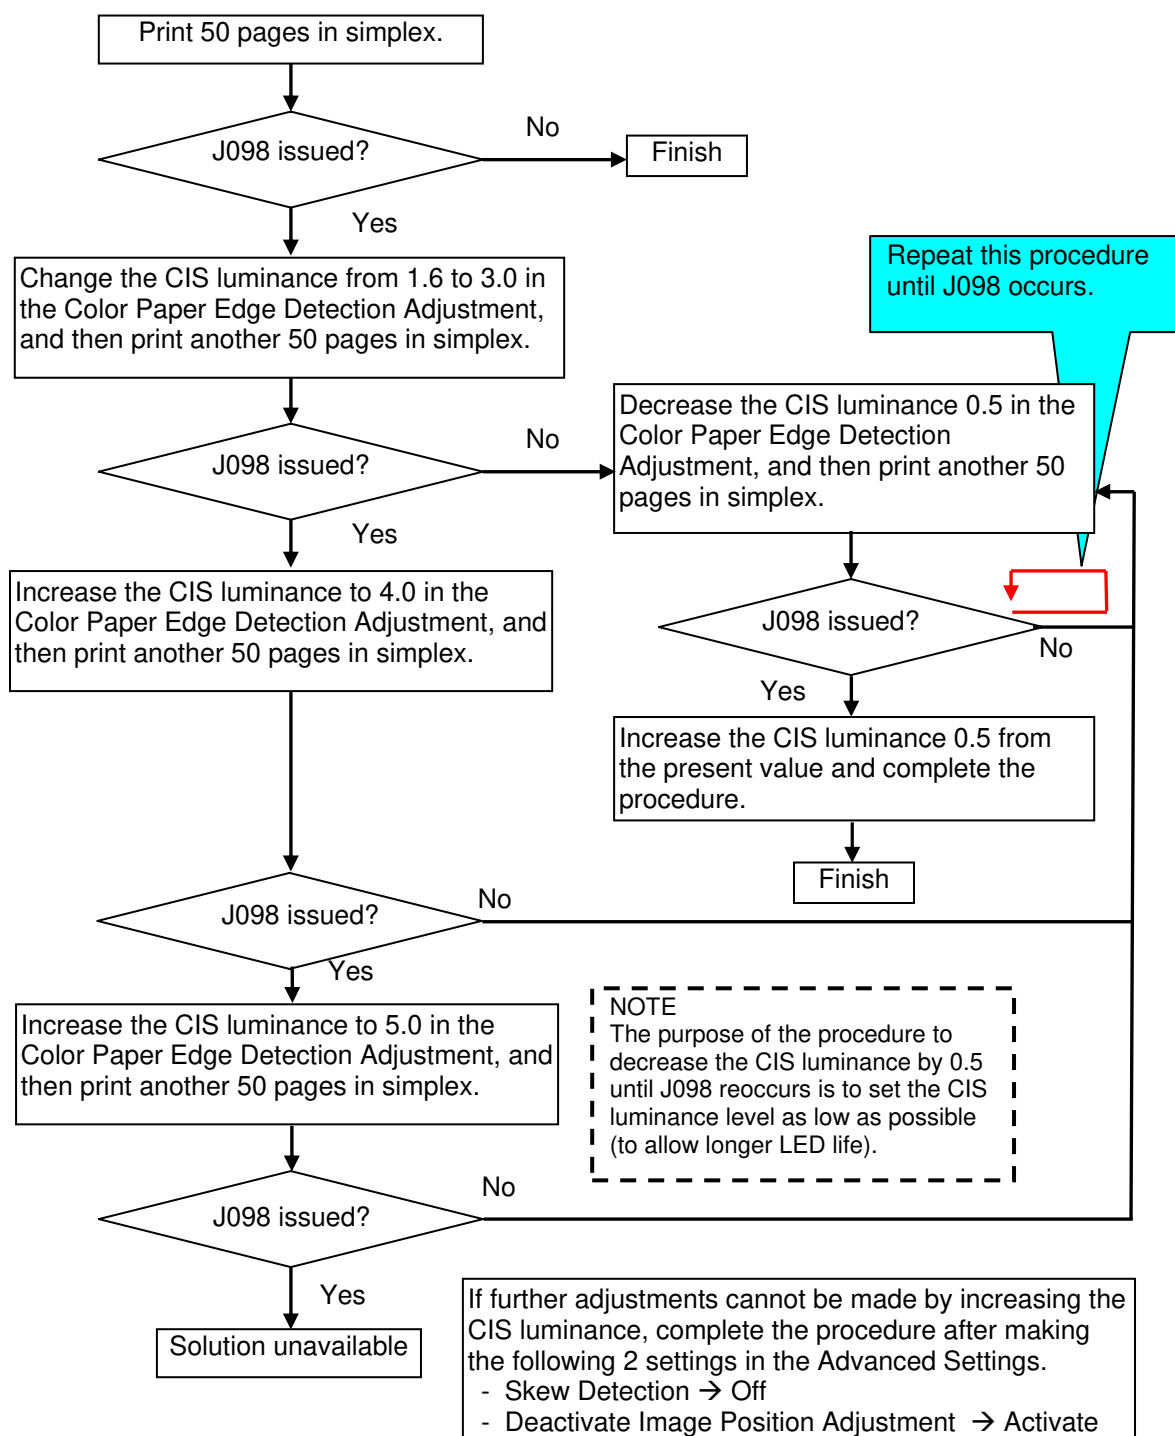
CIS Luminance Adjustment Flow Chart

The CIS fails to correctly detect paper edges, especially when feeding red or blue paper because the light source of the CIS is green.

Adjust the luminance of the CIS in Advanced Settings "06: Color Paper Edge Detection Adjustment".

Although the Color Paper Edge Detection Adjustment allows the CIS luminance level to range between 1 and 5, setting this value to a high level could cause the LED to reach its life quickly. Therefore, it is recommended that the CIS luminance is set to approximately 3.5.

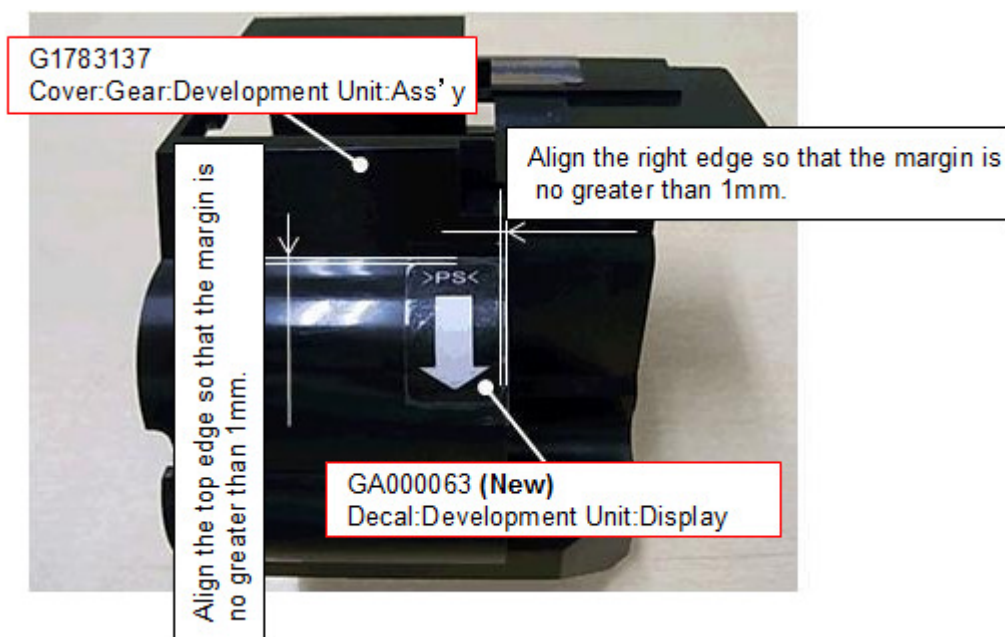
Change : Addition of a decal

Reason : To indicate the direction of development roller rotation. The entrance seal of the development unit could wear and cause adverse effects if the development roller is rotated in the opposite direction.

1. Clean the surface of the Cover: Gear: Development Unit: Ass'y (G1783382) with alcohol.
2. Attach the Decal: Development Unit: Display (GA000063) as shown in the photo below.
3. Make sure the decal is securely attached; no air-bubbles or peel-offs.

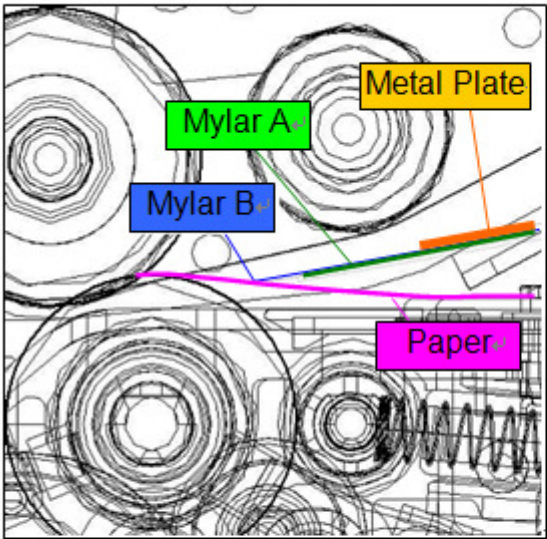
Original (Type AD)	Modified (Type BX)

Reason: To prevent scratched images that could occur when feeding thick paper. Thick paper lifts up the guide plate and causes the tip of the mylar to contact the ITB.

<p>Distance between ITB and Guide Plate: 2.1mm^{±.1} Distance between nip and Guide Plate: 11.7mm^{±.1} Length of Mylar A (green): 12mm^{±.2} Length of Mylar B (blue): 16mm^{±.2}</p>

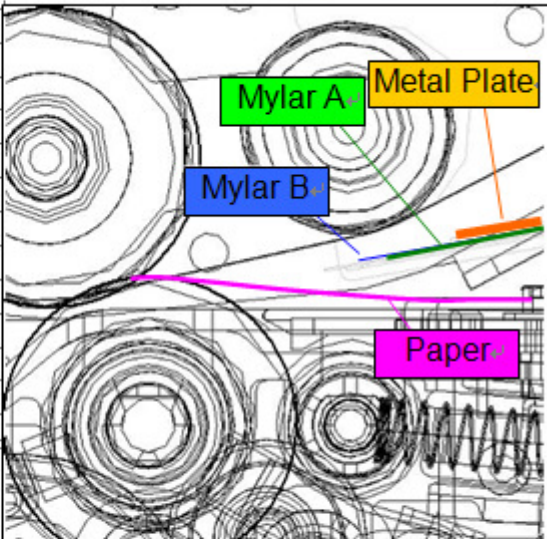
<p>Distance between ITB and Guide Plate: 2.6mm^{±.1} Distance between nip and Guide Plate: 18.6mm^{±.1} Length of Mylar A (green): 10mm^{±.1} Length of Mylar B (blue): 12mm^{±.2}</p>

- The modified guide plate Type BX could cause “poor transfer on leading edge” as a side effect. If this side effect is confirmed, ~~switch the guide plate back to the mass production Type AD, or~~ replace M0776527 with Type BF: M0776522, which was modified to prevent this side effect.

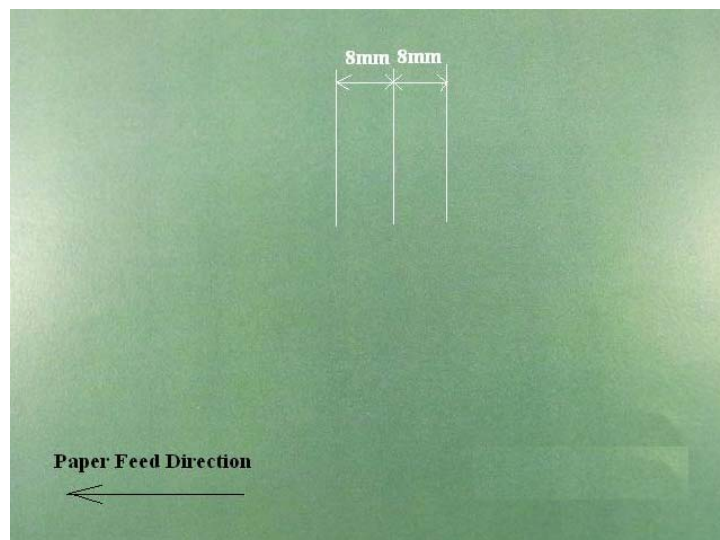
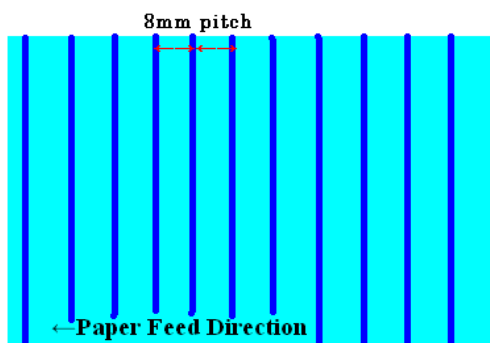
Banding of about 8mm pitch appears throughout the page

Temporary countermeasure: Replace the GEAR:DEVELOPMENT ROLLER Z29

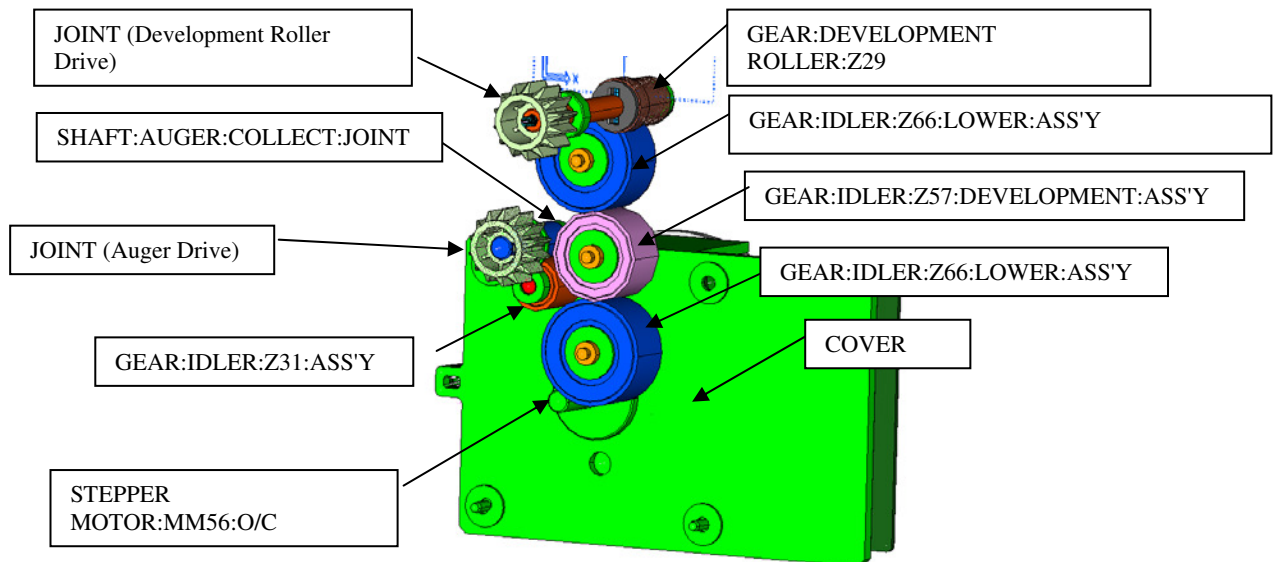
Figure 1: Layout of gears inside the drum drive unit

After shaping the GEAR:DEVELOPMENT ROLLER Z29, the plastic around the gear shrinks. Refer to figure 1 below

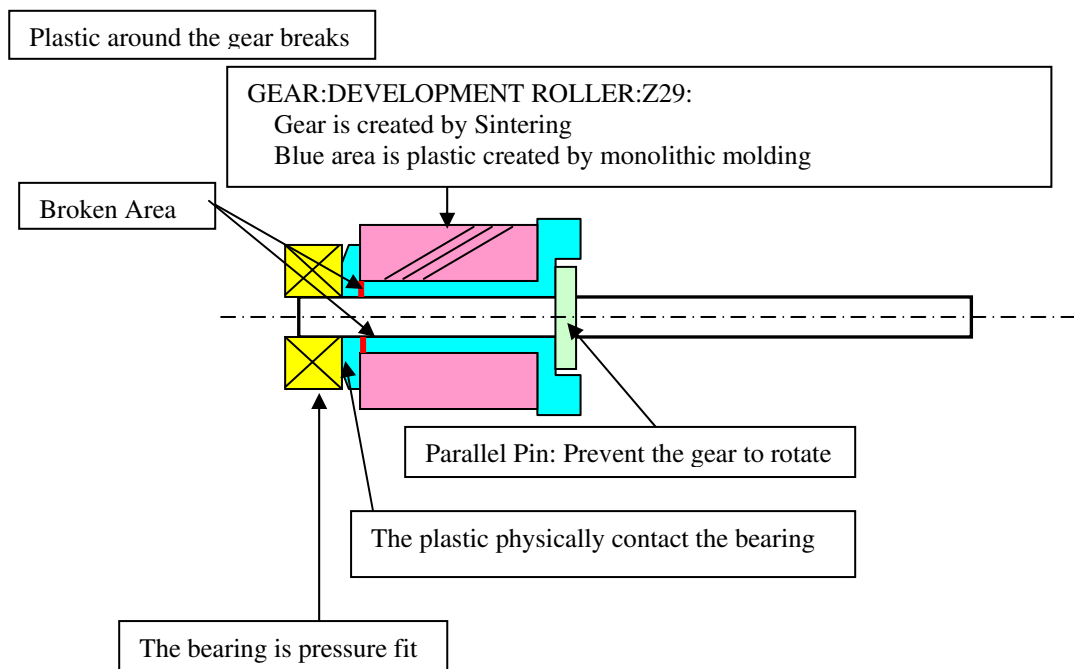
Figure 2 Composition of GEAR : DEVELOPMENT ROLLER Z29

The plastic around the gear breaks (refer to the red lines in figure 2) and creates a backlash. Then, the development roller does not rotate uniformly, which creates the 8mm pitch banding.

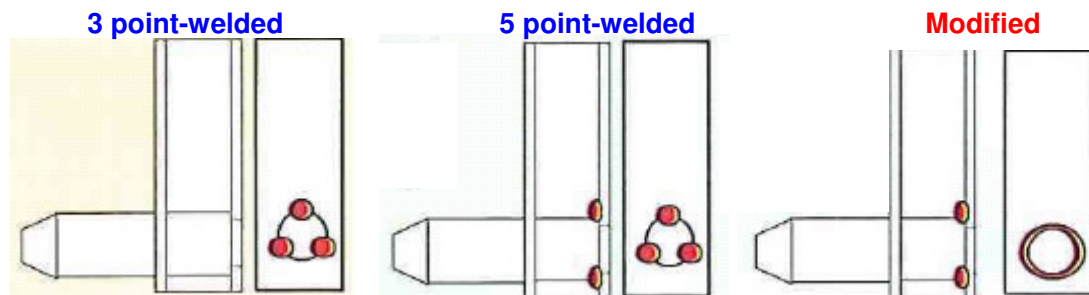
The pins welded to the detachable fusing unit handle for some of the units could loosen after using the handle a few hundred times to load/unload the fusing unit.

The pins could become loose on the currently available 3 point-welded type and 5 point-welded type handles due to the insufficient amount of weld.

* Areas colored in red indicate the locations of the weld.

The handle was modified to apply the weld to the entire periphery of the pin to secure higher durability.

Replace the 3 point-welded handle and the 5 point-welded handle with the modified handle on your next service visit.

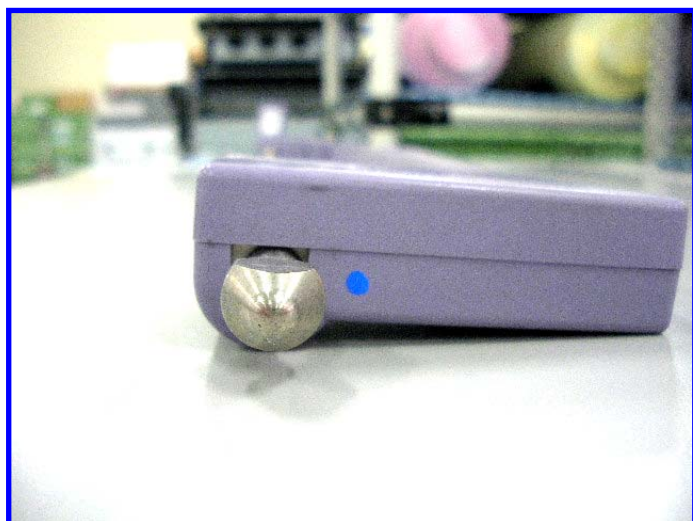
The modified handle is indicated with a mark as shown in the photo below.

Discard the handle after replacing with the modified handle.

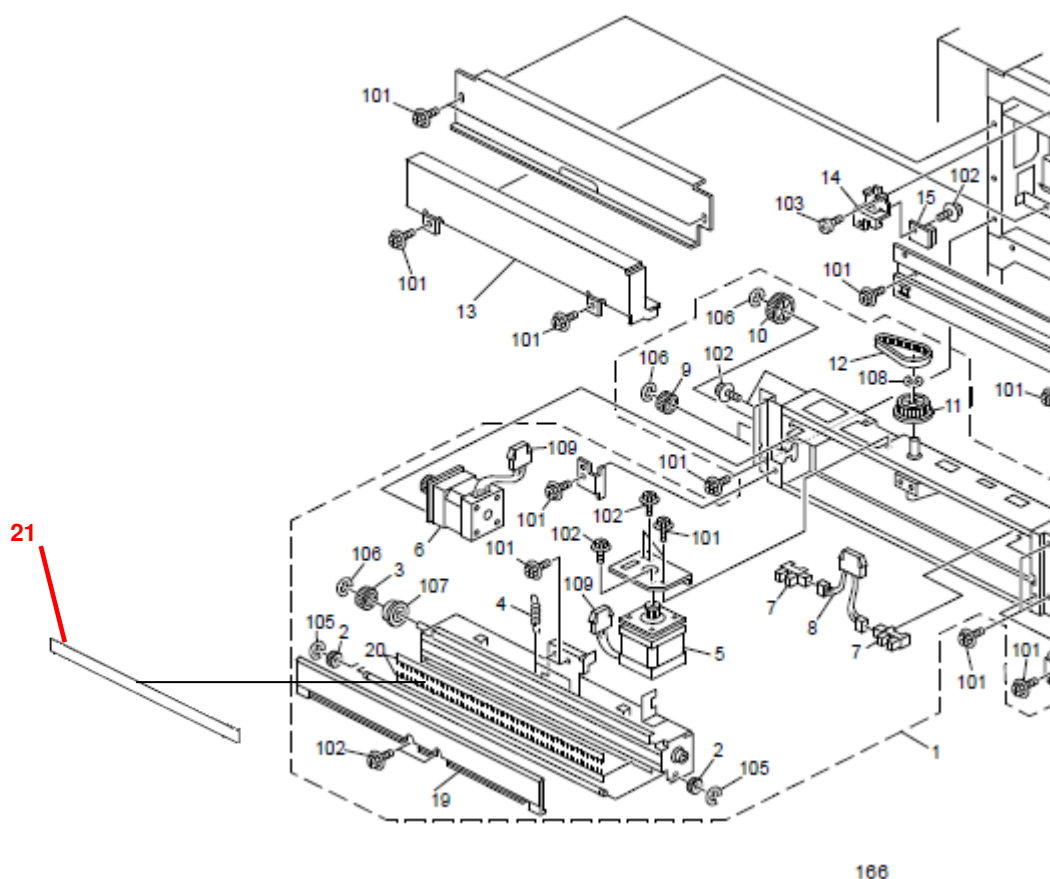
71.Paper Exit Section 13 (D095/M077)

This part was added to prevent possible injuries when fingers accidentally get caught in the Decurl unit.

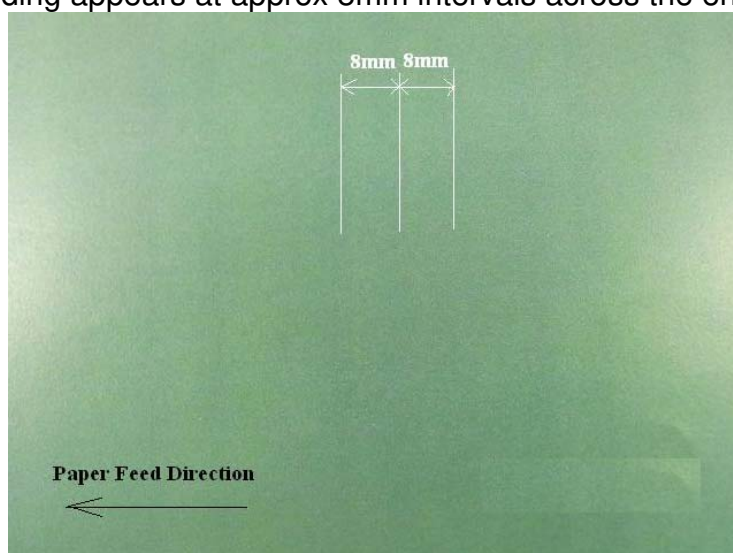
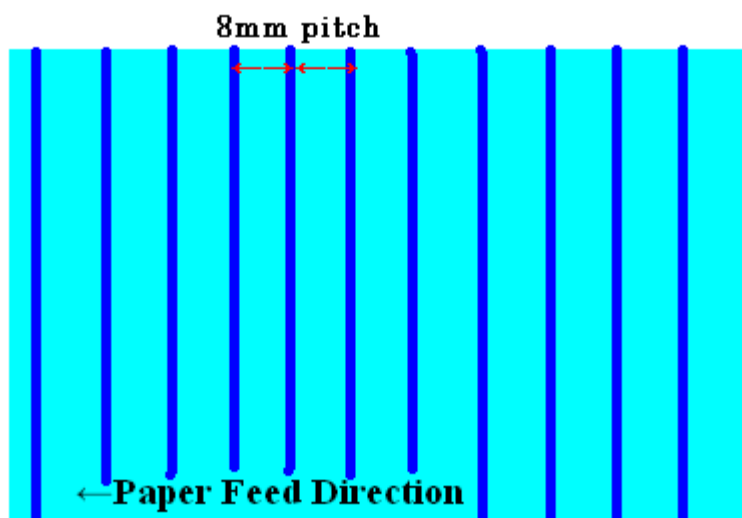
While RTB RM077058a instructs how to replace the “Drive Unit: Around The Photoconductor: Ass’y”, the latest rework requires replacement of only the gear installed in the drive unit to troubleshoot 8mm pitch banding.

SYMPTOM

Banding appears at approx 8mm intervals across the entire page.

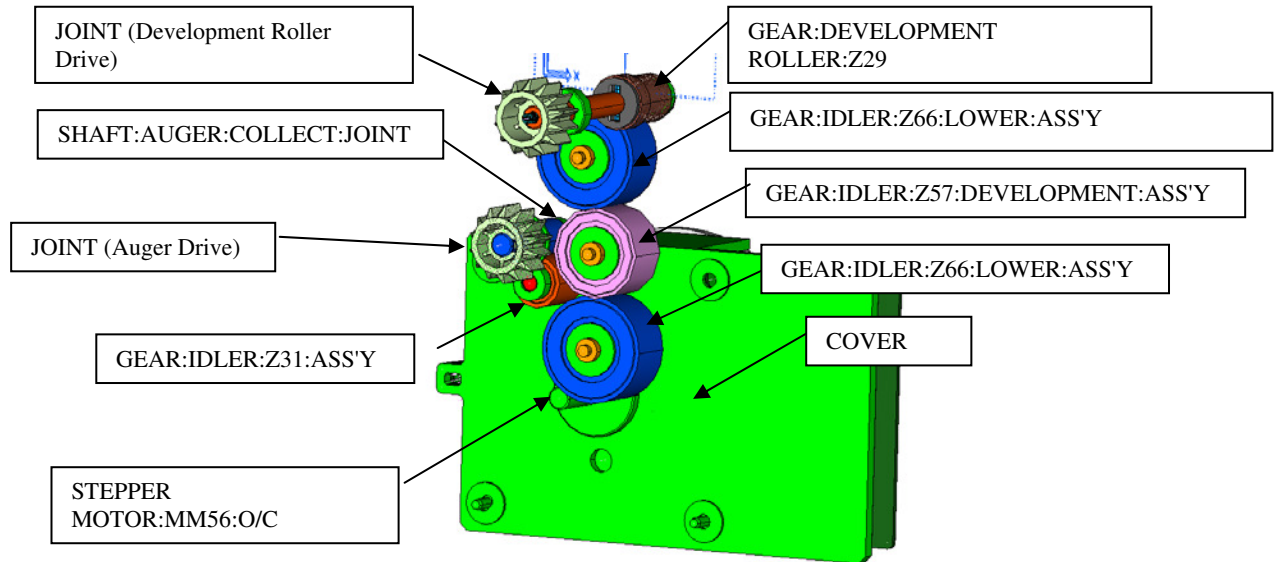
Figure 1: Gears installed in the drum drive unit

The plastic piece incorporated with the sintered gear (GEAR: DEVELOPMENT ROLLER Z29) shrinks and breaks over time, resulting in a backlash which disables consistent revolution of the development roller. (See figures 1 & 2 below.)

Replace the currently installed GEAR:DEVELOPMENT ROLLER Z29 with the following part:

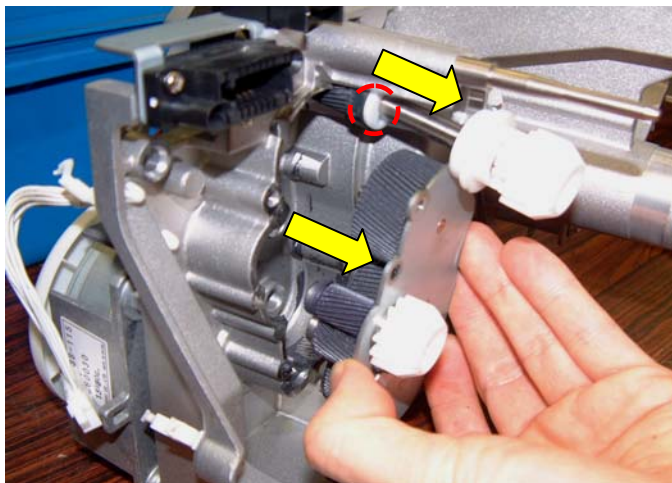
The INSULATOR:REAR:BEARING, circled in red in the photo above, may be detached from the gear box together with the GEAR: DEVELOPMENT ROLLER: Z29. In that case, attach it back to the gear box.

11. Pull out the gear box and the GEAR:DEVELOPMENT ROLLER:Z29 together.

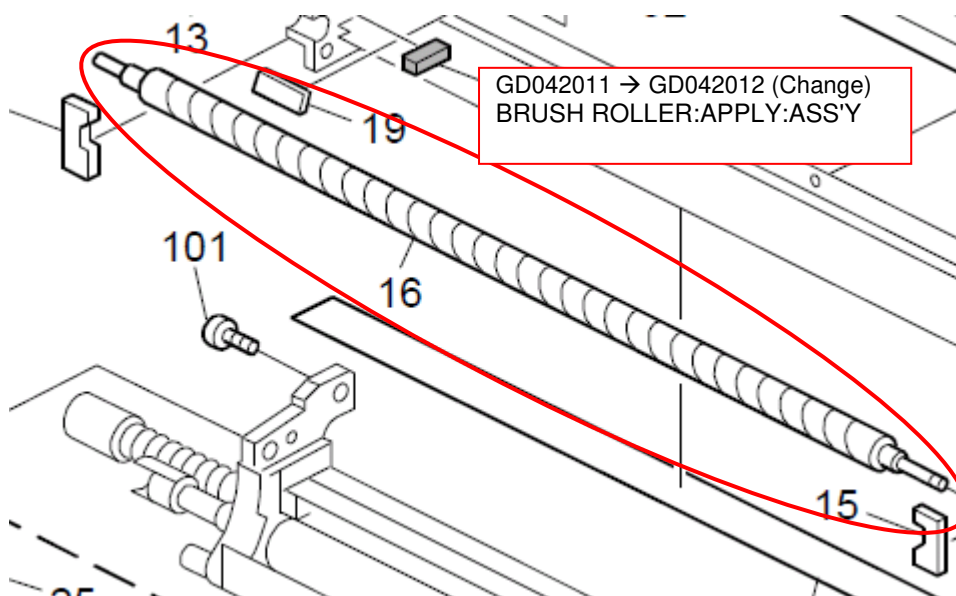
Reason: To prevent the image quality issue known as “Vertical lines” caused by excess lubricant applied to the OPC drum

Action: If you encounter the above image quality issue, replace the brush roller with the new brush roller described below.

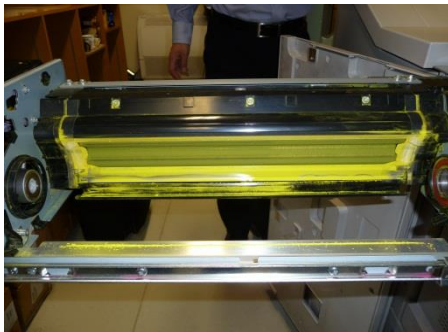
Do this procedure if toner scattering is observed around the development unit as shown in the photo below, which will achieve higher security in preventing toner scattering.

4-3. Vacuum the toner adhered to the opening where the TD sensor was mounted. This is non-circulating toner that blocks the TD sensor and causes false detection of the toner concentration, resulting in an incorrect Vt.

4-1. Take out the development unit and place it on a table upside-down.

4-2. Remove the TD sensor from the development unit. (screw x2)

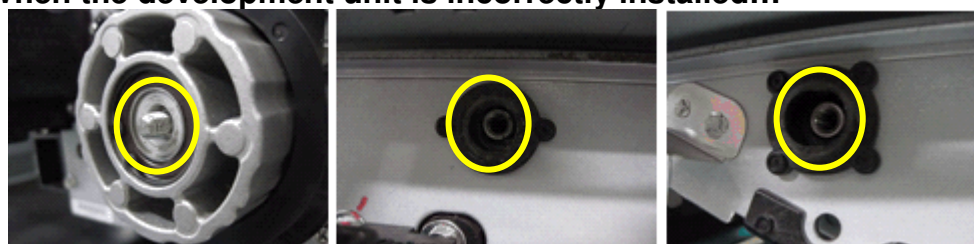
The surface of the knob is clearly protruding against the adjacent area (black-colored) and the screw holes are sunk in and are not clearly visible, as shown in the photos above. In this case, the unit is bounced back towards the front side because the drum internal and drum drive external gears are not properly engaged as shown below.

When the gears are not engaged properly, the drum cleaning unit pushes the drum towards the direction in which the PG is narrowed. Printing in this condition will cause toner to adhere to the development rollers and generate scratches on the drum surface.

If the above SC occurs and heavy scratches are observed on the drum surface, replace the drum with a new one.

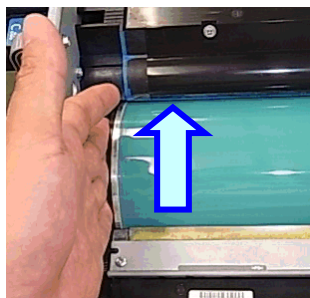
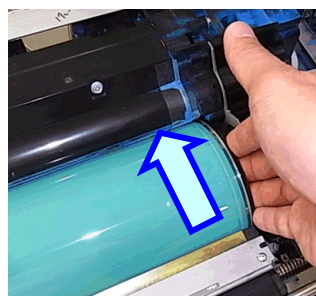
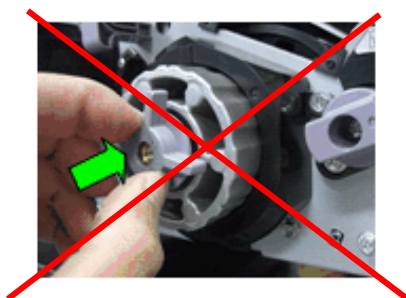
Do not attempt to forcefully fasten the (cross-shaped) drawer stop knob by shoving in the unit. Doing so will NOT help install the unit completely but will only damage the teeth of the internal gear.

If the development unit is not correctly installed, pull out the PCDU and slightly reposition the drum so that the internal and external gears are engaged properly.

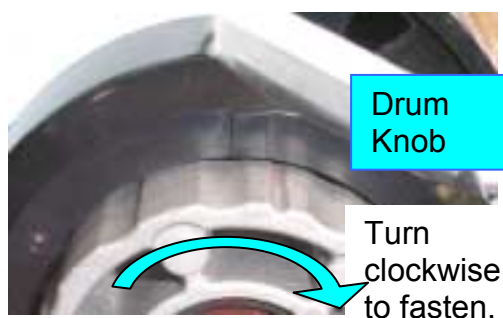
Do NOT fasten the drum knob when the development unit is installed.
Do NOT fasten the drum knob when the drum cleaning unit is installed.

Fastening the drum knob with the drum cleaning unit installed will cause the drum cleaning unit to apply pressure to the drum and narrow the PG at the front side.

If the drum knob is loosened with the drum cleaning unit installed, make sure to remove the drum cleaning unit, and then fasten the knob.

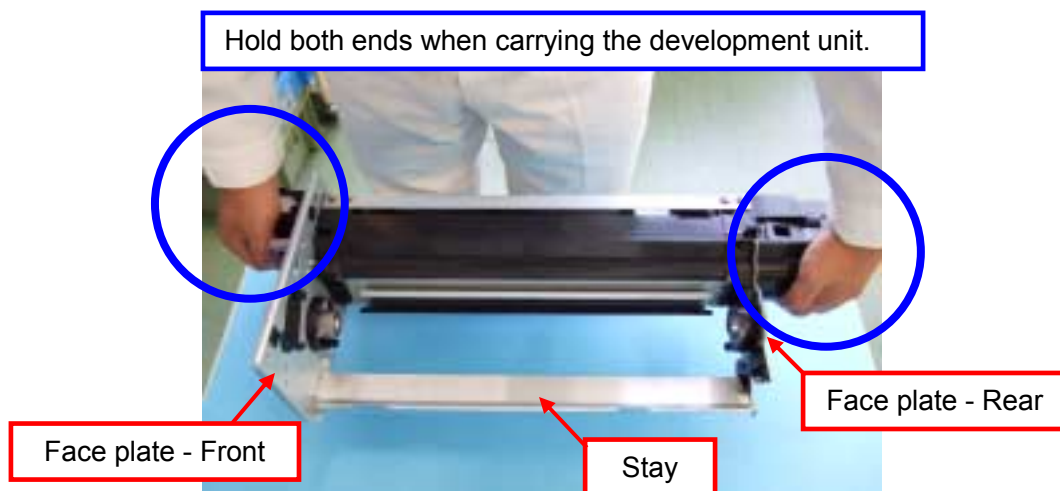
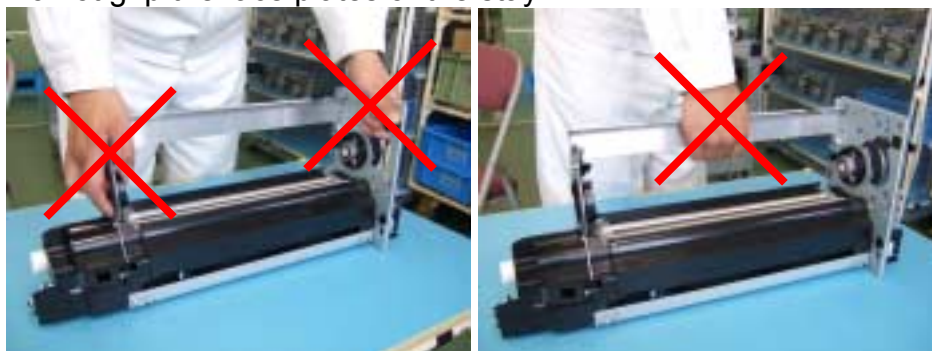
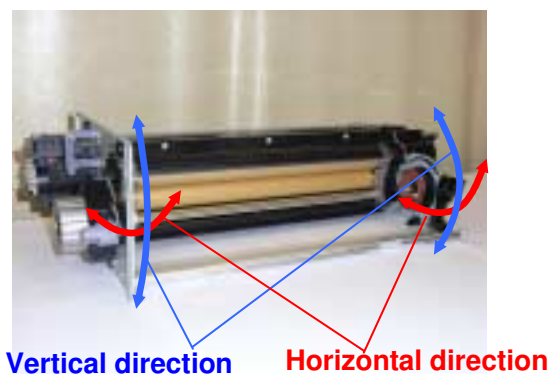
Do not grip the face plates or the stay.

Applying external pressure will deform the front and rear plates in vertical and horizontal directions, resulting in fluctuation of the PG.

- Always hold the prescribed locations when handling the development unit.
- Never apply external pressure to the front and rear plates and the stay.

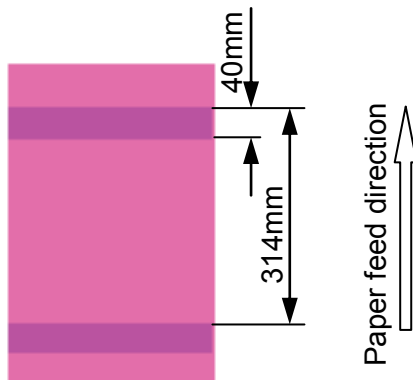
40mm wide dark bands appear at 314mm intervals

Normally, the exhaust fans behind the PCDU that operate for a prescribed time after completing a job could ventilate the ozone in approximately two hours. However, when the machine is run under most, if not all, of the following conditions, ozone emission increases and causes ozone to accumulate easily.

- Charge Corona exceeds 100K
- The machine is operated in a low temperature/low humidity environment, and the correction values are applied to the charge corona unit according to the environment
- The machine is left unused overnight in a low temperature/humidity environment with its power turned off

Dark Bands could appear on the first job in the morning when meeting the above conditions.

This bulletin provides information on the External Power Supply Unit exclusive to the Aries-P1.5/C1.5 and Aegis-P1/C1. The external PSU, which activates the exhaust fans located behind the PCDU, was registered as a service part to counter uneven density issues (dark bands) caused by ozone accumulation that occurs under specific conditions. (See 'Cause' on the following page.)

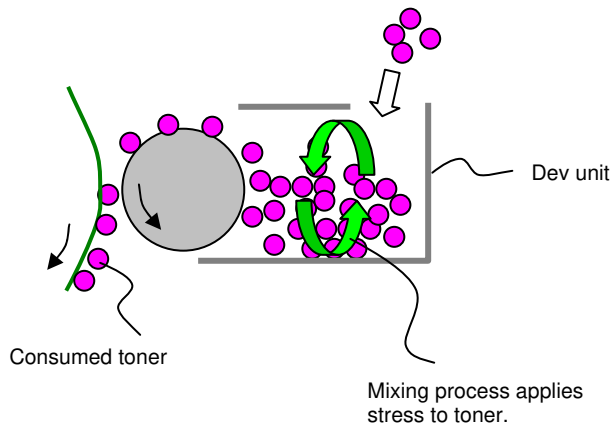
Toner is supplied proportionately to its consumption rate.

Average coverage is 4% or lower.

Toner stays in the dev unit for an extended time and is applied with a lot of stress in the mixing process.

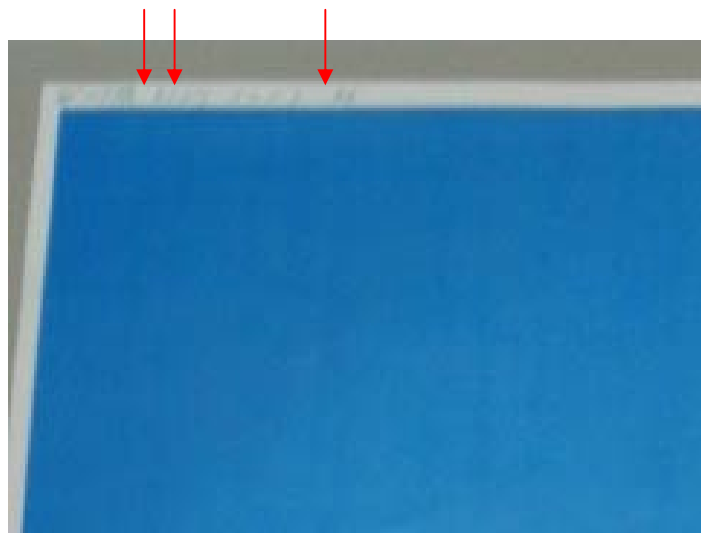
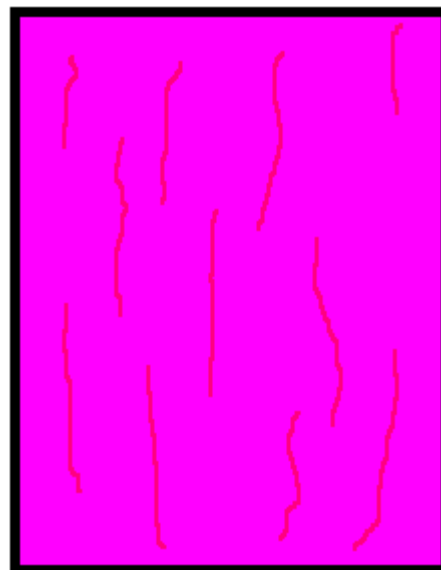
The symptom known as “fuzzy lines” is a result of insufficient supply of toner/developer mixture to the drum surface via the development rollers.

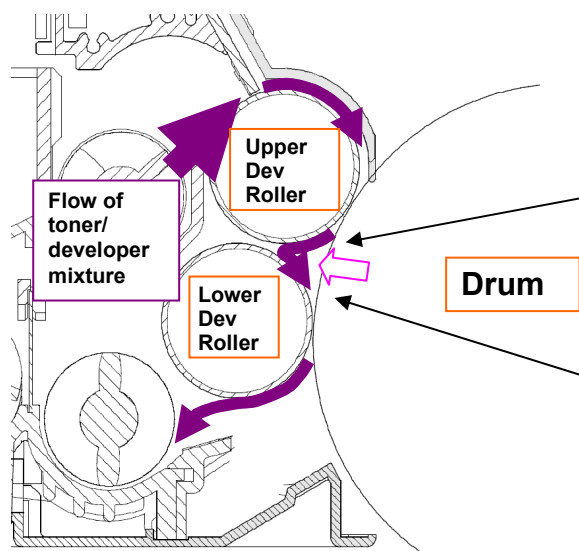
Photos A and B below show the slit between the upper and lower development rollers viewed from the drum.

Photo A: The “fuzzy” condition of the toner/developer mixture is reflected directly to the output, generating the fuzzy lines.

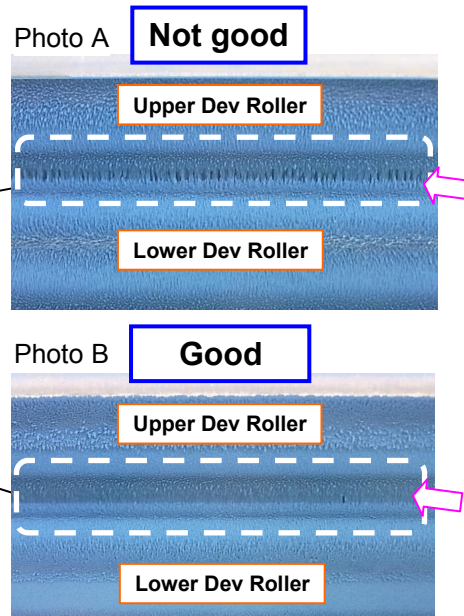
Photo B: The mixture is solid and generates proper output.

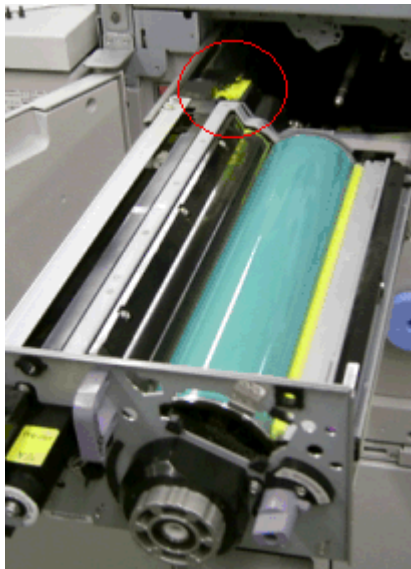
Photo 1

Toner supply from the sub-hopper to the development unit is obstructed by toner clumps that form in the path connecting the two components (red circle in Photo 1), and generates excess load on the sub-hopper shaft with a possibility of breaking the shaft (Photo 2).

Check for toner clumps in the toner supply path between the sub-hopper and the development unit (circled in red in the photos below), and if found, remove the clumps with a vacuum cleaner.

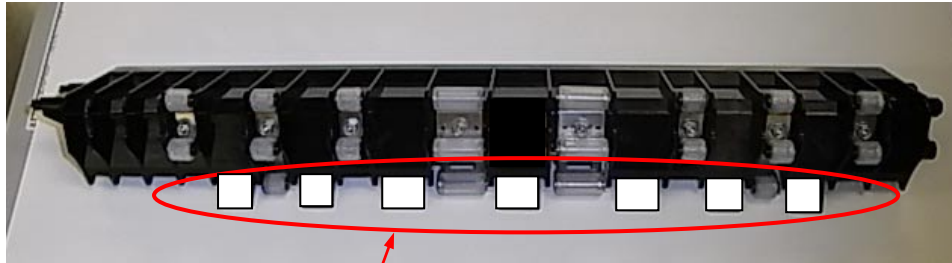
Check for toner adhesion on these tips.

Disassemble as described below to check for toner adhesion at the tip of the paper exit guide assembly. If toner adhesion is confirmed, clean with alcohol.

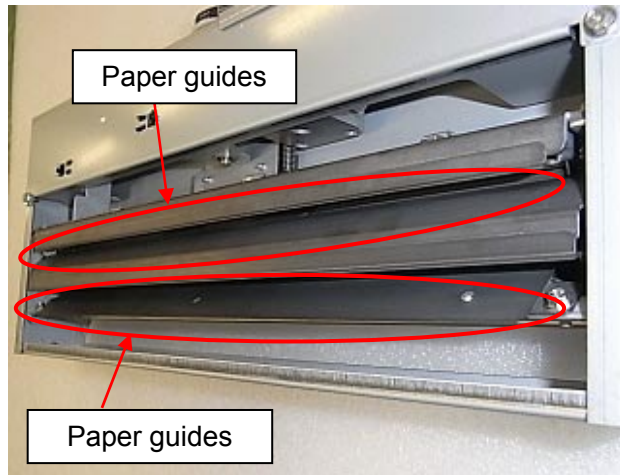
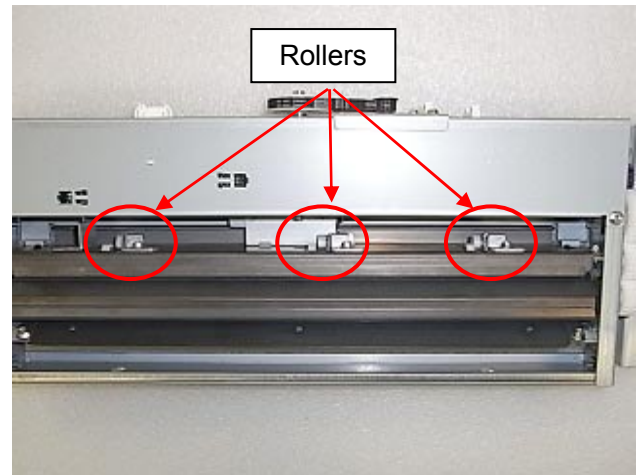
Entrance

Remove the de-curl unit by following the procedure described below to check for toner adhesion on its guide plates and rollers. If toner adhesion is confirmed, clean with alcohol.

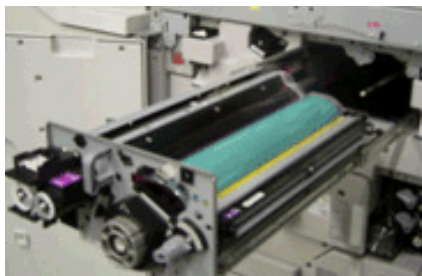
Photo 1

- SC324~327; development motor lock (KCMY)
- SC396~399; drum lock (KCMY)
- SC320~323 (Development bias: high voltage error: KCMY) caused by excessive scratches on the drum surface (See "Reference" on the following page.)

IMPORTANT: Work carefully to avoid damage to the drum with the screwdriver.

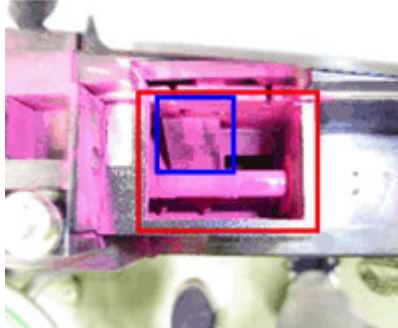
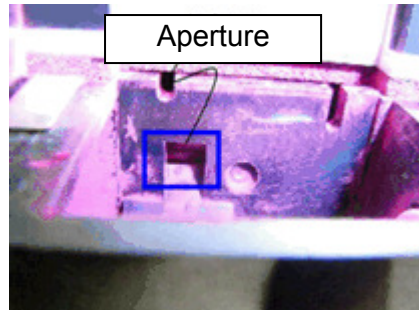
5. Check if the aperture (indicated in blue) is clearly visible as in the photos below.
Disposal of excess developer is disabled when this aperture is clogged.

Therefore, if allowed, it is recommended to carry out the check on a weekly basis.

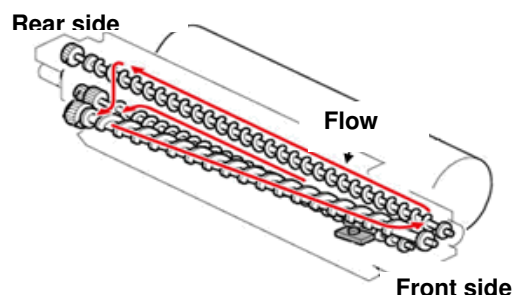
Due to the nature of the developer flow inside the development unit, excess developer in the unit causes toner to accumulate at the rear side (lower auger) of the development roller.

Toner accumulation results in forming toner clumps that scratch the surface of the drum.

Excessively scratched drum could cause SC 320~323 (Development bias: high voltage error: KCMY).

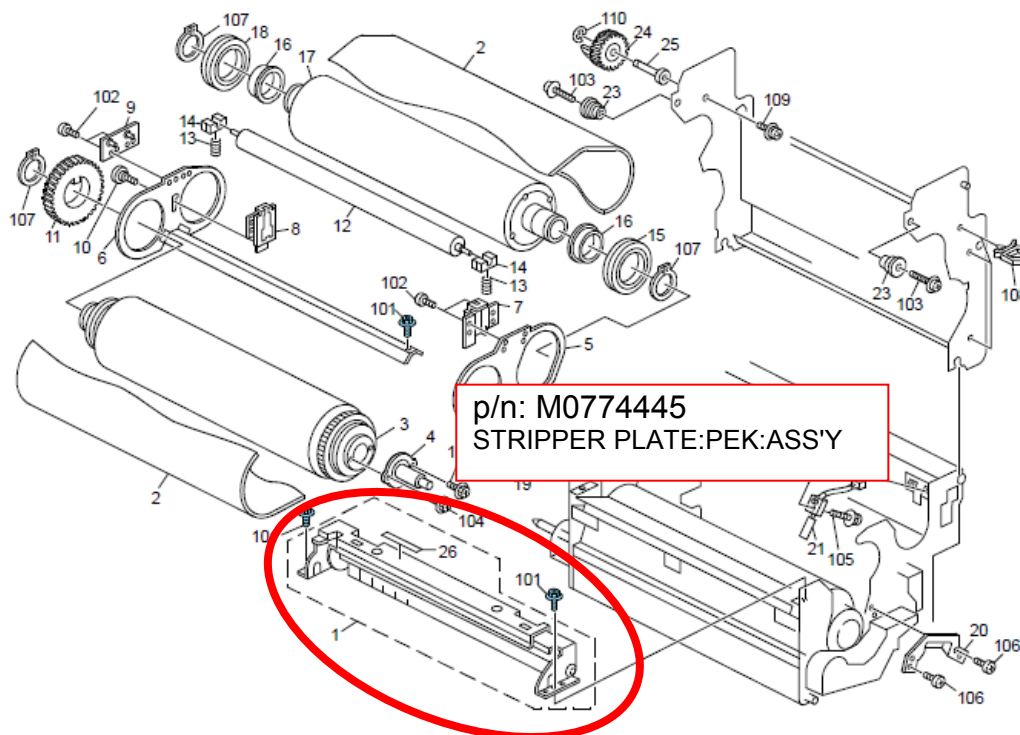
56.Fusing Unit 5 (D095/M077)

Reason: Higher durability; to prevent breakage of the stripper plate caused by paper jams.

IMPORTANT: The new stripper plate has the following side effect. Chances of generating glossy lines/streaks are higher compared with the original stripper plate (p/n: M0774491). If this side effect is confirmed with the new stripper plate, change the machine settings as described in the following pages.

NOTE: This new stripper plate DOES NOT have to be procured for all MIF. Only replace as necessary in accordance with your customer's machine usage conditions.

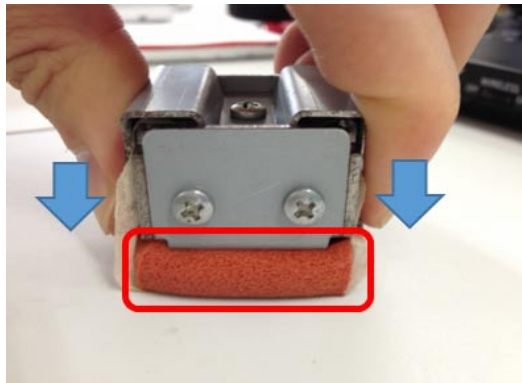
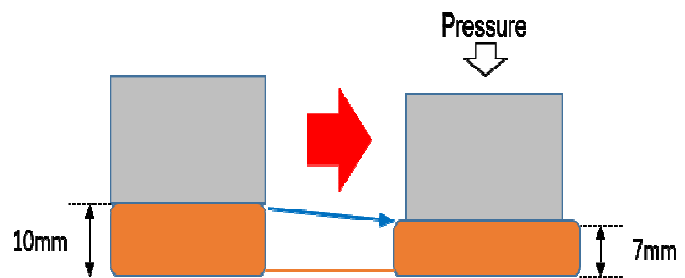
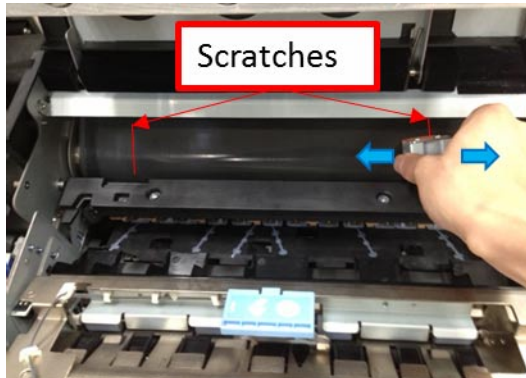
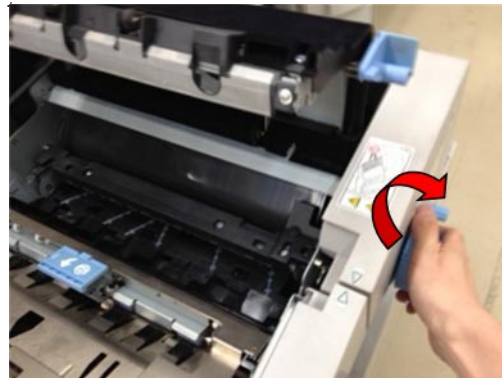
NOTE: See photos and diagrams below for a reference on the appropriate amount of pressure that should be applied when polishing the belt.

3. Rub M0774287 WEB:POLISH:FUSING:ASS'Y against the fusing belt to smoothen the scratches and rotate the knob clockwise so that the entire belt can be polished. **Rub approximately 30 times for each location, although this will depend on the condition of the scratches.**

4. After polishing the fusing belt, put back the fusing unit.
5. Print out sample copies to check if vertical lines appear or not.

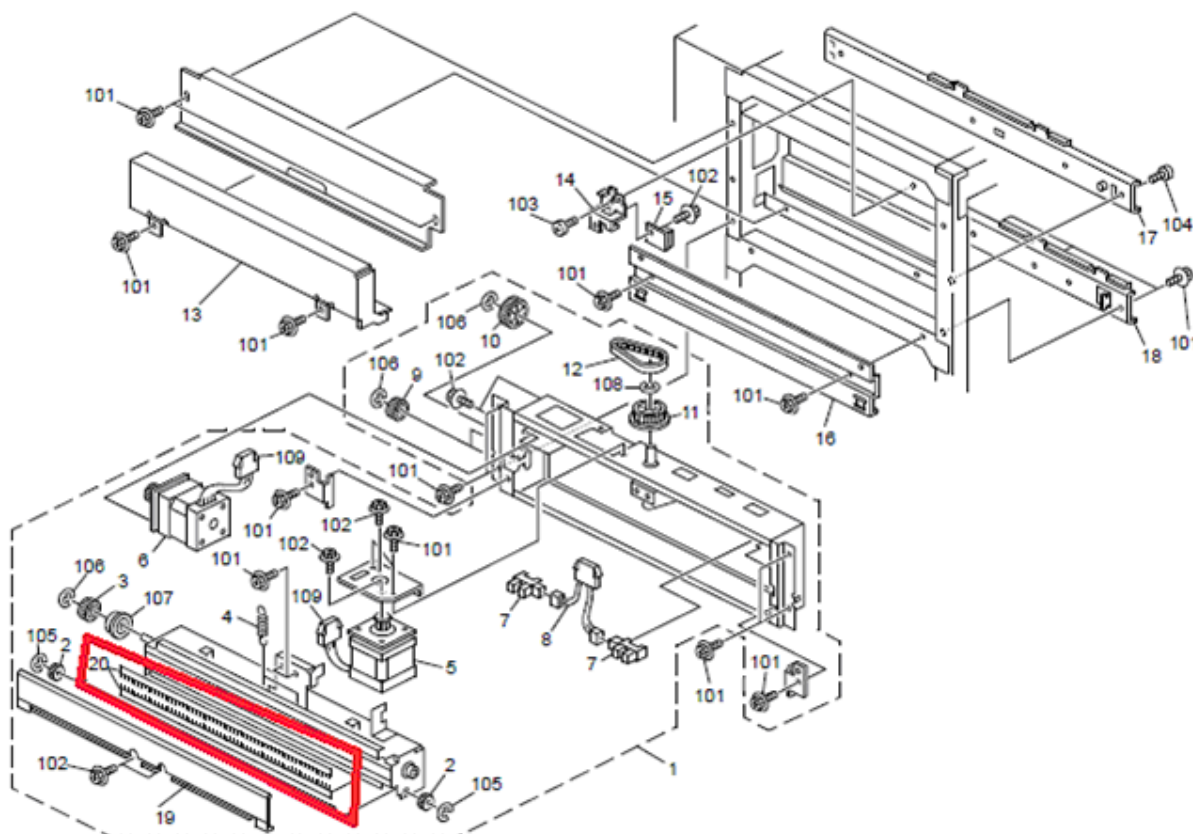
71.Paper Exit Section 13 (D095/M077)

The yellow rectangles represent the discharge brushes.

1. Disassemble the de-curler unit and clean the rollers inside.
2. If the problem persists, replace the discharge brushes (indicated in red below) in the de-curler unit.

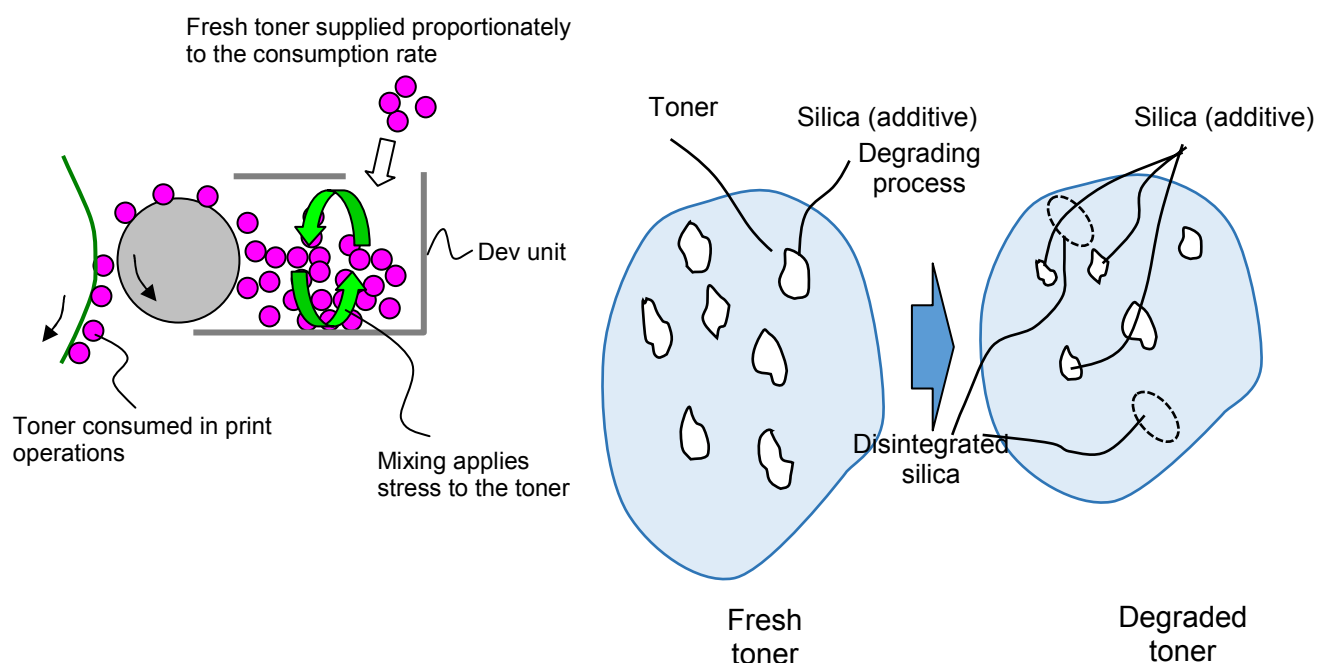
Toner degrades when fresh toner is not supplied to the development unit due to its low consumption rate, which is caused by the following 3 factors:

- Low image coverage ratio
- Idling of C, M, Y development units when printing in B/W mode
- Idling of the mainframe while optional devices are in operation

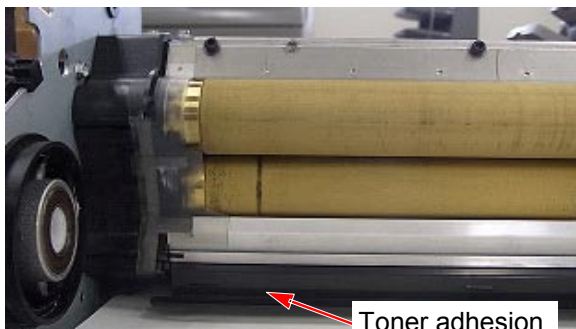
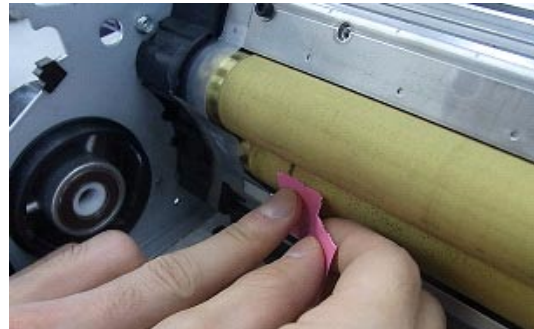
Another factor that causes drum scratches is a narrow PG (potential gap), in which the gap between the development roller and drum is narrower than the specification. In this condition, stress is applied to the developer in the development process because the developer is forced to move through a narrow gap, generating excess electrical current along with heat and pressure. As a result, developer adheres to the surface of the development roller and toner accumulation continues, eventually scratching the drum.

- A narrow PG could be caused by an incompletely fastened drum knob. Refer to the following RTB for the proper drum knob fastening procedure.
 - RG178128d (pages 5~9)
- Check that the drum is properly installed.
 - RG178128d (page 4)
- Remove the toner adhered to the surface of the development roller.
 - RG178128d

- Do #208 "Execute Toner Refreshing" in the Adjustment Settings for Skilled Operators Menu.
NOTE: The developer DOES NOT have to be replaced.

If the DG (doctor gap) is clogged with toner, remove the clogged toner with a piece of paper, then do #208 "Execute Toner Refreshing" again.
