Model: Aries-P1.5	Date: 04-Oct-10	No.: RM077001h
-------------------	-----------------	----------------

Subject: Firmware Release Note: Engine		Prepared by: T. Miyamoto	
From: 1st PP Tech Service Sect., PP Tech Service Dept.			
Classification:	<input type="checkbox"/> Troubleshooting <input type="checkbox"/> Mechanical <input type="checkbox"/> Paper path <input type="checkbox"/> Product Safety	<input type="checkbox"/> Part information <input type="checkbox"/> Electrical <input type="checkbox"/> Transmit/receive <input checked="" type="checkbox"/> Other (Firmware)	<input type="checkbox"/> Action required <input type="checkbox"/> Service manual revision <input type="checkbox"/> Retrofit information <input checked="" type="checkbox"/> Tier 2

This RTB has been issued to announce the firmware release information for the **Engine**.

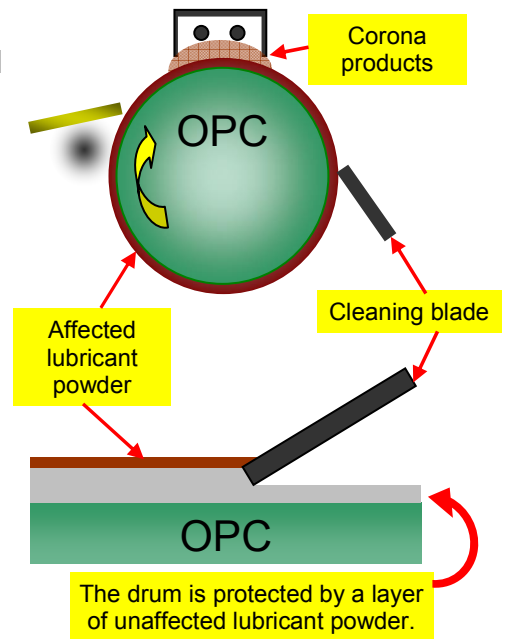
Images appear unclear and fuzzy when running the machine in a high temperature and high humidity operational environment.

In a high temperature/humidity environment, corona products cause the lubricant powder to decompose and ionize, which combines with moisture. In this condition, the drum surface resistivity is reduced and dots are not aligned as expected to properly develop the electrostatic image.

Do #203 “Execute Photoconductor Refreshing” of the Adjustment Settings for Skilled Operators to remove the affected lubricant powder (decomposed and ionized), which stays only on the surface layer.

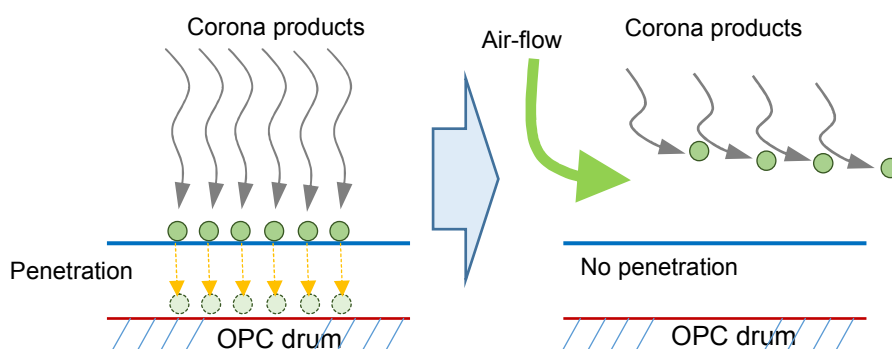
Image density appears uneven, and darker compared to the surrounding area, when running the machine in a low temperature and low humidity environment.

Keep the exhaust fans running continuously to completely get rid of corona products from the system by modifying the settings below.

1. Enter User Tools → System Settings → Timer Setting, and set the Timer Setting to OFF.
2. SP1-940-03: Ozone fan timer setting (default: 56min)
Change this value to "1270" min.
SP1-940-04: Development fan timer setting (default: 56min)
Change this value to "1270" min.
SP1-202-01: Heating roller temperature in low power mode (default: 110 degrees C)
Change this value to "0" degrees C.

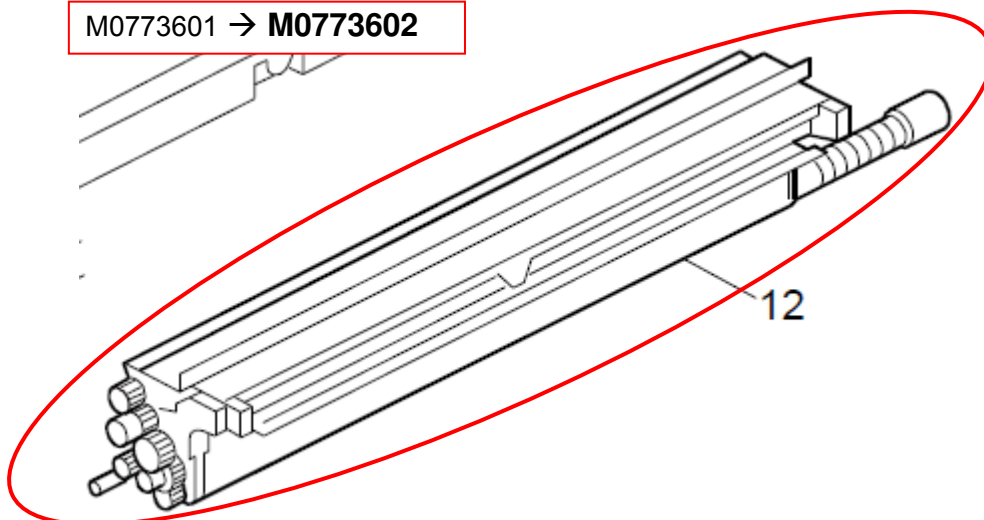
M0773601 → **M0773602**

Reason: To prevent SC39x (drum lock) caused by a toner blockage between the cleaning brush and the toner collection coil

- Higher performance of the agitator prevents toner from overflowing and generating printouts stained with toner.
- Higher performance of the agitator prevents toner clumps from forming at the aperture, which can break the gear or completely disable the drum cleaning operation.

- Replace the drum cleaning unit by ordering the modified drum cleaning unit (p/n: M0773602). DO NOT procure the agitator (p/n: M0773674) individually as it is assembled at the factory with a special tool and cannot be installed in the field.
- After installing the modified drum cleaning unit (p/n: M0773602), replace the PM parts contained in the unit individually as in the standard process.

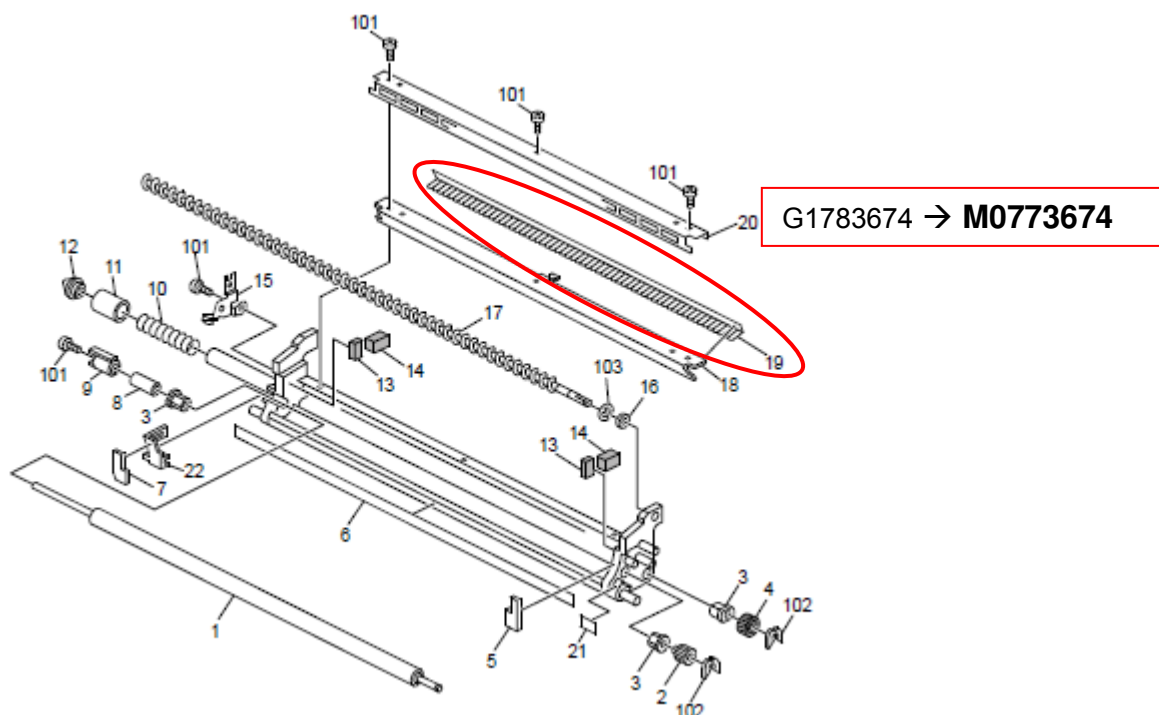
Old Part Number	New Part Number	Description	Q'ty	Int	Page	Index	Note
G1783674	M0773674	VIBRATINGPLATE: TONER COLLECTION COIL	1	X/O	99	19	Change

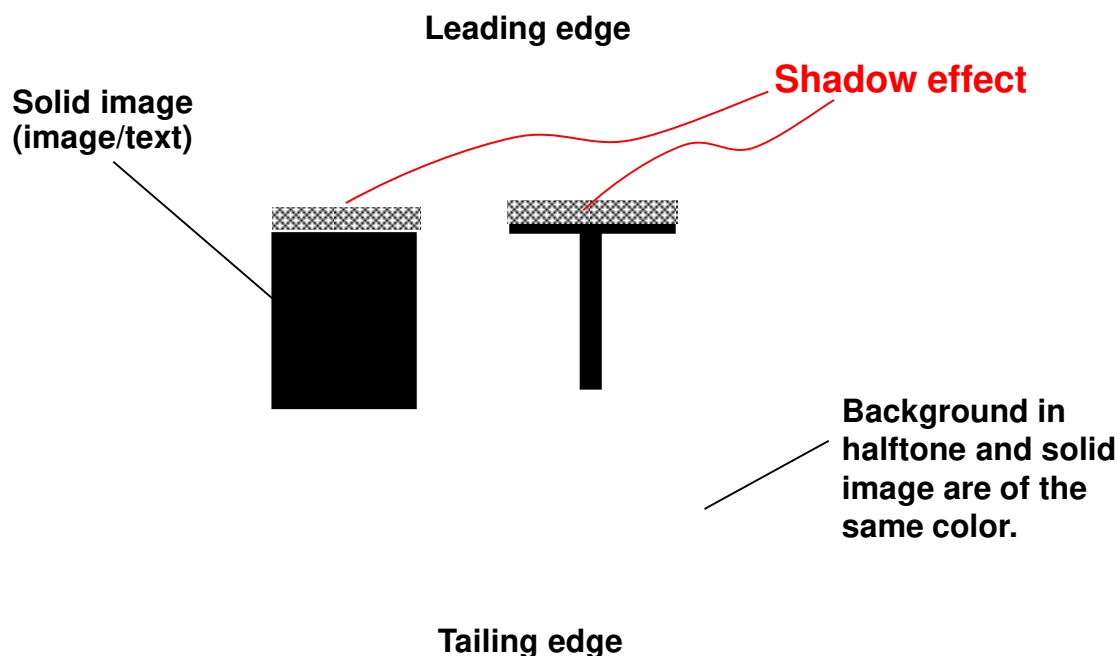
Symptom

If a solid image is printed over a halftone background image and the images are of the same color, the leading edge of the solid image appears darker, generating a "shadow" effect. The symptom is more likely to occur in Black.

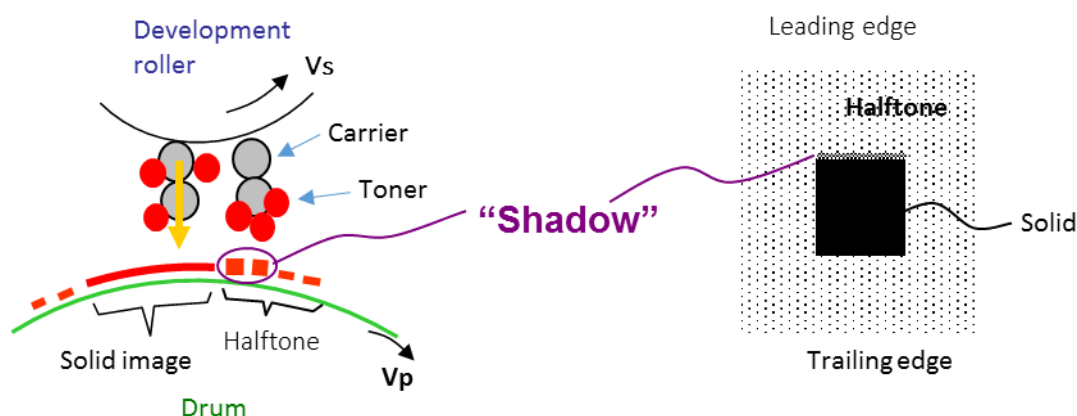
Cause

In the development process, toner is pulled from the surface of the development roller and transferred to the photoconductive drum. However, because the rotation speed of the development roller (V_s) is faster than the rotation speed of the drum (V_p), toner for the solid image is not transferred accurately to the drum, slightly exceeding the optimum position and causes the density of the background image adjacent to the leading edge of the solid image to become higher.

Note: The lower the toner charge level, the higher the risk.

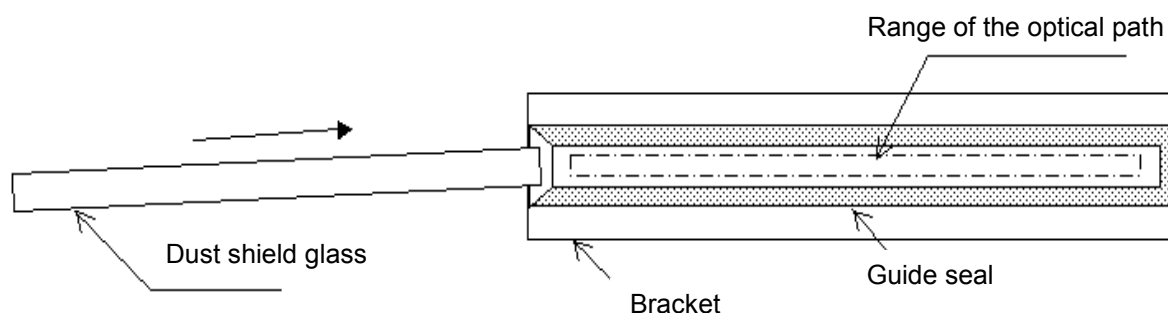
After cleaning the dust shield glass and sliding it back into the laser unit, it is falsely inserted at an angle, causing the guide seal attached inside the bracket to peel off. The guide seal removed and squashed inside the bracket blocks the laser, resulting in the white line.

1. The dust shield glass is inserted into the bracket at an angle.

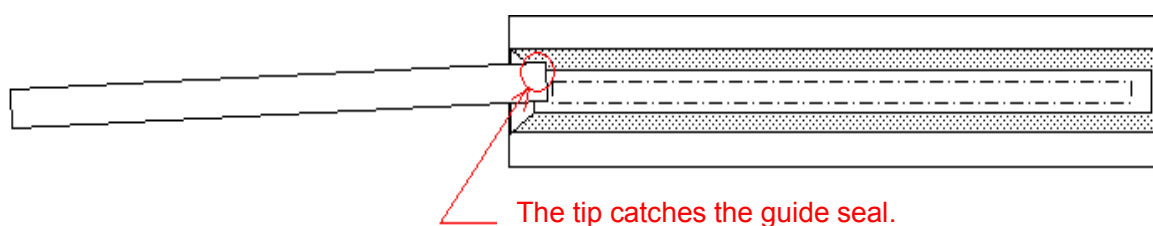
2. The tip of the dust shield glass catches the guide seal.

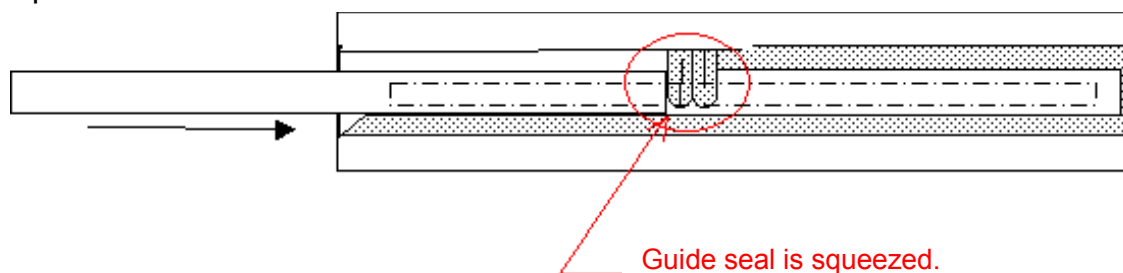
3. The guide seal is peeled off and squeezed inside, creating a blockage in the optical path.

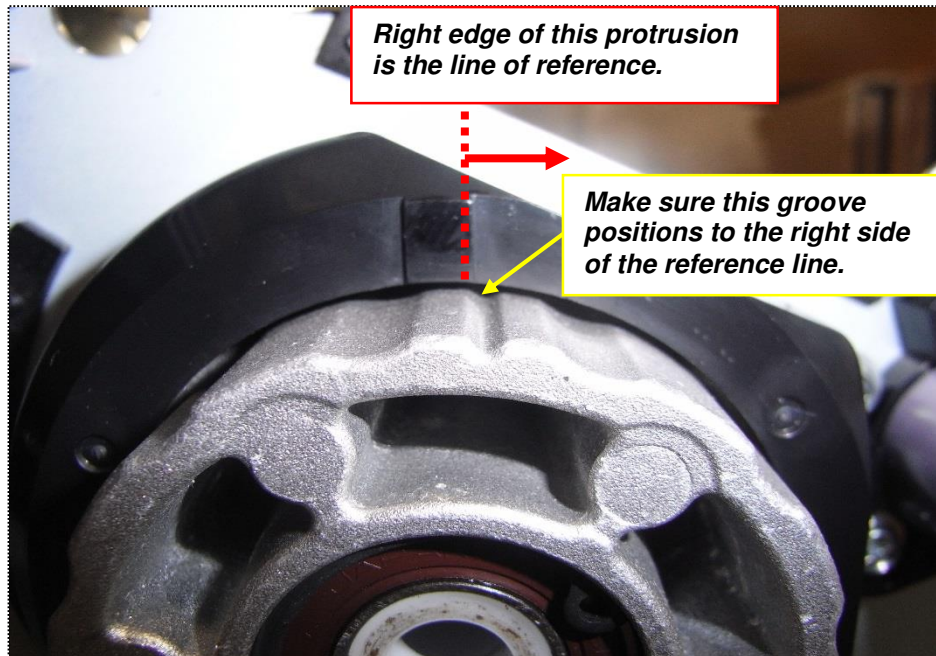
Correct Drum Knob Position

Tighten the Drum Knob so that the groove on the Drum Knob positions to the right side of the plastic protrusion on the PCDU as shown in the photo below.

Note: Turn the drum knob until it stops and cannot be further tightened.

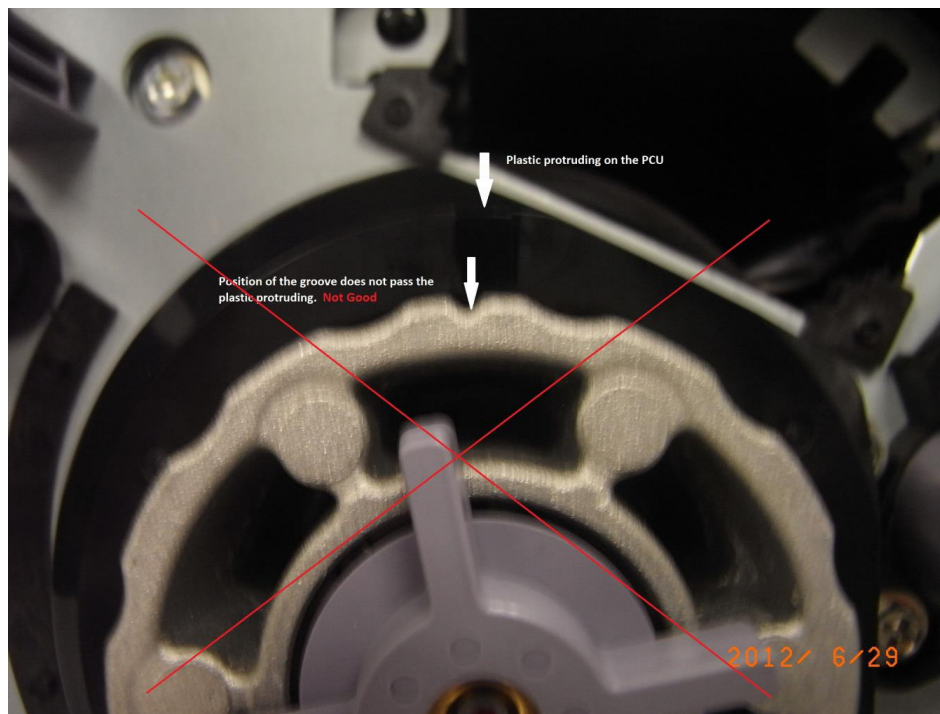
Incorrect Drum Knob Position

Fastening the drum knob with the drum cleaning unit installed will cause the drum cleaning unit to apply pressure to the drum and narrow the PG at the front side.

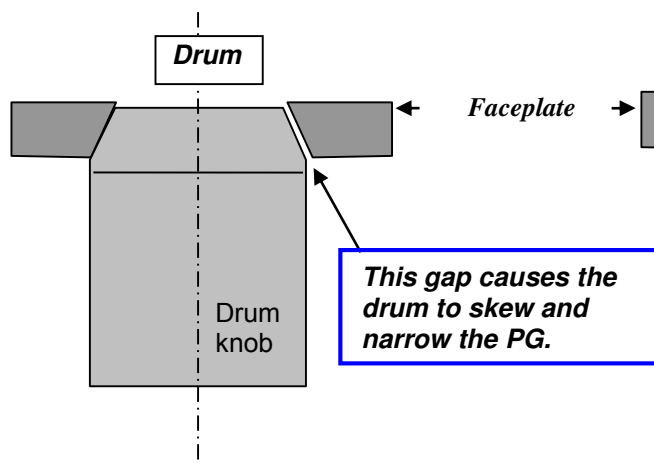
[Incompletely tightened drum knob]

If the drum knob is not fastened completely, the PG becomes narrow and causes drum scratches. Do the following procedure to remove toner adhered to the Mg sleeves.

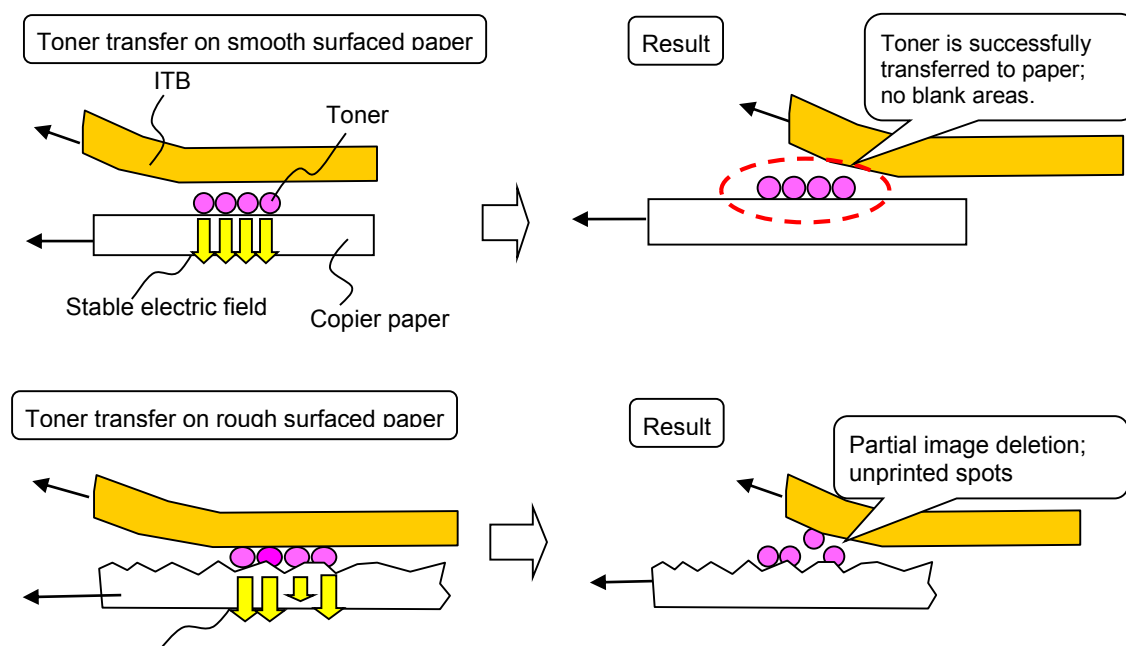
- Rough surfaced paper; unstable electric field -

Cause	Solution		Side effect
Paper with rough surface causes unstable electric field in the toner transfer process.	Image processing	Calibration	None
		Screening setting	Reduced image resolution
Toner degradation	Engine setting	Toner refresh amount	Toner yield will decrease if average coverage is 4% or lower
		ACS switch setting	<i>Productivity will slightly decreased by switching the print mode.</i>

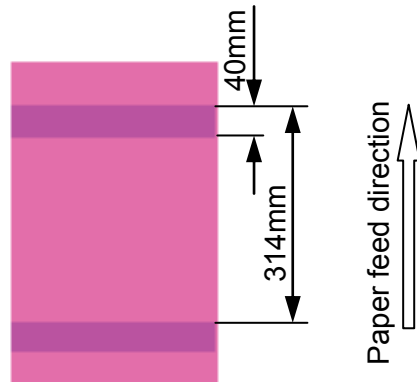
5-1. 40mm wide dark bands appear in 314mm pitch

Image density appears uneven, darker compared to the surrounding area, when running the machine in low temperature and low humidity environment.

Keep the exhaust fans running continuously to completely get rid of corona products from the system by modifying the settings below.

1. Enter User Tools → System Settings → Timer Setting, and set the Timer Setting to OFF.
2. SP1-940-03: Ozone fan timer setting (default: 56min)
Change this value to "1270" min.
- SP1-940-04: Development fan timer setting (default: 56min)
Change this value to "1270" min.
- SP1-202-01: Heating roller temperature in low power mode (default: 110 degrees C)
Change this value to "0" degrees C.

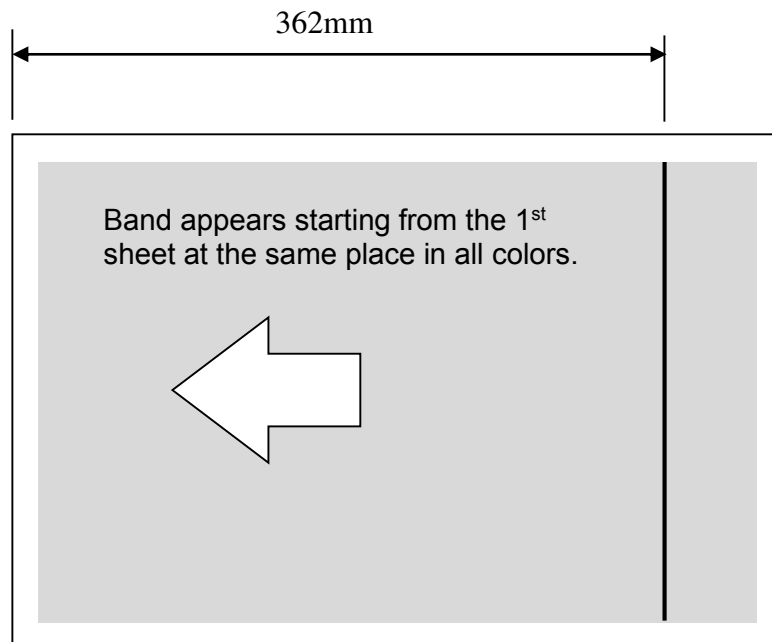
362mm from the leading edge in all colors and paper sizes

1. Register the paper in use to the Paper Library.
2. In Advanced Settings, adjust **No15: Paper Transfer Feed Speed Adjustment** to a value +/- 0.2% against the current value.

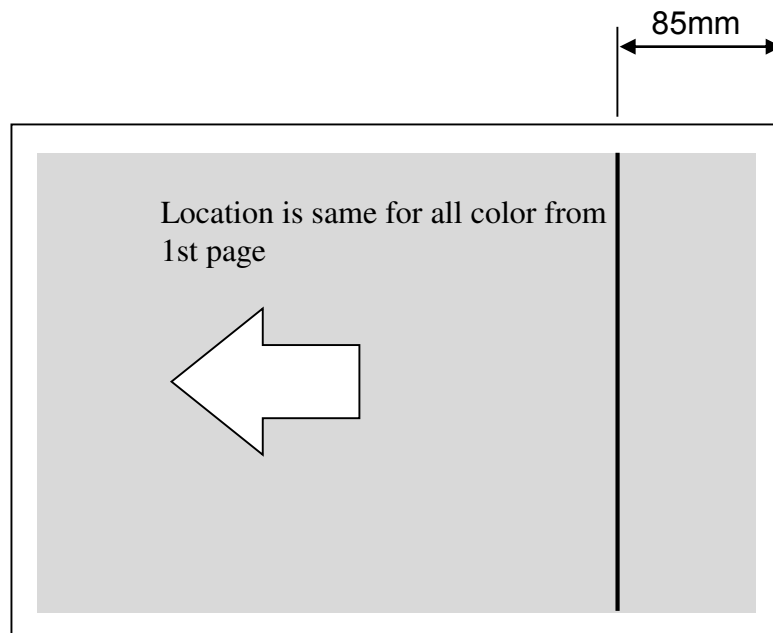
85mm from the trailing edge in all colors and paper sizes

1. Register the paper in use to the Paper Library.
2. In Advanced Settings, adjust **No15: Paper Transfer Feed Speed Adjustment** to a value +/- 0.2% against the current value.

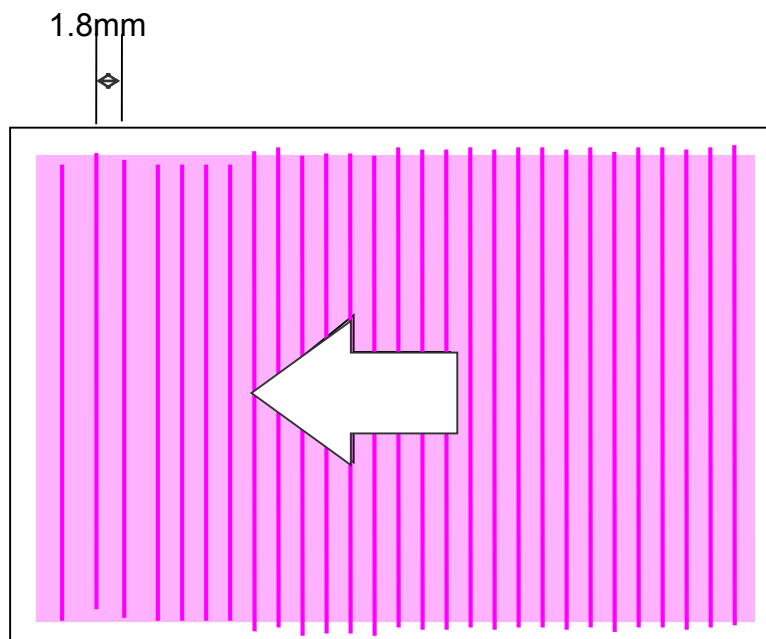
Across the entire page in all or specific color(s)

Change the Dither to "dot".

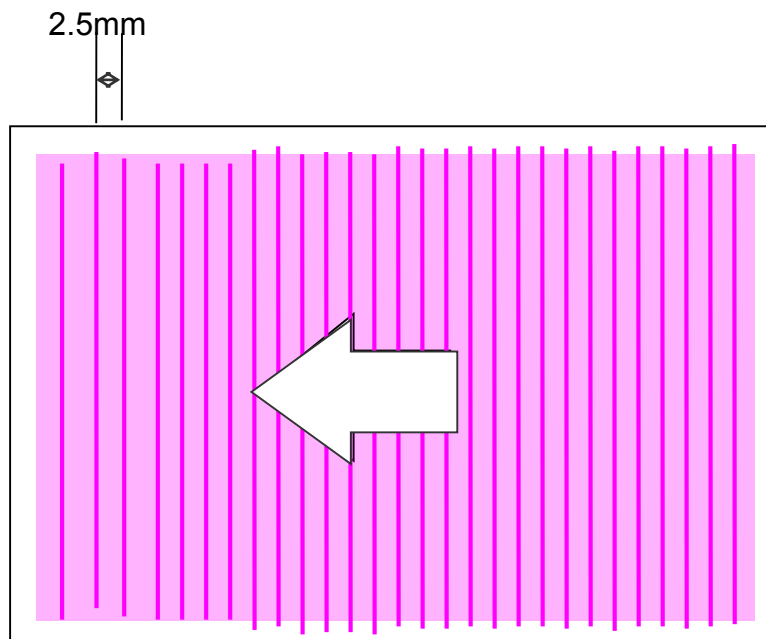
Across the entire page in all or specific color(s)

Action**Change the Dither to "line"**

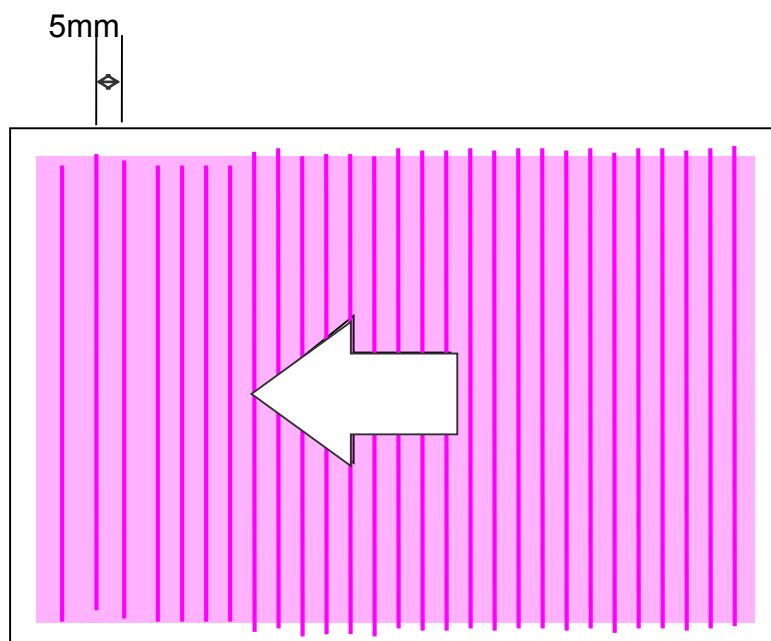
No.7 5mm Pitch Banding
Cause

Across the entire page

1. Register the paper in use to the Paper Library.
2. In Advanced Settings **No15: Paper Transfer Feed Speed Adjustment**, reduce the paper feed speed to -0.1% or -0.2% from the current speed.

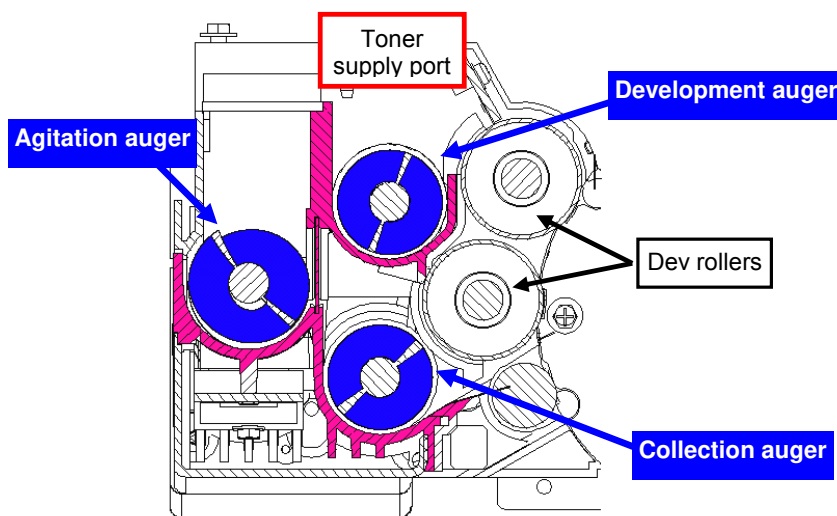
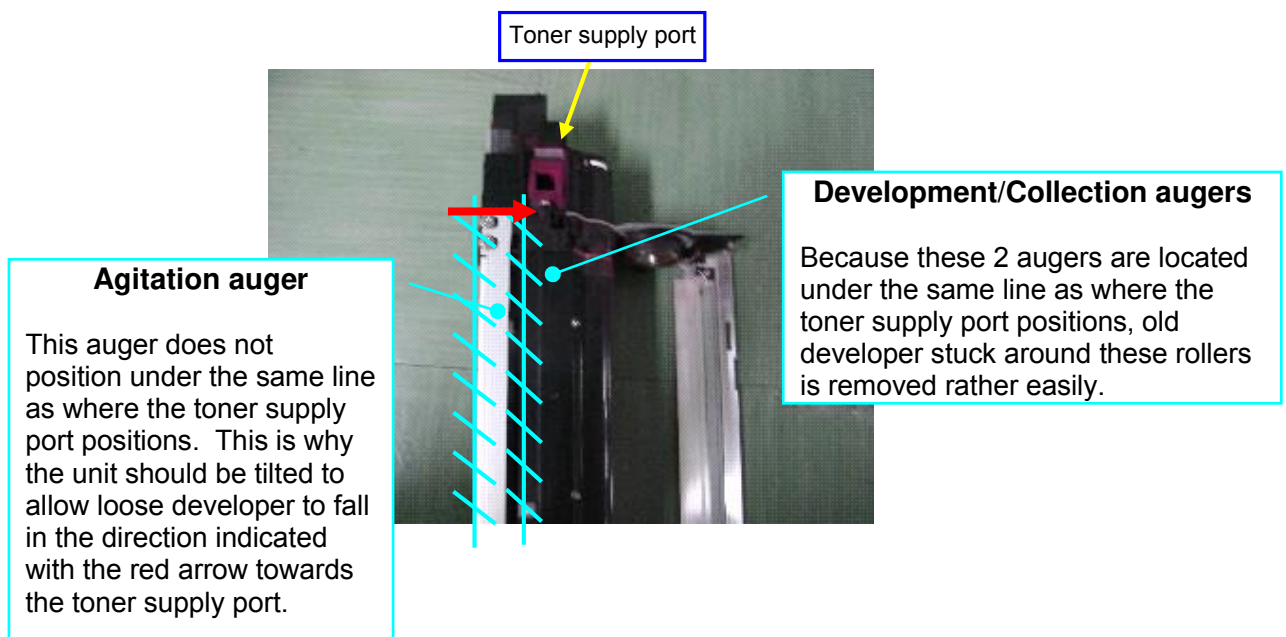
Developer tends to accumulate in the gap between the rollers and casings (indicated in pink in the cross-section diagram below), and once accumulated, it cannot be easily removed in the standard developer removal procedure, thus this additional procedure is required.

The reason for tilting the unit as you remove old developer is due to the composition of the 3 augers as shown below. Developer stuck around the Development and Collection augers is removed rather easily as these augers position under the toner supply port whereas the Agitation auger does not. Tilting and shaking the unit helps the developer stuck around the Agitation auger to fall towards the toner supply port.

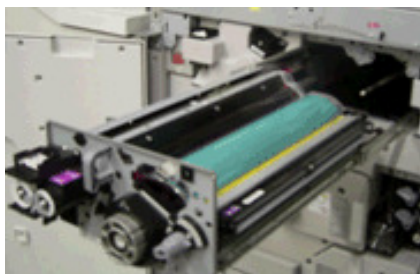
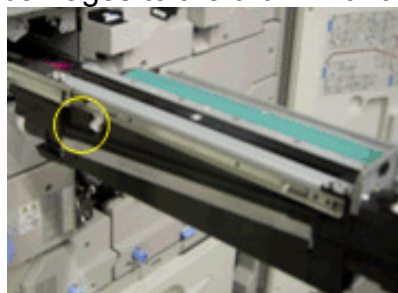
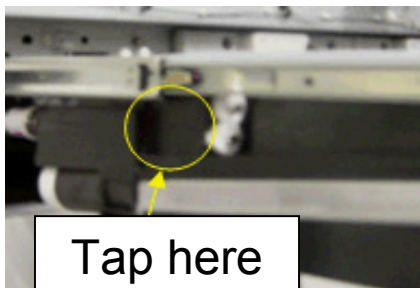
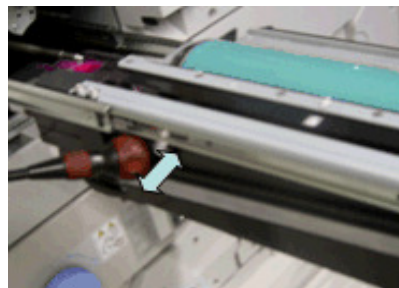
When old developer cannot properly exit the development unit due to a clog in the aperture, the amount of developer in the unit increases and could cause SC32x or SC39x as a result of excess load on the development motor.

3-2. Hold a screwdriver upside-down and hit the area circled in yellow with the grip of the screwdriver.

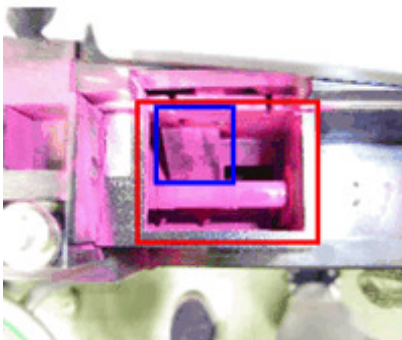
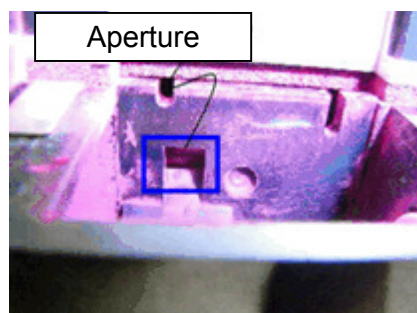
3-7. Check if the aperture (indicated in blue in the photos below) is clearly visible. If the aperture is clogged, clean the area squared in red in the bottom left photo. If a vacuum cleaner is not in hand, hold the unit so that the aperture faces down and remove old developer from the unit.

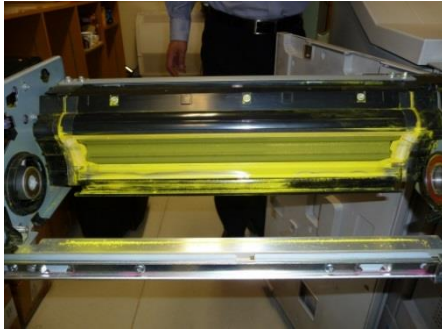
Do this procedure, if toner scattering is observed around the development unit as shown in the photo below.

- 4-1. Take out the development unit and place it on a table upside-down.
- 4-2. Remove the TD sensor from the development unit. (screw x2)
- 4-3. Vacuum the toner adhered to the opening where the TD sensor was mounted. This toner blocks the TD sensor and causes false detection of the toner concentration, resulting in incorrect Vt.

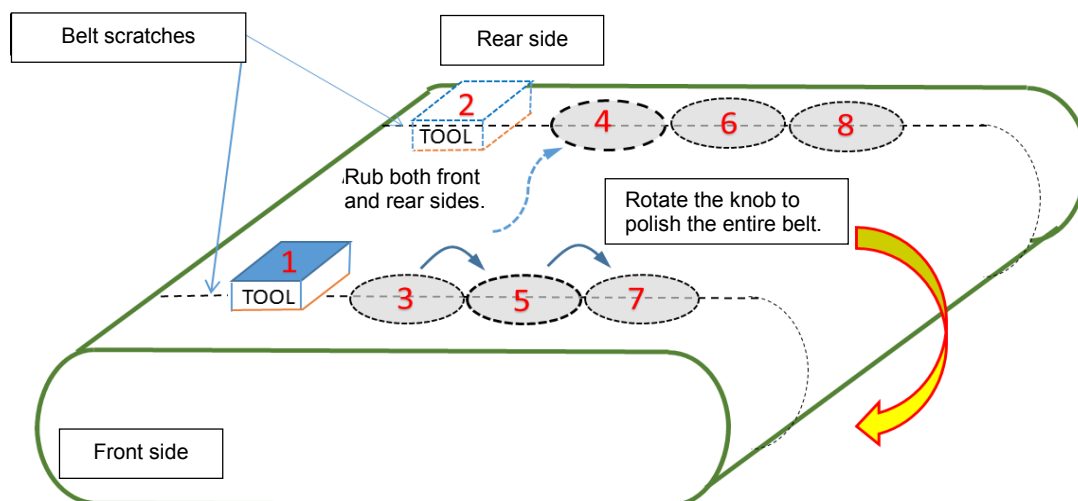
7. Gloss lines (vertical lines) caused by belt scratches

3. Rub the polishing tool (p/n: M0774287 WEB:POLISH:FUSING:ASS'Y) against the fusing belt to smoothen the scratches and rotate the knob clockwise so that the entire belt can be polished. **Rub approximately 30 times for each location, although this will depend on the condition of the scratches.**

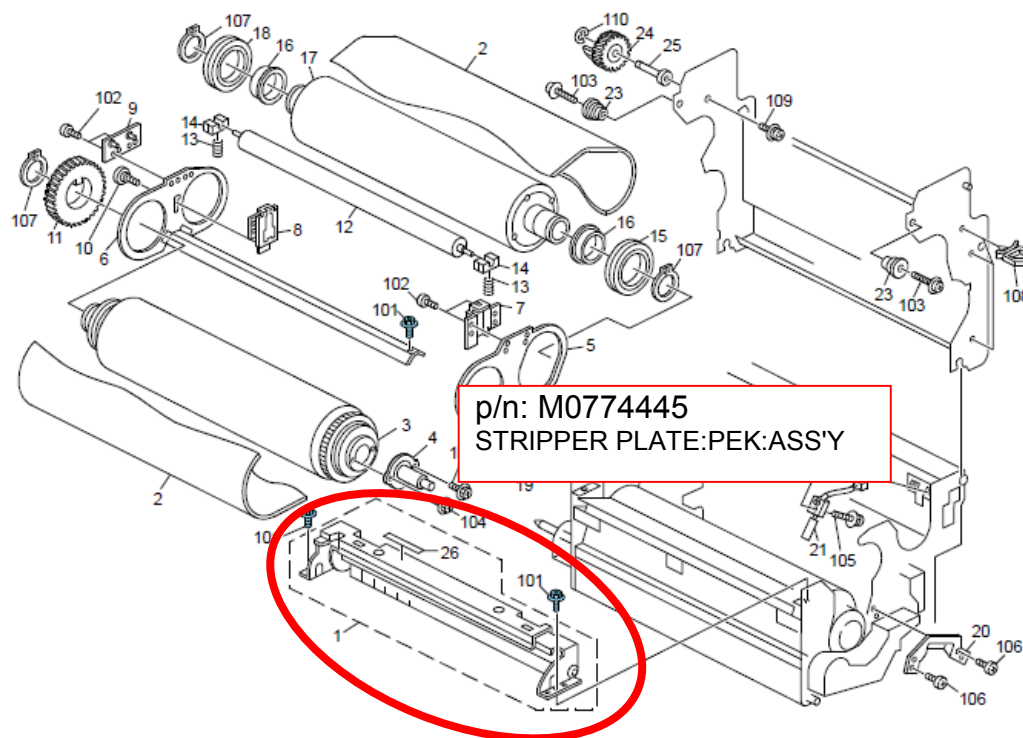
56.Fusing Unit 5 (D095/M077)

8. Damaged fusing stripper plate caused by paper jams

The new stripper plate was developed for higher durability, to prevent breakages caused by paper jams.

Replace with the new Stripper Plate (p/n: M0774445), if the machine has experienced paper jams in the fusing unit with the original Stripper Plate (p/n: M0774491).

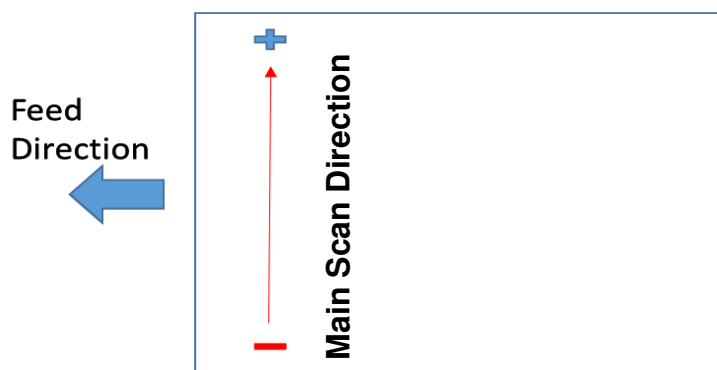
Laser beam is not emitted to the correct position on the drum due to the change in size of the image creation related components (laser unit, drum and ITB) as a result of change in temperature and humidity in and around the machine.

1. Execute MUSIC and print the affected job.
2. Measure the amount of misalignment for C, M and Y (in millimeters or micrometers or inches) in the Main Scan direction using a magnifier.

3. Use the Excel file embedded in the Appendix of this RTB to convert the measurements into the number of dots and sub dots. Input the resulting values into the following SP.

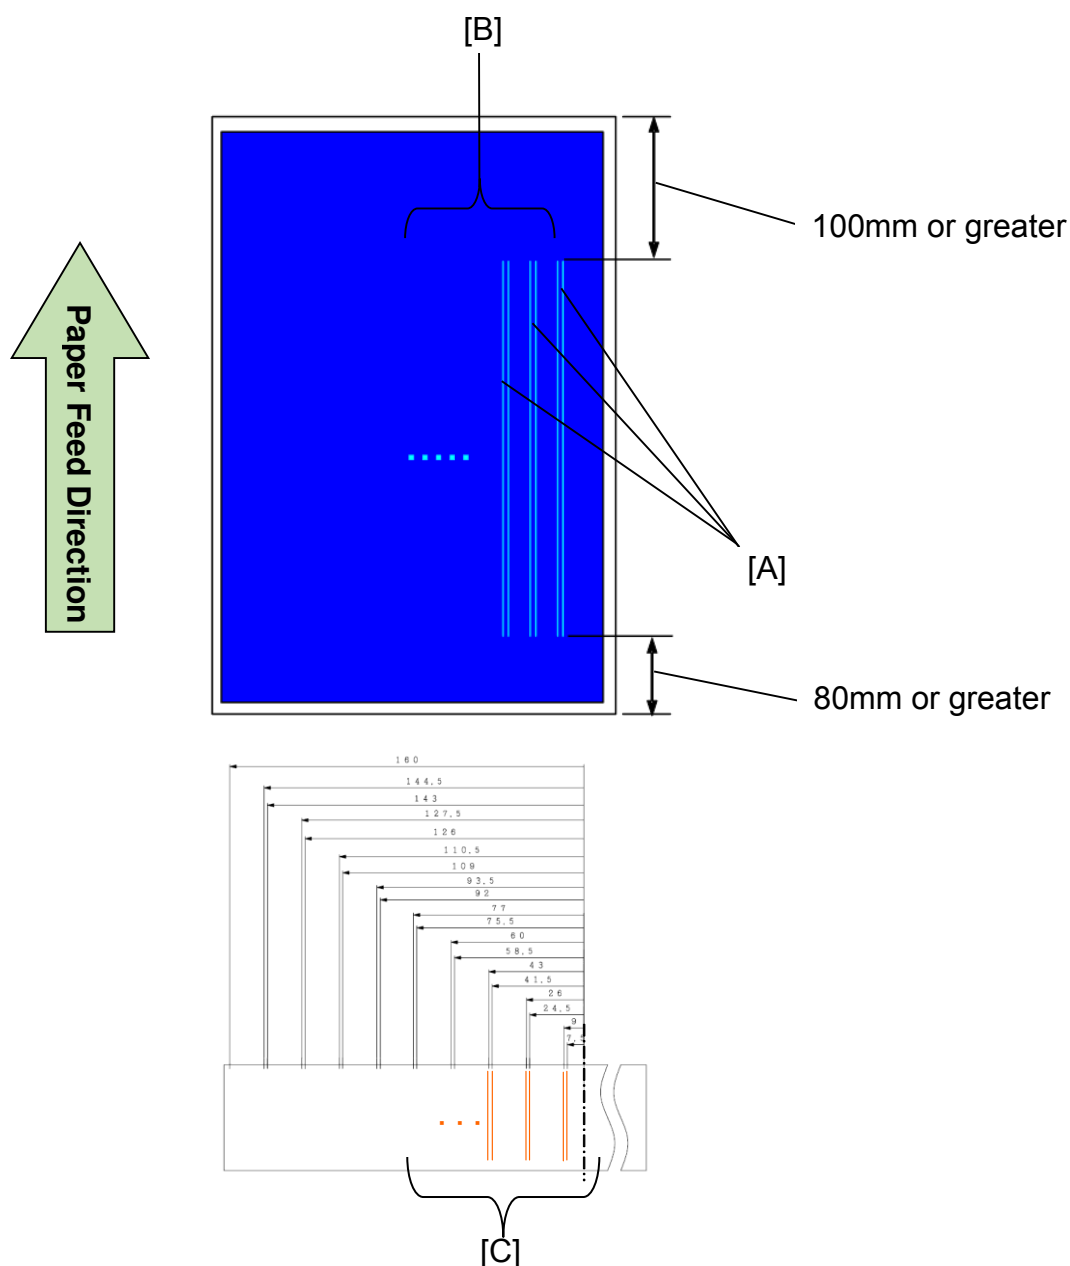
SYMPTOM 1

Glossy streaks [A] appear along the paper feed direction in an area between 100mm from the leading edge and 80mm from the trailing at an interval [B] which corresponds to the fusing stripper plate [C].

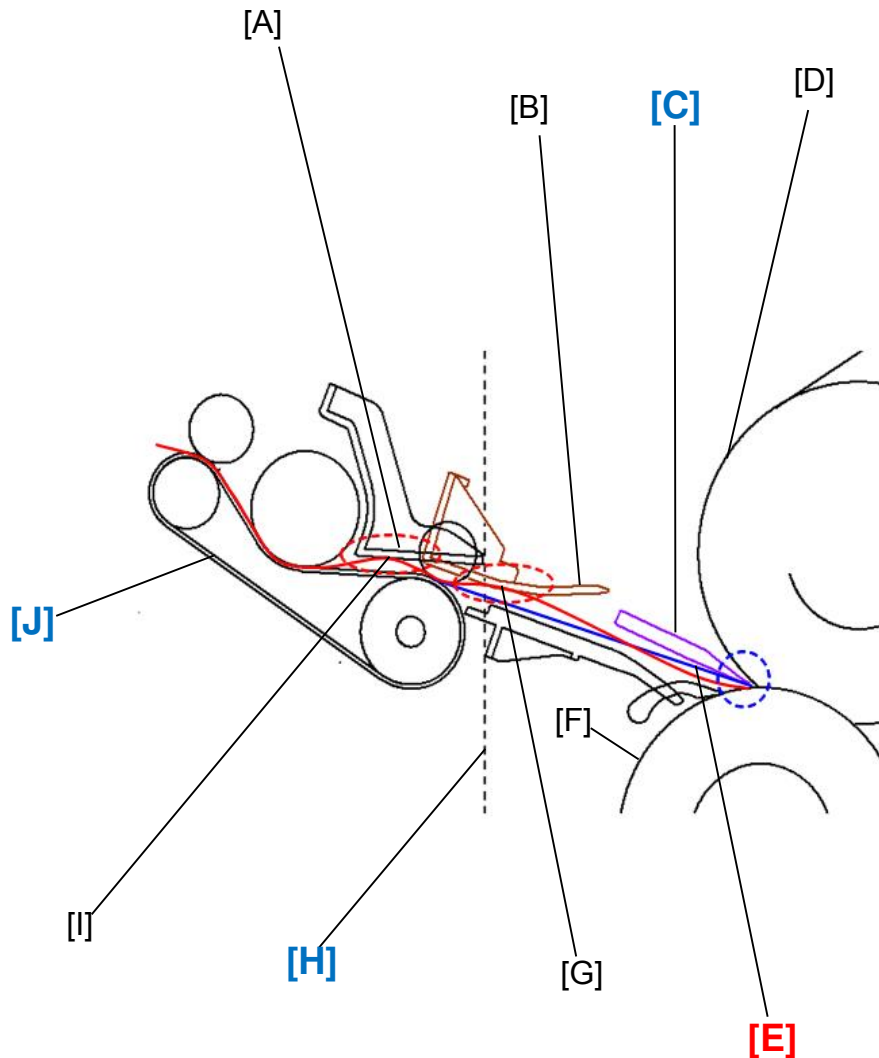
Fig 1. Problem mechanism

Paper (blue) is pulled at both ends between the switchback unit [J] and fusing unit [H] and is scratched by the stripper plate [C] at location [E].

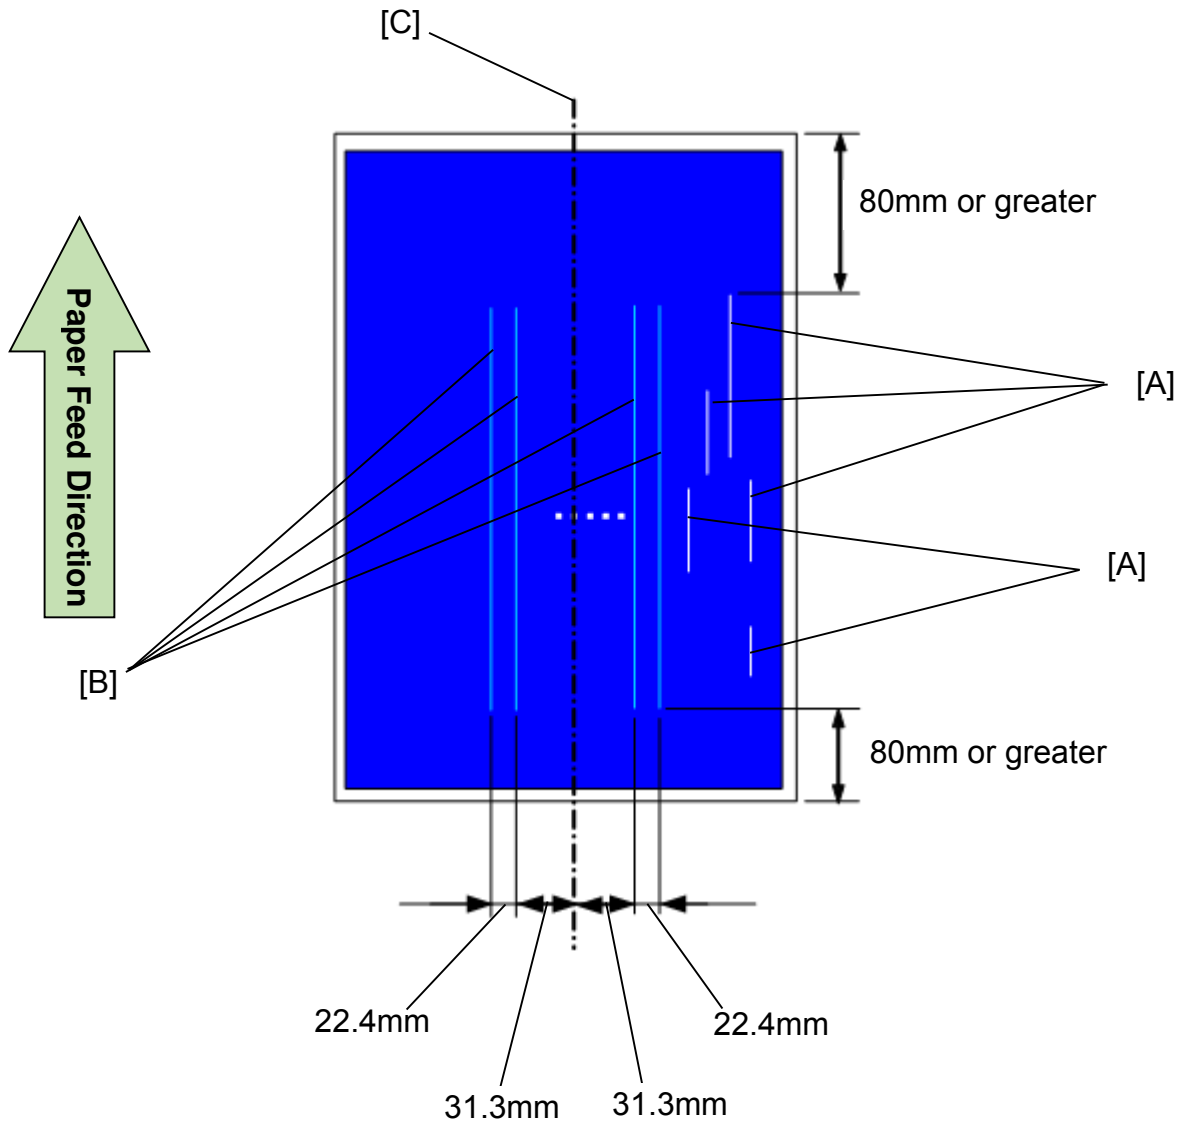
2-a. Glossy streaks [A] appear along the paper feed direction in an area between 80mm from the leading and trailing edges. Locations of the streaks are random in the feed direction.

2-b. Four glossy streaks [B] appear along the paper feed direction in an area between 80mm from the leading and trailing edges.

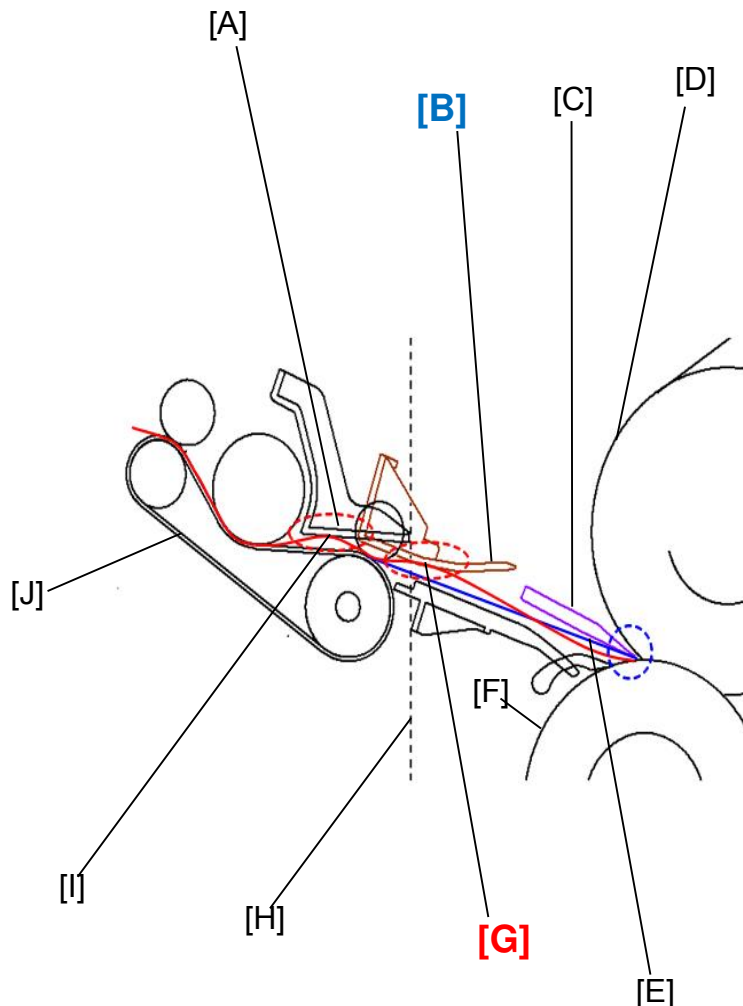
Fig 2. Problem mechanism

Paper (**red**) is deflected when passed from the fusing unit to the switchback unit and contacts the upper exit guide plate [B] at location [G].

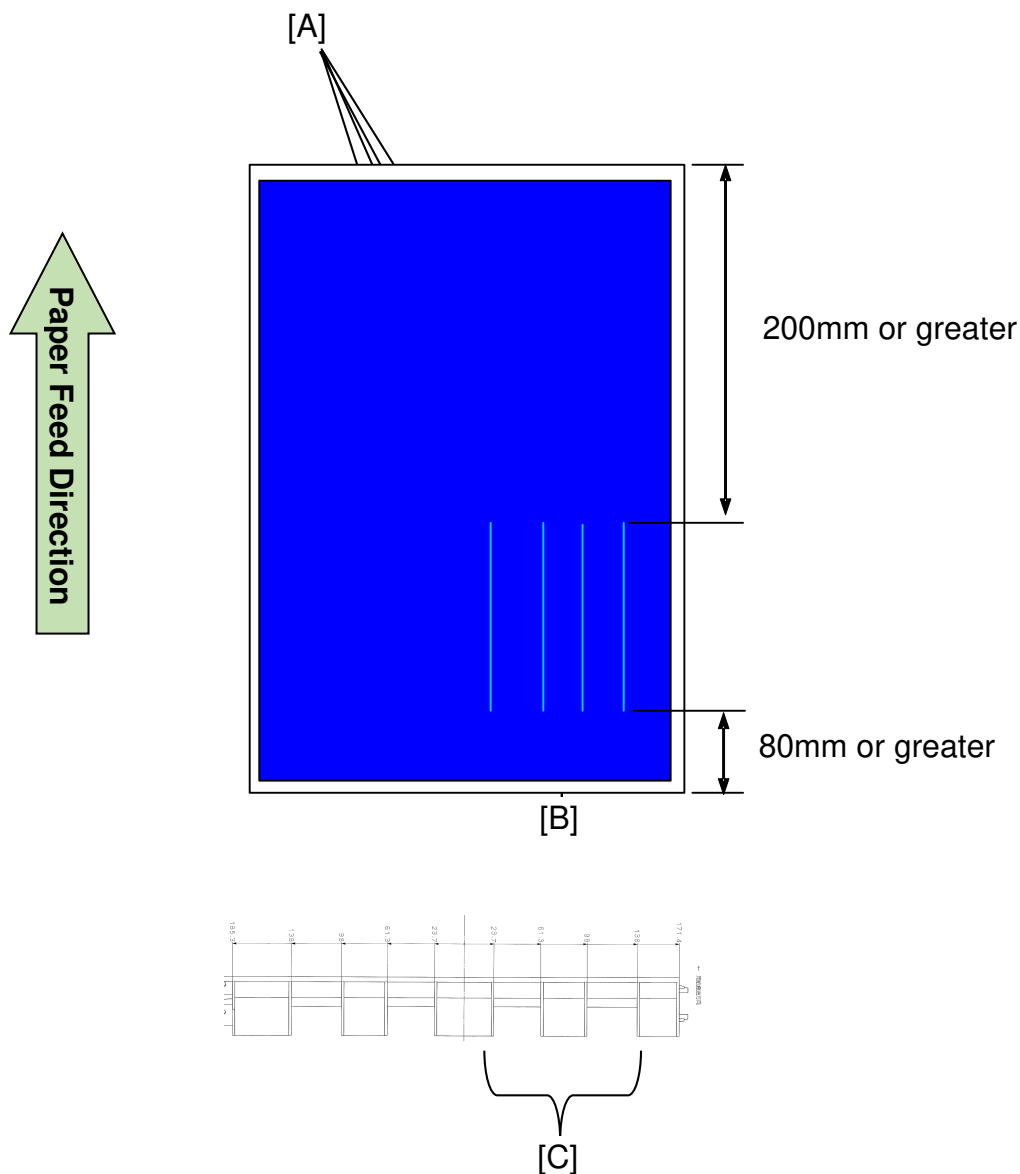
SYMPTOM 3

Glossy streaks [A] appear along the paper feed direction in an area between 200mm from the leading edge and 80mm from the trailing edge at an interval [B] which corresponds to the ribs on the cooling belt entrance plate [C].

Same as the solution for symptom 2.

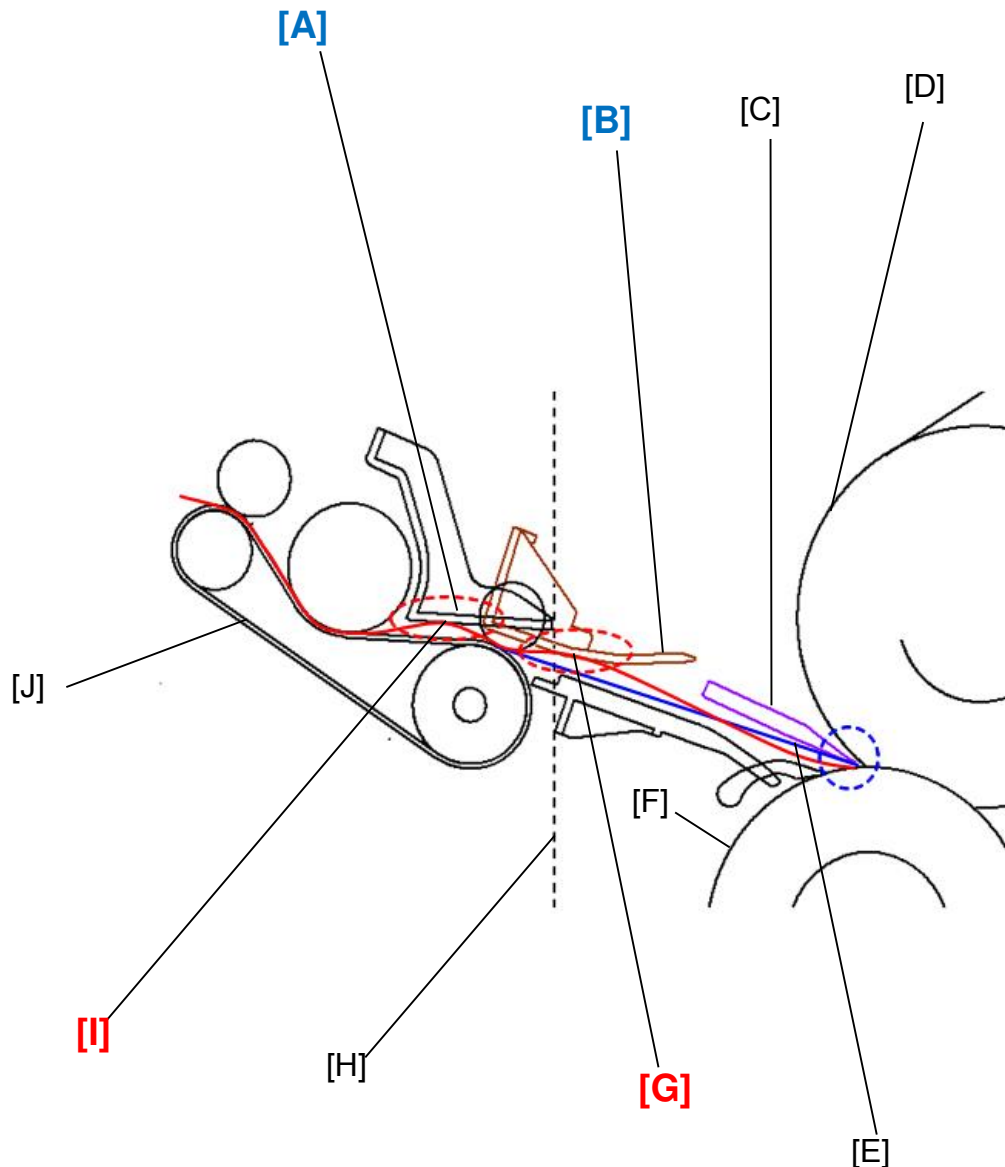
Fig 3. Problem mechanism

Paper (**red**) is deflected when passed from the fusing unit to the switchback unit and contacts the cooling belt entrance guide plate [A] and upper exit guide plate [B] at 2 locations [I] and [G].
