Model: Aries-P1.5	Date: 04-Oct-10	No.: RM077001h
-------------------	-----------------	----------------

Subject: Firmware Release Note: Engine		Prepared by: T. Miyamoto	
From: 1st PP Tech Service Sect., PP Tech Service Dept.			
Classification:	<input type="checkbox"/> Troubleshooting <input type="checkbox"/> Mechanical <input type="checkbox"/> Paper path <input type="checkbox"/> Product Safety	<input type="checkbox"/> Part information <input type="checkbox"/> Electrical <input type="checkbox"/> Transmit/receive <input checked="" type="checkbox"/> Other (Firmware)	<input type="checkbox"/> Action required <input type="checkbox"/> Service manual revision <input type="checkbox"/> Retrofit information <input checked="" type="checkbox"/> Tier 2

This RTB has been issued to announce the firmware release information for the **Engine**.

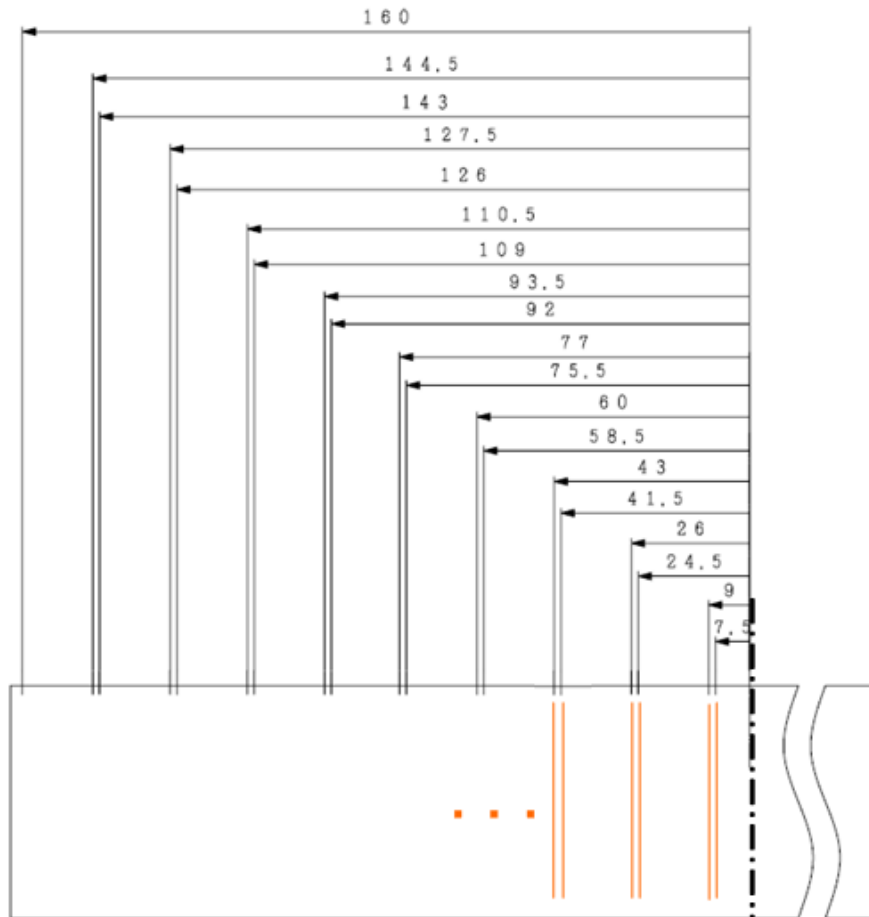
Fig 4. Fusing stripper plate
Location of the streaks from paper center [A]

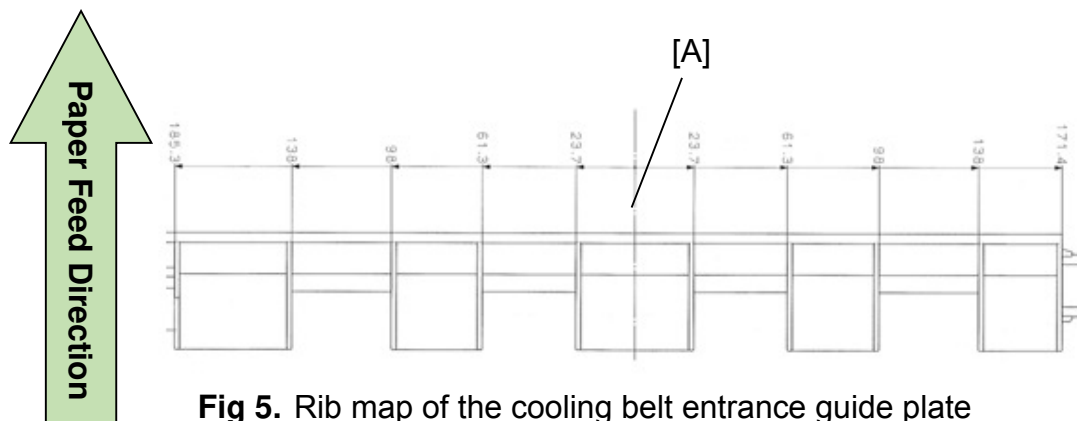
Fig 5. Rib map of the cooling belt entrance guide plate
[A]: Paper Center

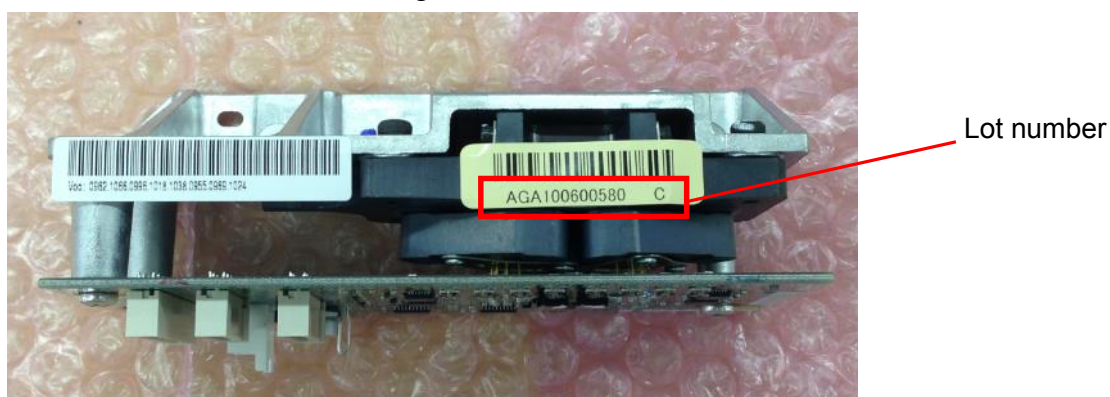
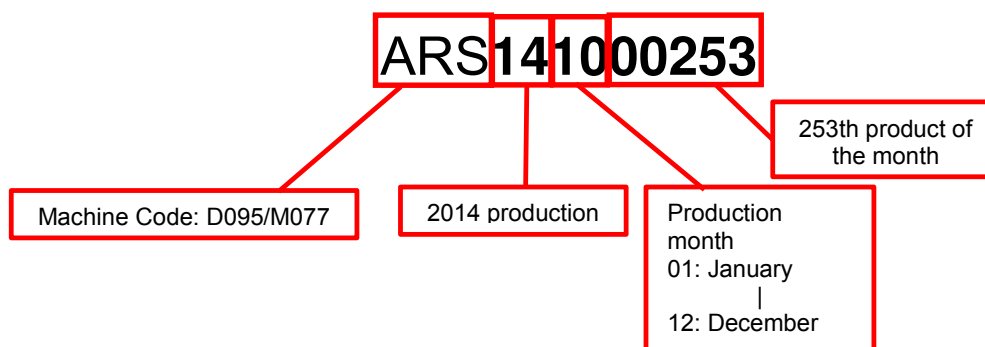
When replacing with a new laser diode (LD) unit procured as a service part, spacer seals may have to be attached to the LD unit before replacement, which depends upon the lot number. Make sure to check the lot number of the new LD unit before installation.

- If the lot number is **ARS141000253 or greater** (for example, ARS141000270), spacer seals are included as accessory parts to the LD unit. See the instructions below to install the spacer seals.
- If the lot number is ARS141000252 or smaller (for example, ARS140900005), spacer seals are not included. Disregard the instructions below.

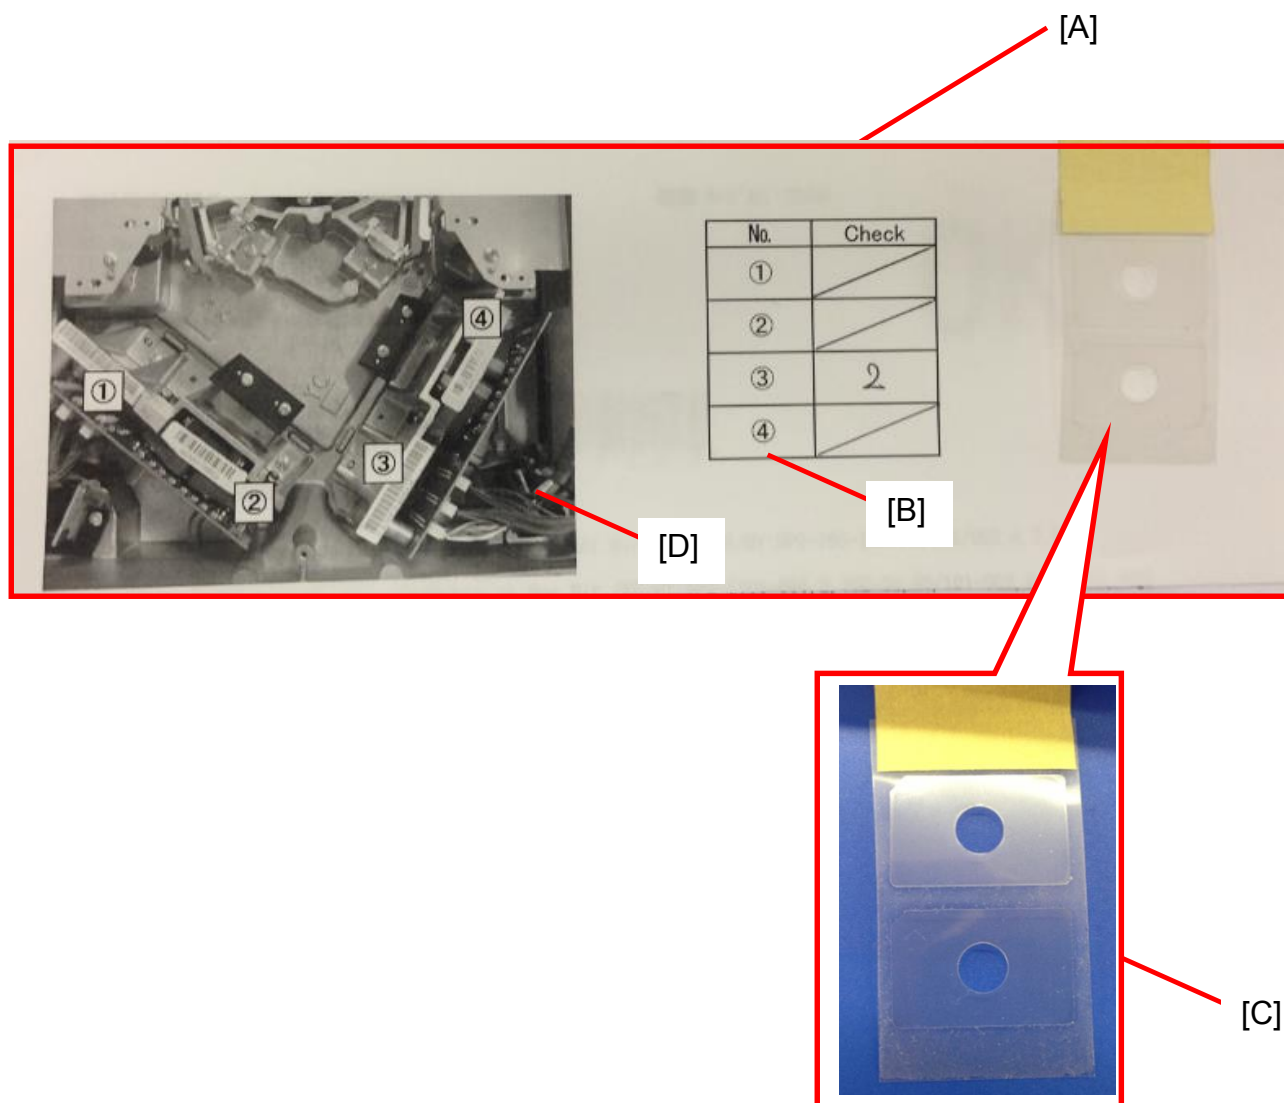
Spacer seals [C] are provided together with an instruction sheet [A]. Numbers 1~4 in table [B] on the instruction sheet correspond to the numbers in the photo indicating where the spacer seals need to be attached. Quantities of the spacer seals are handwritten in the table to indicate how many seals need to be attached.

The example below shows that 2 spacer seals need to be attached to location ③.

NOTE: The spacer seals may have 4 different types of thickness, but all spacer seals need to be attached to the same location according to the instruction sheet [A].

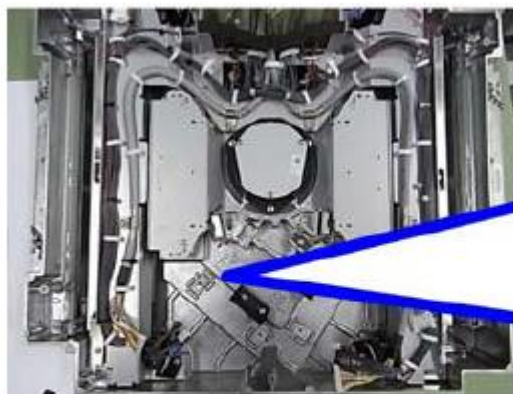
You may find spacer(s) attached to the laser unit when removing the original LD unit as shown in the photo below. (A spacer is attached to location ①.)

DO NOT remove spacer(s) originally attached. When installing the new LD unit, attach new spacer(s) on top of the original spacer(s).
