Technical Bulletin

Model: AG-P1	Date: 18-Sep-08	No.: RG178001c

a italioo haro boon addo			
Subject: Firmwar	re Release Note: NIB		Prepared	d by: H.Matsui
From: PPBG/Ser	vice Planning Dept.			
Classification:	☐ Troubleshooting ☐ Mechanical	☐ Part informa☐ Electrical	tion	☐ Action required ☐ Service manual revision
	☐ Paper path ☐ Other ()	☐ Transmit/rec	eive	☐ Retrofit information

This RTB has been issued to announce the firmware release information for the NIB.

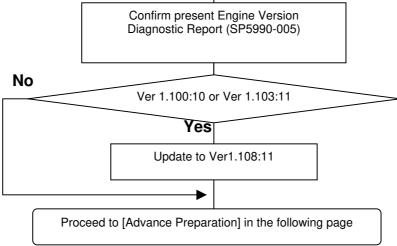
(*1) WatchDogTimeOut ERROR

While the software timer resets the hardware timer in a certain interval, WatchDogTimeOut error occurs when this reset is not executed after a lapse of time specified and the hardware timer reaching a time-out state. This problem has been confirmed with versions 1.100:10 and 1.103:11 and has been resolved from 1.108:11. Hence firmware is updated in the particular order mentioned in above.

Start Confirm present Engine Version Diagnostic Report (SP5990-005)

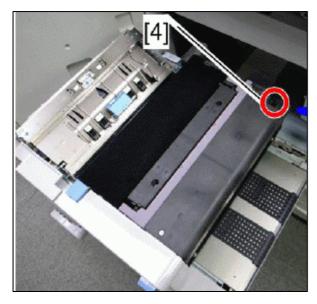
Previous procedure

As seen in the illustration below, oil was supplied at one place in the rear of the machine.

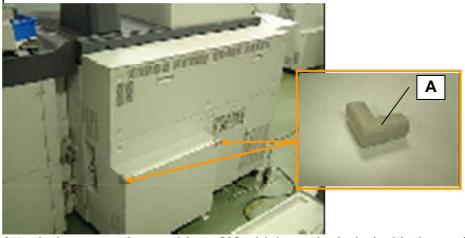
Protective cushions for the rear controller box are added in the accessories for the G178 printer.

Attach the protective cushions [A] which are included with the mainframe to both top corners of the rear controller box as shown above when installing the G178 printer.

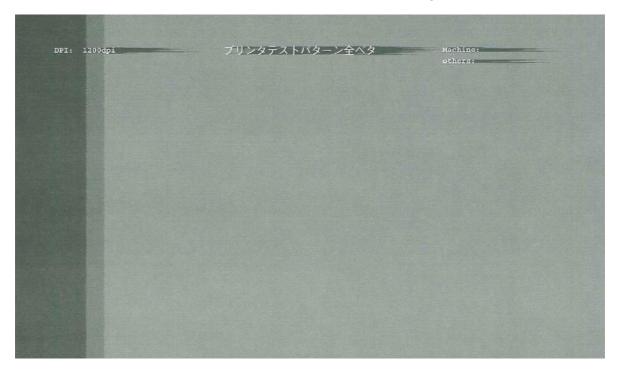
An abnormal picture is generated as seen below when connection of CN415 is incomplete. An abnormal picture as seen below is an example when printing an all-black picture.

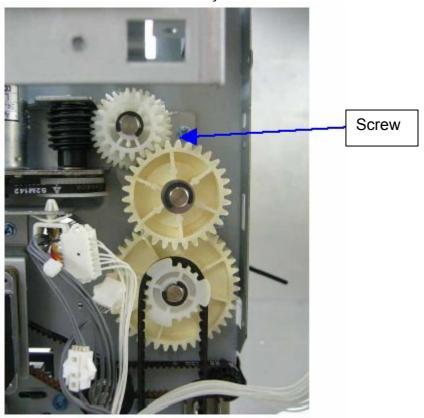
Area with bracket dislocated

Remove the screw indicated by the arrow and raise the bracket connected to the motor.

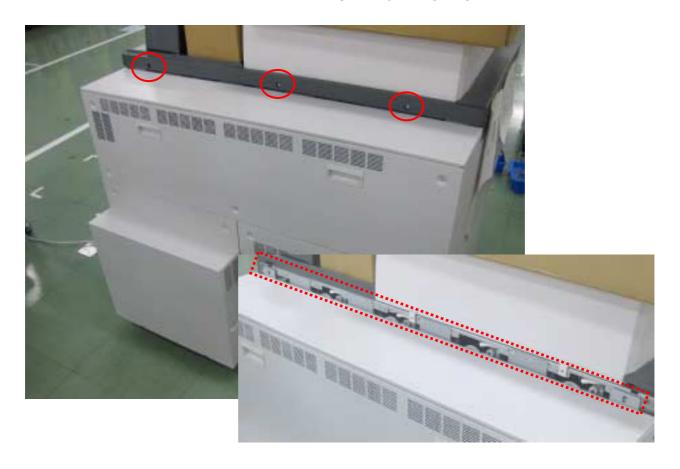
Symptom: In the durability test, the rubber roller was damaged. Pieces of the damaged

parts interfered with the screw and caused "SC489 Waste toner transport

Cause: Durability of the rubber roller was insufficient.

- 4. Replacing the Rubber Roller in the Toner Recycling Unit
- 1. Remove 3 screws and remove the molded plate by lifting it up.

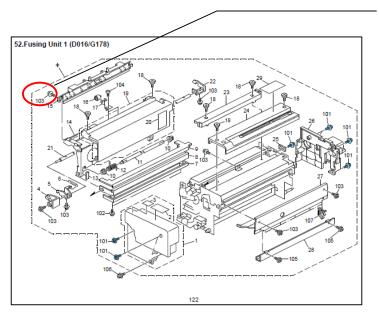
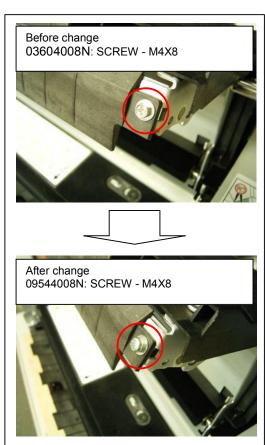
The screw applied for "Guide:Paper Exit Sub-unit:Upper" has been changed with a more reliable screw; not easily loosened.

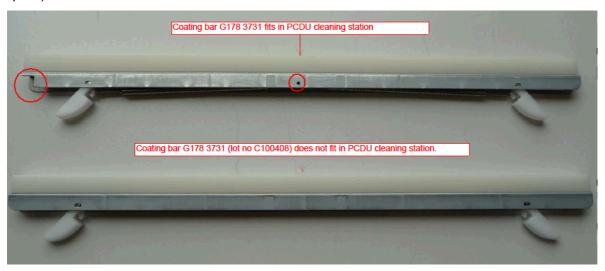
Due to the incorrect shape of this part, it cannot be attached to the Cleaning Unit.

Please check the difference in shape as shown in the photo below. (The lower part is the incorrect part.)

Please check the spare parts in stock and dispose of the object part immediately. Please refer to the "Lot No." indicated on the parts number label for identification.

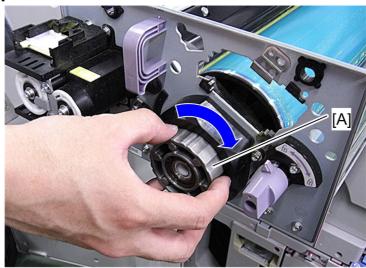
The gap between the drum and development roller is precisely adjusted at the factory. However, this gap may be uneven if the drum unit is not correctly installed in the PCDU drawer after installing or replacing the drum unit. The uneven gap between the drum and the development roller may cause some image problems (white spots, uneven toner density, toner blocking in strips on the development roller and so on). Follow the important point for the drum unit installation as described below.

• Rotate the drum lock nut [A] clockwise until the drum lock nut [A] stops and does not rotate any more, when installing or replacing the drum unit.

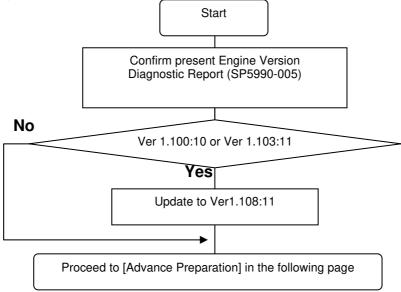
When a direct update to the latest version is attempted from either Version1.100:10 or 1.103:11, WatchDogTimeOut ERROR(*1) could occur resulting in a non-functioning of the operation panel, and the machine will stop. As replacement of the BCU board will be required to resolve this error, please ensure to follow this correct procedure.

While the software timer resets the hardware timer in a certain interval, WatchDogTimeOut error occurs when this reset is not executed after a lapse of time specified and the hardware timer reaching a time-out state. This problem has been confirmed with versions 1.100:10 and 1.103:11 and has been resolved from 1.108:11. Hence firmware is updated in the particular order mentioned in above.

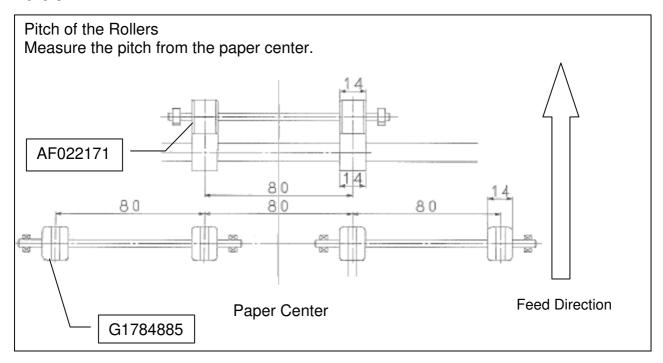
For the determination of whether or not the curls/scratches/marks are caused by the rollers, please check and compare the pitch of the curls/scratches/marks against the pitch of the rollers.

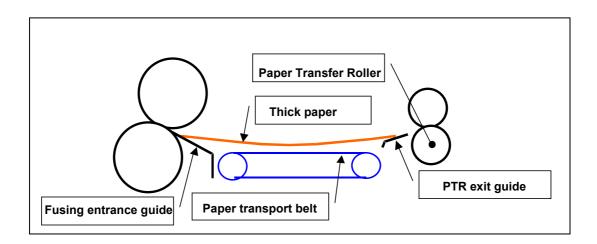
If less flexible thick SEF paper is used, there is a possibility that paper moves over the paper transport belt without touching it (see the picture below). As a result, JAM38 can occur. Changing the paper orientation from SEF to LEF can improve this.

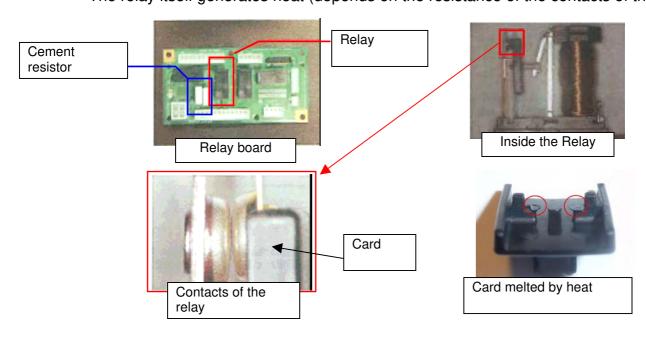
- The heat generated by the cement resistors near the relay raises the temperature inside the relay.
- Load on the fusing motor increases.
 - Mechanical drive load on the fusing motor increases due to the following factors.
 - → PM parts in the fusing unit are used more than the PM replacement cycle.
 - ♦ By using paper that contains a lot of calcium carbonate, the oil application gets dirty, and the oil film on the fusing belt gets less uniform.

As a result, the electrical current in the fusing motor increases. This causes the cement resistors and relay to generate more heat than usual.

The relay itself generates heat (depends on the resistance of the contacts of the relay)

As a result, the p/n changes from G1785281 to **G1785304**. When relay failure occurs, use the part with p/n **G1785304** as a replacement.

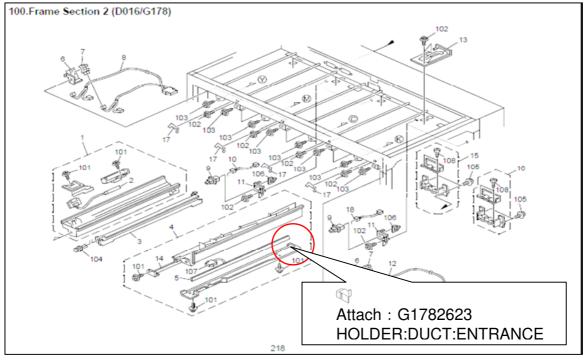
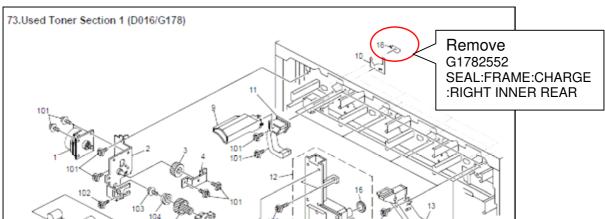
Change/Reason: From the result of our verification, we found out that by increasing the speed of air flow inside the charge corona unit, blurred Image can be reduced. Removing the "Seal: Frame Charge Right Inner Rear" at the entrance of the duct, which controls the air flow, and attach a new part on the duct, in order to increase the air flow to reduce the blurred image. Attention: If you removed the "seal" and did not attach the new part (Holder), air flow changes and

Attention: If you removed the "seal" and did not attach the new part (Holder), air flow changes and will cause some failure in the machine.

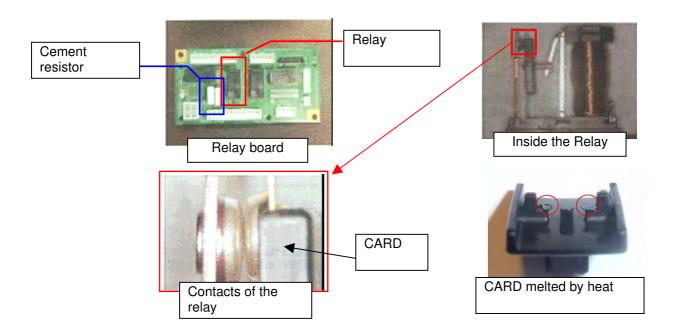
- The heat generated by the cement resistors near the relay raises the temperature inside the relay.
- Load on the fusing motor increases.
 - Mechanical drive load on the fusing motor increases because of the following factors.
 - → PM parts in the fusing unit are used more than the PM replacement cycle.
 - ♦ By using paper that contains a lot of calcium carbonate, the oil application gets dirty, and the oil film on the fusing belt gets less uniform.

As a result, the electrical current of the fusing motor increases. This causes the cement resistors and relay to generate more heat than usual.

Please replace the relay board for machines having the following serial numbers at your next service visit. If the machine is installed with the relay board p/n G1785281, replacement with the new relay board p/n G1789911 is required. Replacement is not required if the machine is already installed with relay board p/n G1785304. Please refer to the next page for distinguishing between the old/new relay boards. Replacement will take approximately 15 minutes.

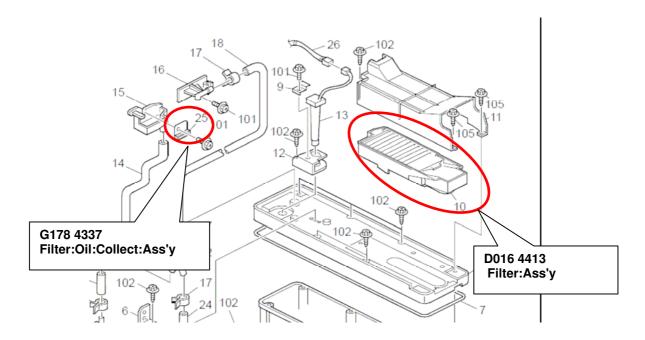
A fault in the current engine firmware clears the PM counter of the Oil Tank Filter when clearing the PM counter of the fusing unit. When the counter of the fusing unit is cleared upon its replacement, the correct PM interval of the Oil Tank Filter cannot be identified as it is falsely cleared, disabling its replacement at the correct timing. Calcium carbonate deposits are formed in the Oil Tank Filter over time, degrading the filtering function, and may cause oil leaks.

2. Replace both filters circled below when replacing the fusing unit.

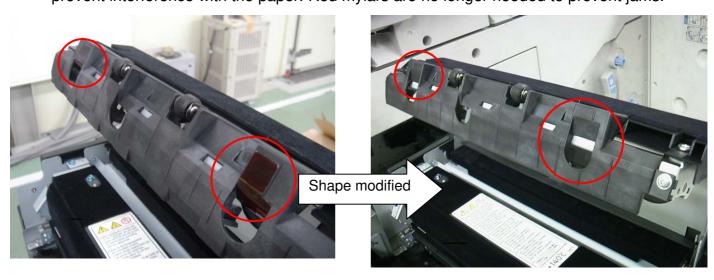
The shape of the paper exit guide (areas circled in red below) has been modified to prevent interference with the paper. Red mylars are no longer needed to prevent jams.

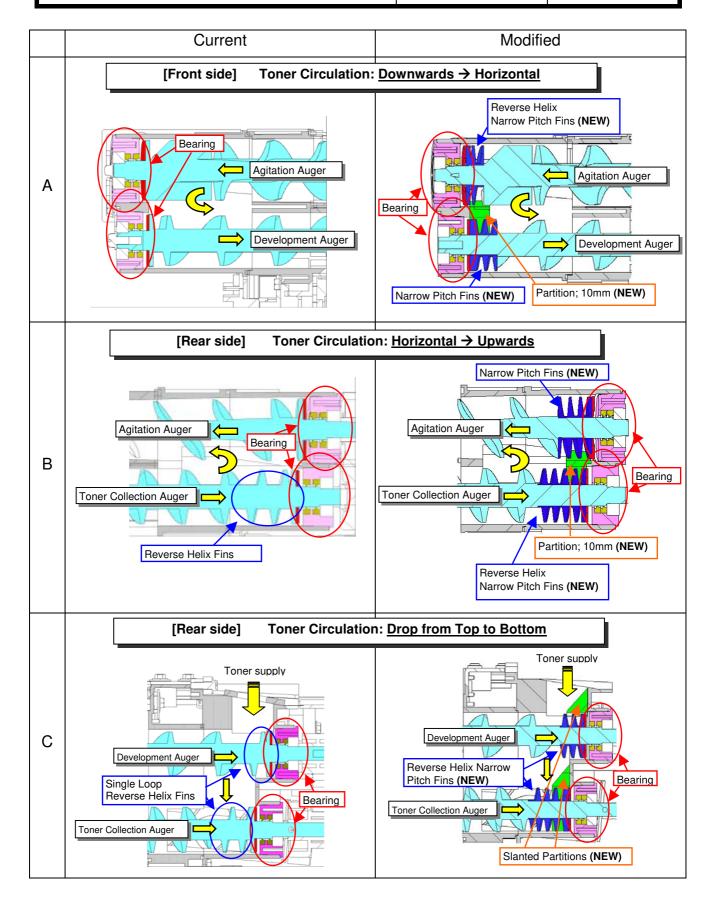
Reason: To prevent firefly spots originating from toner clumps. The modified development unit is designed to reduce the chances of toner leakage into the bearing which generates the toner clumps.

Modifications as mentioned below have been implemented in the 3 locations A, B, & C, to reduce the amount of toner leakage into the bearings.

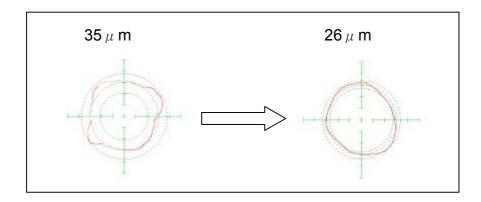
Change: The manufacturing process of the Aluminum Drum Shell has been modified.

Reason: The above modification has been implemented to prevent uneven density (bandings) originating from inaccurate circularity of the drums. The new process has improved the circularity of the drums, providing the new drums with higher accuracy in the external diameter deviation; improvement in its tolerance specification from the previous 35 μ m to the current 26 μ m.

Please replace with the modified "D0169510" drums when encountering <u>80mm pitch</u> <u>bandings</u> as shown on the following page.

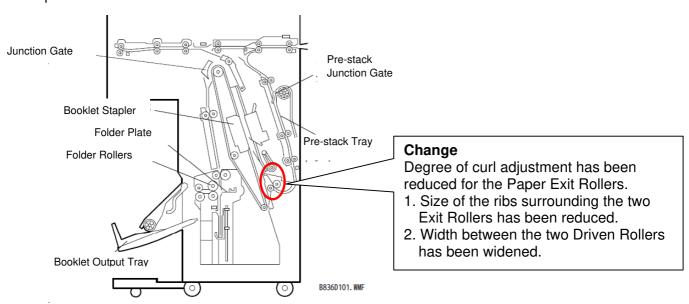
The previous Exit Rollers with large ribs causes excessive pressure against the sheets.

Paper Exit Rollers and Driven Rollers have been modified as described below.

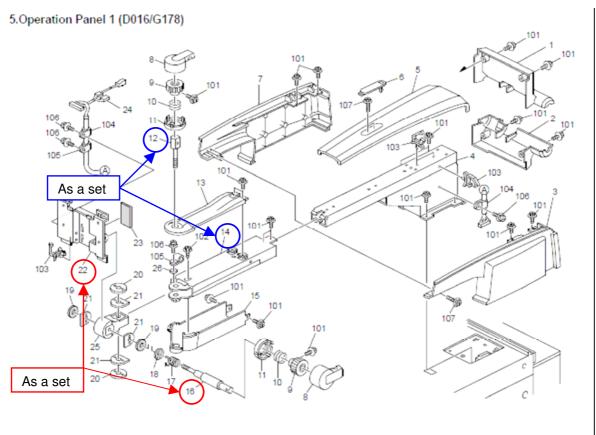
Reason: A problem was found in the assembling process of these parts at the factory.

The 4 relative parts have been modified to gain higher tolerance.

If a machine requires replacement of these parts, please replace them as a set as described in the table above and diagram below.

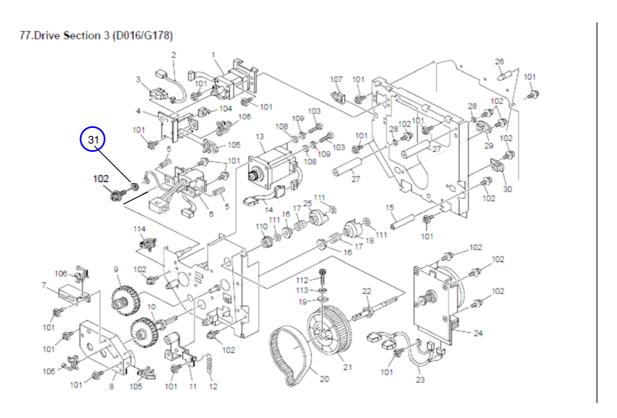
Reason: A screw hole in the drive section was damaged in the manufacturing process. 'Washer: M4' has been added to prevent this problem. Damage to this screw

hole has not been reported from the field.

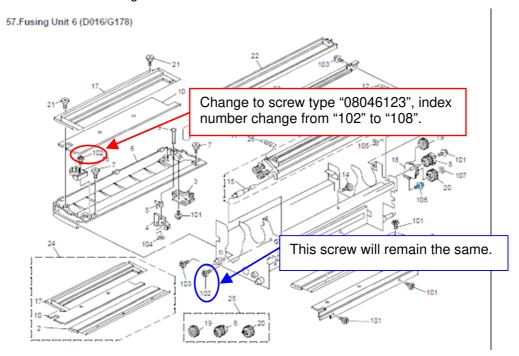
Change/Reason: Screw types have been changed in the fuser unit to prevent loosening.

NOTE: Among 2 "M3x8" screws used in this section, only the screw indicated in red in the diagram below has been changed.

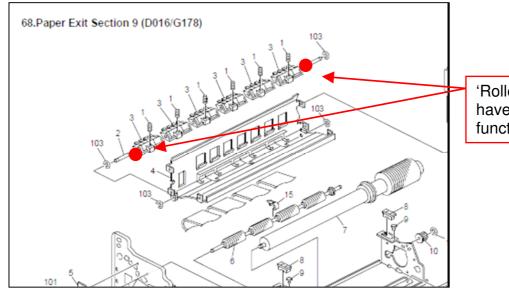
Parts have been added and modified in the paper exit area to resolve dog-ears which had occurred in the media qualification test. Dog-ears owing to the parts described in this bulletin have not been reported from the field.

'Roller: Belt Tensioners' have been added to function as spacers.

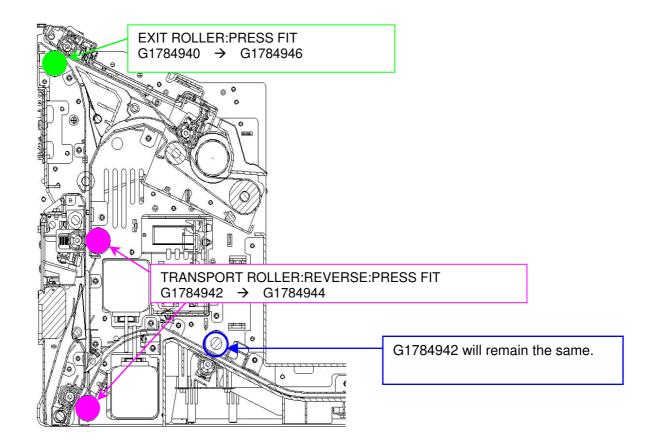
Material of the EXIT ROLLER and TRANSPORT ROLLER has been changed from EPDM rubber to urethane for better grip. When a replacement is required for any of the following 3 rollers, replace them as a set.

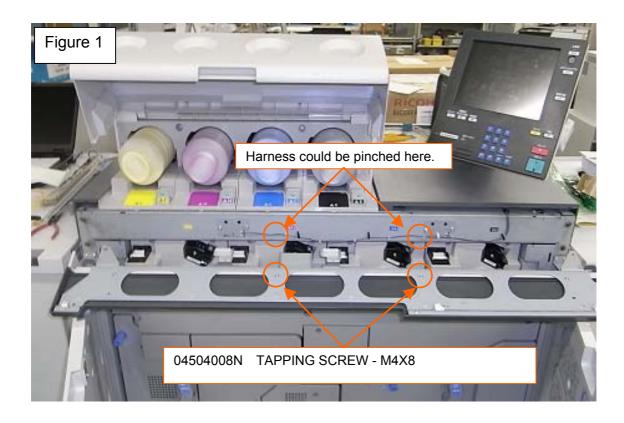
Screws applied to the front-top cover have been changed to prevent damage to the harness when attaching the cover (See figure 1).

The new screws will allow securing a 0.6mm gap between the frame and the screw head (See figure 2).

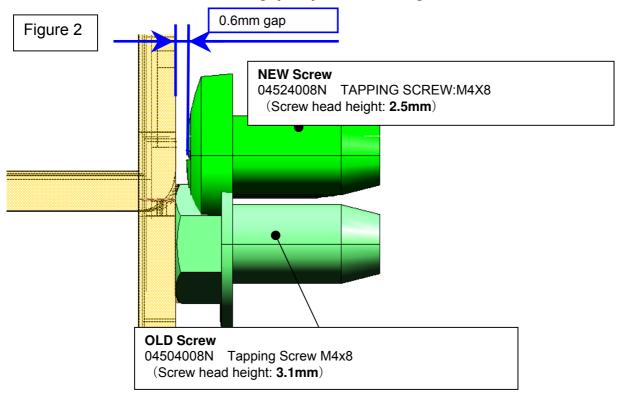
New screws will secure a 0.6mm gap to prevent damage to the harness.

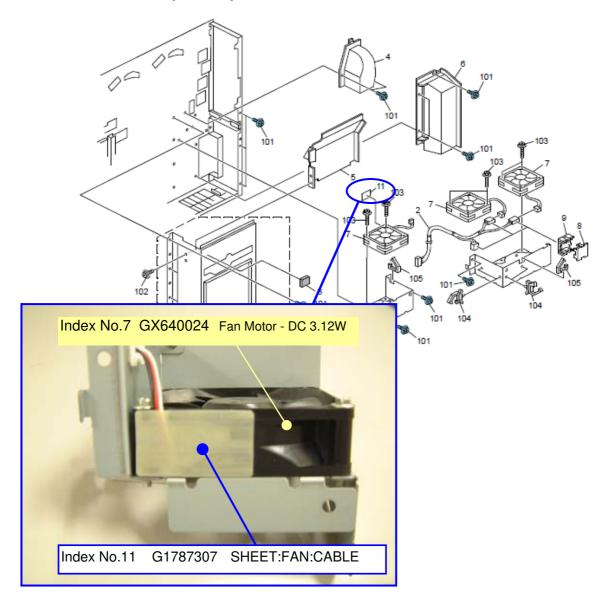
Improvement in the factory assembling process: a protection sheet has been added to the fan component to prevent damage to the harness.

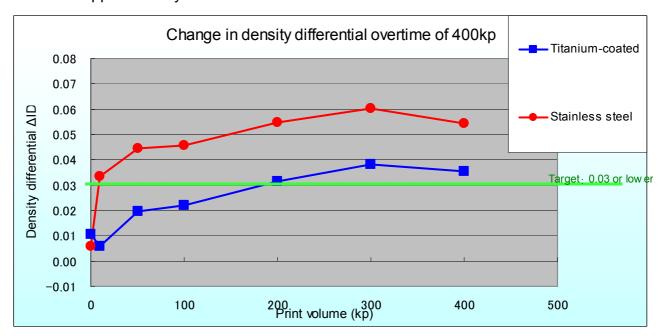
The graph below describes the relation between density differential and print volume. While stainless steel development rollers require replacement of the developer at approximately 30K, the titanium-coated development rollers lengthen the replacement interval to approximately 200K.

Density differential is calculated by making 6 measurements on a printout for locations A to F and taking the average density differentials of A-D (rear), B-E (center), and C-F (front).

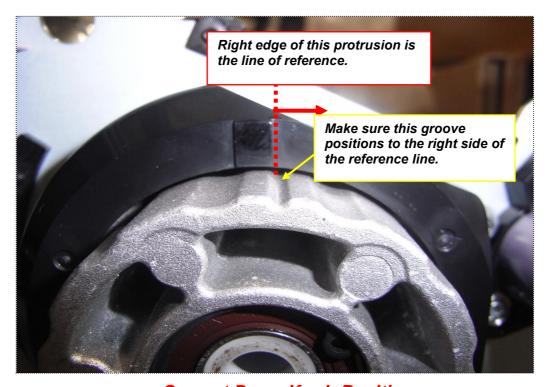
Correct Drum Knob Position

Tighten the Drum Knob so that the groove on the Drum Knob goes past the plastic protrusion on the PCDU as shown in the photo below.

Note: Turn the drum knob until it stops and cannot be further tightened.

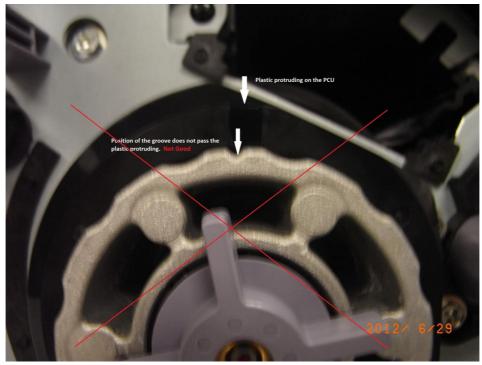
Fastening the drum knob with the drum cleaning unit installed will cause the drum cleaning unit to apply pressure to the drum and narrow the PG at the front side.

Incorrect Drum Knob Position

If the drum knob is loosened with the drum cleaning unit installed, make sure to remove the drum cleaning unit, and then fasten the knob.

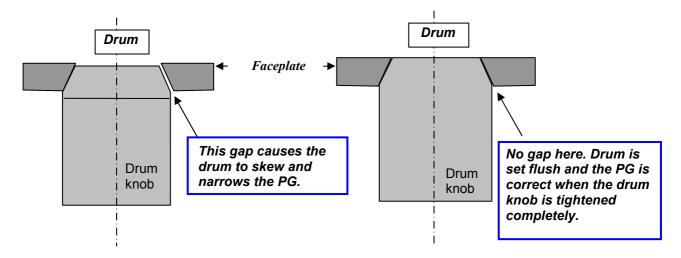
Diagrams showing the drum knob position

[Incompletely tightened drum knob] [Completely tightened drum knob]

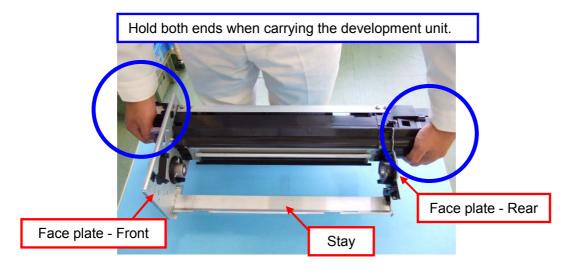
- 1) Variation in image density
- 2) Different density between left and right sides on a page
- 3) Toner adhesion to the development rollers
- 4) Scratches on the drums resulting from toner adhesion to the development rollers
- 5) Toner clumps caused by narrowed PG
- Always hold the prescribed locations when handling the development unit.
- Never apply external pressure to the front and rear plates and the stay.

Do not grip the face plates or the stay.

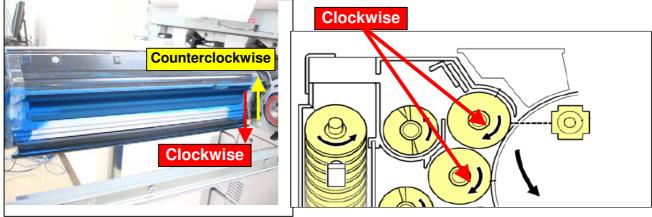
Rotating the development rollers counterclockwise with the developer installed will cause toner to adhere to the development rollers (see Reference below), resulting in higher chances of damaging the drums. Make sure to clear out the developer from the unit in advance when rotating the developer rollers counterclockwise.

Also, please do NOT clear the PM counter if the developer removed is to be re-installed and used again.

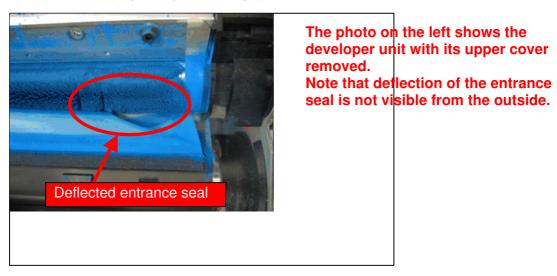
Reference

Rotating the development rollers counterclockwise with the developer installed will cause the entrance seal to deflect (especially at the edge).

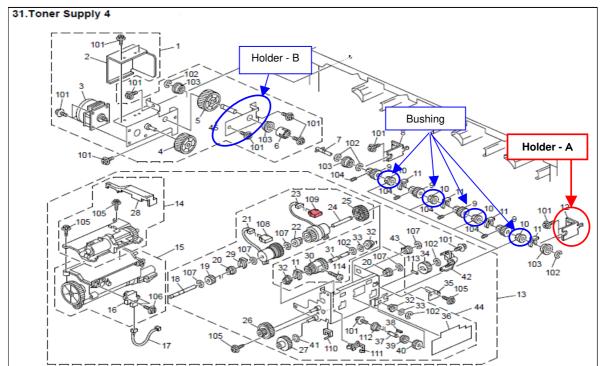
- The bushings and Holder-B will give enough support to secure the drive shaft. Removal of the Holder-A will not affect the function.
- Removing the Holder-A will prevent further abrasion of the drive shaft and SC328.
- A worn drive shaft can be continuously used and will not affect the function.

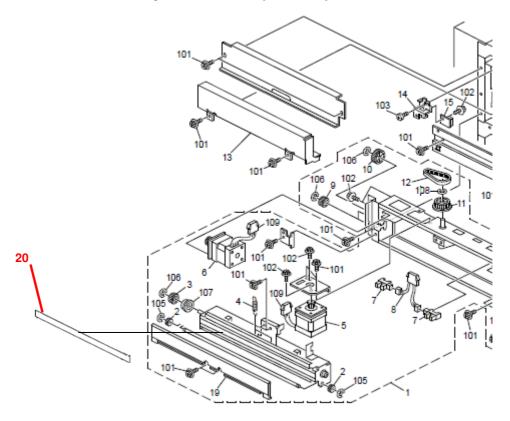
72.Paper Exit Section 13 (D016/G178)

This part was added to prevent possible injuries when fingers accidentally get caught in the Decurl unit.

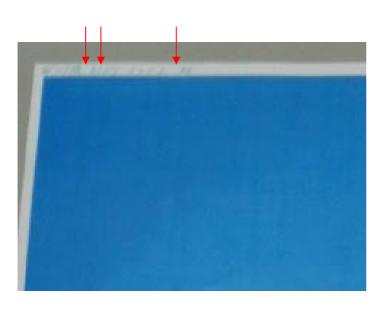
The symptom known as "fuzzy lines" is a result of insufficient supply of toner/developer mixture to the drum surface via the development rollers.

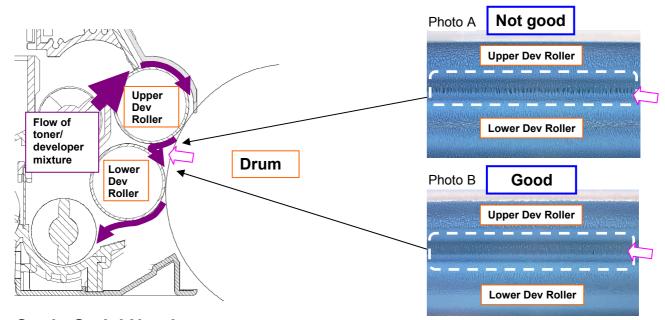
Photo A: The "fuzzy" condition of the toner/developer mixture is reflected directly to the output, generating the fuzzy lines.

Photo B: The mixture is solid and generates proper output.

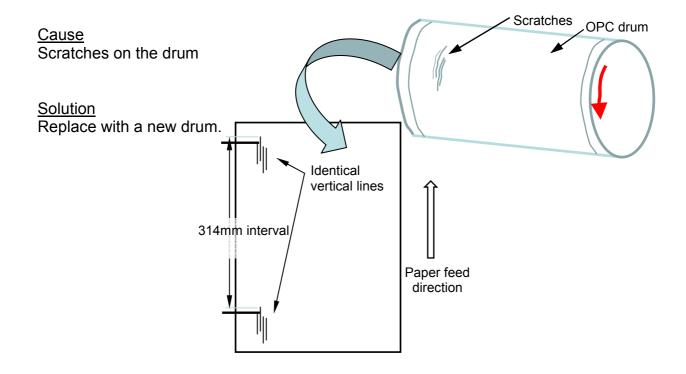
Vertical lines appear at a 314 mm interval (= drum circumference).

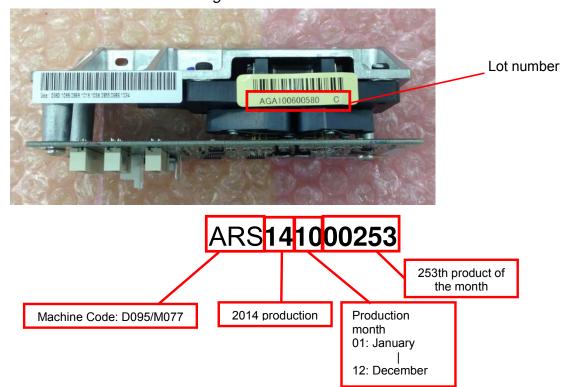
When replacing with a new laser diode (LD) unit procured as a service part, spacer seals may have to be attached to the LD unit before its replacement, which depends upon the lot number. Make sure to check the lot number of the new LD unit before installation.

- If the lot number is ARS141000253 or greater (for example, ARS141000270), spacer seals are included as accessory parts to the LD unit. See instructions below to install the spacer seals.
- If the lot number is ARS141000252 or smaller (for example, ARS140900005), spacer seals are not included. Disregard the instructions below.

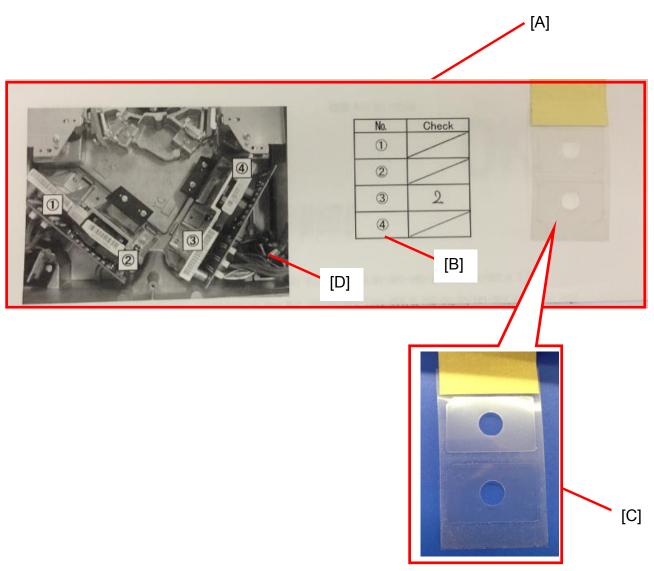
Spacer seals [C] are provided together with an instruction sheet [A]. Numbers 1~4 in table [B] on the instruction sheet correspond to the call-outs in the photo indicating to where the spacer seals need to be attached. Quantities of the spacer seals are handwritten in the table to indicate how many seals need to be attached.

The example below shows that 2 spacer seals need to be attached to location 3.

NOTE: The spacer seals may have 4 different types of thickness, but all spacer seals need to be attached to the same location according to the instruction sheet [A].

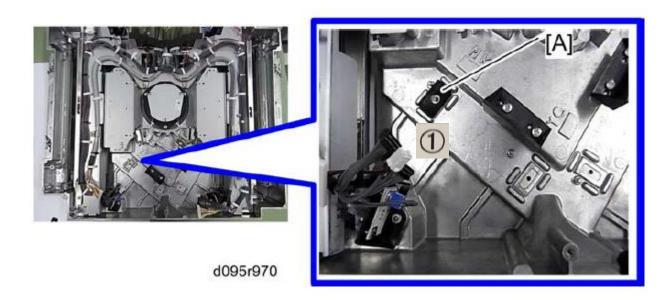
You may find spacer(s) attached to the laser unit when removing the original LD unit as shown in the photo below. (Spacer is attached to location $\bigcirc{}$.)

DO NOT remove spacer(s) originally attached. When installing the new LD unit, attach new spacer(s) on top of the original spacer(s).
