Model: PN-MF2a	Date: 27-04-09	No.: RM048001e
----------------	----------------	----------------

Subject: Firmware Release Note: System Firmware		Prepared by: Y.Gaman	
From: 2nd Overseas Tech Support Sec., 2nd PQM Dept.			
Classification:	<input type="checkbox"/> Troubleshooting <input type="checkbox"/> Mechanical <input type="checkbox"/> Paper path <input type="checkbox"/> Product Safety	<input type="checkbox"/> Part information <input type="checkbox"/> Electrical <input type="checkbox"/> Transmit/receive <input checked="" type="checkbox"/> Other ()	<input type="checkbox"/> Action required <input type="checkbox"/> Service manual revision <input type="checkbox"/> Retrofit information <input checked="" type="checkbox"/> Tier 2

Model: PN-MF2b		Date: 07-Aug-09	No.: RM048003
Subject: Fax background appears black		Prepared by: Y.Gaman	
From: 1st Tech. Support Sec. Service Support Dept.			
Classification:	<input checked="" type="checkbox"/> Troubleshooting	<input type="checkbox"/> Part information	<input type="checkbox"/> Action required
	<input type="checkbox"/> Mechanical	<input type="checkbox"/> Electrical	<input type="checkbox"/> Service manual revision
	<input type="checkbox"/> Pap

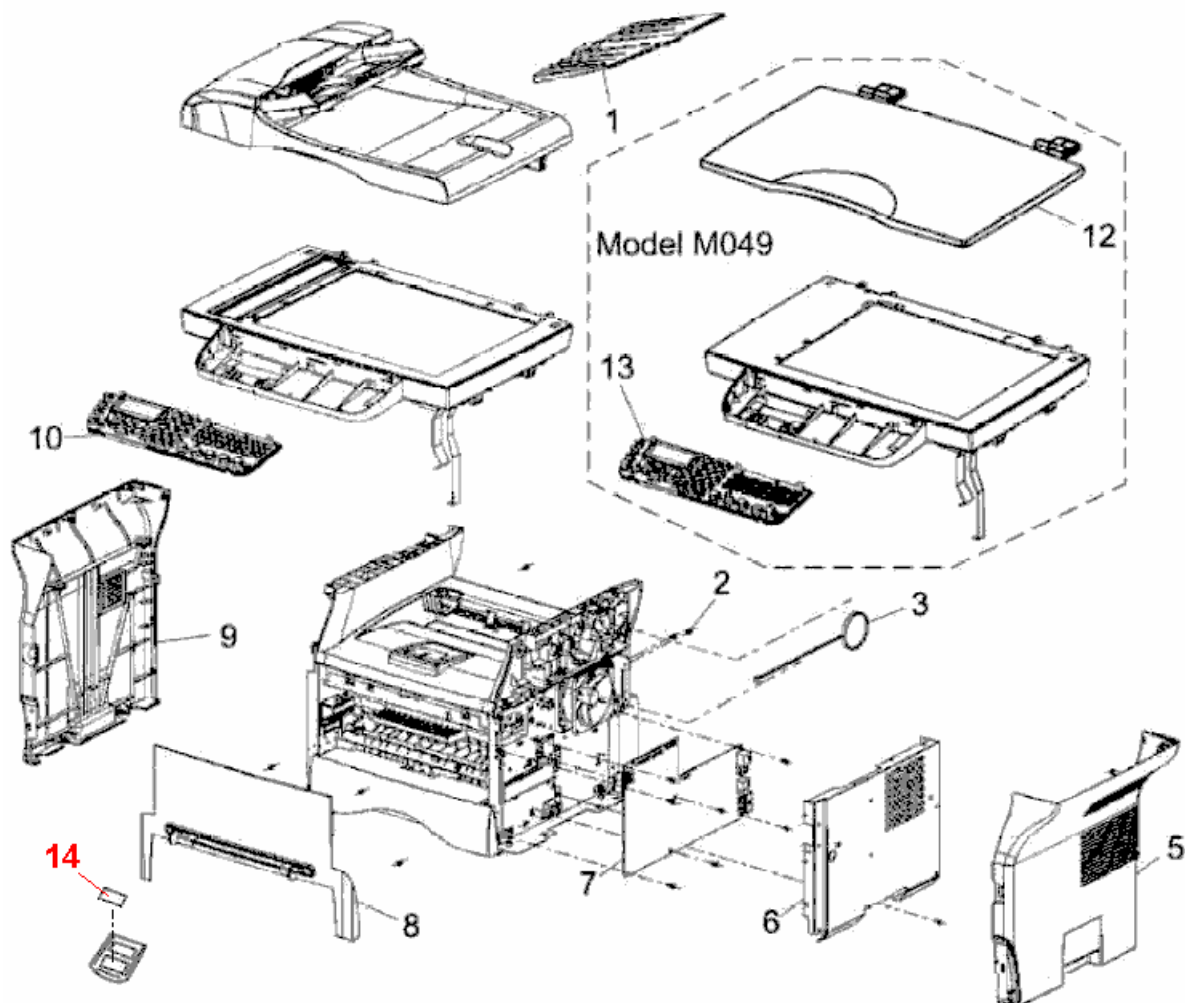
2.Exterior 2 (M048/M049)

Model: PN-MF2b		Date: 09-Dec-09	No.: RM048005
Subject: Harness:Motor&Sensor (ADF Unit)		Prepared by: Y. Gaman	
From: 2nd Overseas Tech Support Sec. 2nd PQM Dept			
Classification:	<input type="checkbox"/> Troubleshooting <input type="checkbox"/> Mechanical <input type="checkbox"/> Paper path <input type="checkbox"/> Product Safety	<input checked="" type="checkbox"/> Part information <input type="checkbox"/> Electrical <input type="checkbox"/> Transmit/receive <input type="checkbox"/> Other ()	<input type="checkbox"/> Action required <input type="checkbox"/> Service manual revision <input type="checkbox"/> Retrofit information <input type="checkbox"/> Tier 2

New part number	Description	Q'ty	Int	Page	Index	Note
M0481059	HARNESS:MOTOR & SENSOR	1	-	17	6
