Model: Model RN-MF1		Date: 25-May-09	No.: RM016001
Subject: How to access Maintenance Mode		Prepared by: Y.Yoshida	
From: 1st Tech. Support Sec. Service Support Dept.			
Classification:	<input type="checkbox"/> Troubleshooting <input type="checkbox"/> Mechanical <input type="checkbox"/> Paper path <input type="checkbox"/> Product Safety	<input type="checkbox"/> Part information <input type="checkbox"/> Electrical <input type="checkbox"/> Transmit/receive <input type="checkbox"/> Other ()	<input type="checkbox"/> Action required <input checked="" type="checkbox"/> Service manual revision <input type="checkbox"/> Retrofit information <input checked="" type="checkbox"/> Tier 2

Model: RN-MF1		Date: 08-Jan-10	No.: RM016004
Subject: Duplex Jam (Defective Feeler)		Prepared by: Y. Gaman	
From: 2nd Overseas Tech Support Sec. 2nd PQM Dept			
Classification:	<input checked="" type="checkbox"/> Troubleshooting <input type="checkbox"/> Mechanical <input checked="" type="checkbox"/> Paper path <input type="checkbox"/> Product Safety	<input type="checkbox"/> Part information <input type="checkbox"/> Electrical <input type="checkbox"/> Transmit/receive <input type="checkbox"/> Other ()	<input typ

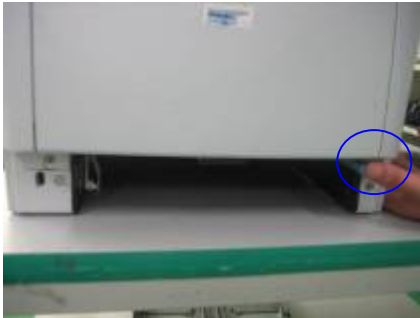
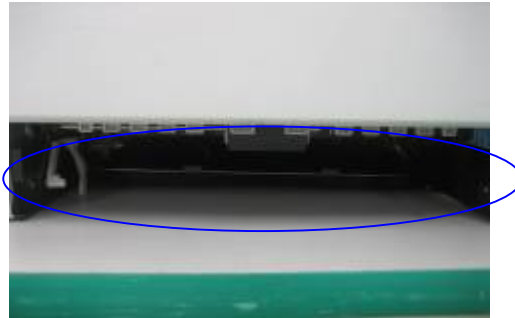
- 1) Pull tray 1 out completely with both hands.
(Place the tray on a flat surface.)
- 2) Push the blue lever.
Pushing the blue lever lowers the duplex transport unit.

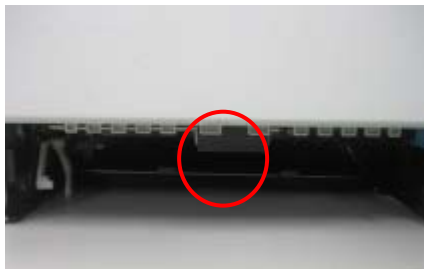
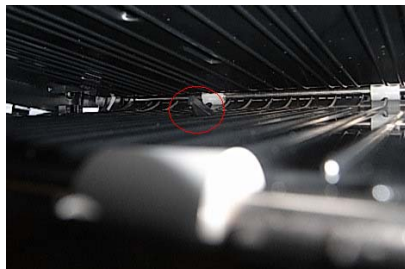
- 3) Check the shape of the feeler: M0134778
(Feeler:Sensor:Horizontal Transport).

Check the shape of the feeler in the middle of the lower guide with a flashlight.

The defective feeler is shorter.

Replace the feeler if it is defective.
Remove the AIO first before you do this procedure.

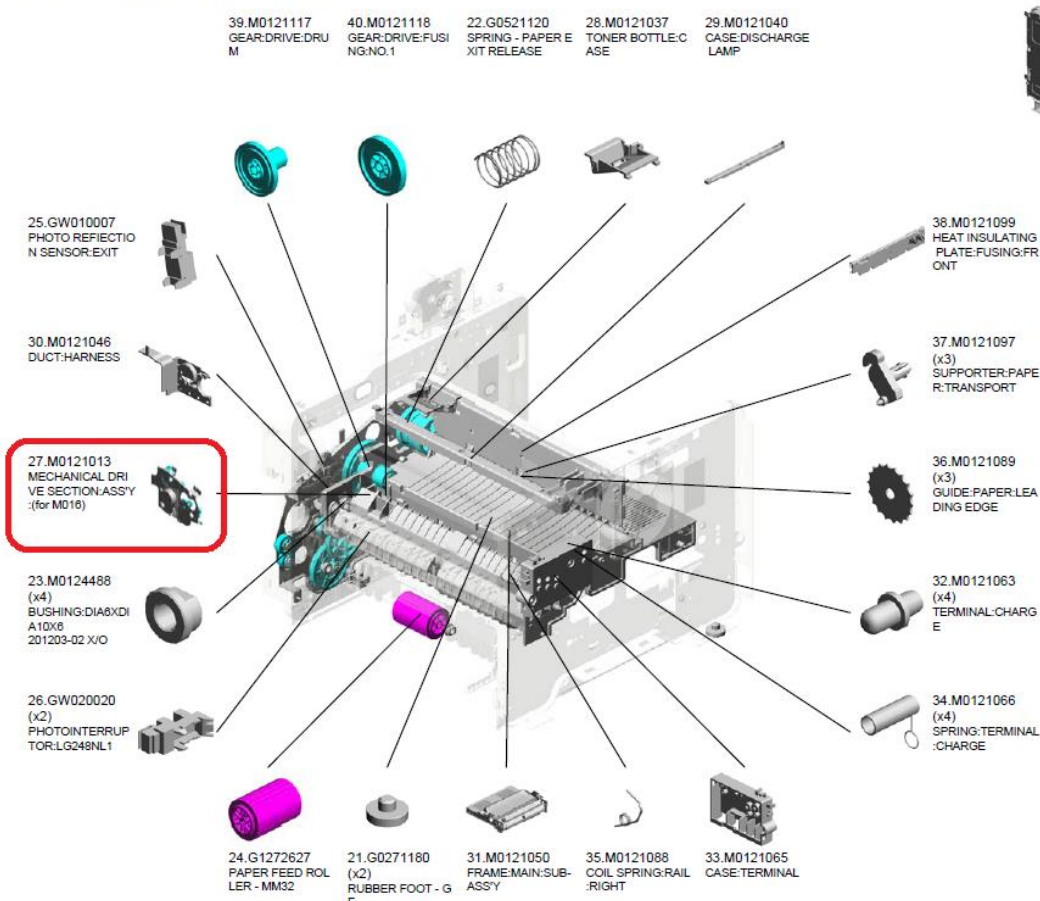
U008 MAIN FRAME/PAPER FEED

Description	PN	Correction	Reason
MECHANICAL DRIVE SECTION:ASS'Y:(for M016)	M0121013	Part Elimination	This part cannot be provided by the manufacturer. Please order the sub pieces instead of the ASS'Y.
