Model: PE-P1E	Date: 07-Apr-09	No.: RM035001c
---------------	-----------------	----------------

Subject: Firmware History - Engine		Prepared by: H.K.	
From: 2nd Overseas Tech Support Sec., 2nd PQM Dept.			
Classification:	<input type="checkbox"/> Troubleshooting	<input type="checkbox"/> Part information	<input type="checkbox"/> Action required
	<input type="checkbox"/> Mechanical	<input type="checkbox"/> Electrical	<input type="checkbox"/> Service manual revision
	<input type="checkbox"/> Paper path	<input type="checkbox"/> Transmit/receive	<input type="checkbox"/> Retrofit information
	<input type="checkbox"/> Product Safety	<input checked="" type="checkbox"/> Other (Firmware History)	<input checked="" type="checkbox"/> Tier 2

Model: Model PE-P1E		Date: 31-Aug-09	No.: RM035003
Subject: Reducing the color toner consumption in BK mode		Prepared by: H.K.	
From: 1st Tech. Support Sec. Service Support Dept.			
Classification:	<input checked="" type="checkbox"/> Troubleshooting	<input type="checkbox"/> Part information	<input type="checkbox"/> Action required
	<input type="checkbox"/> Mechanical	<input type="checkbox"/> Electrical	<input type="checkbox"/> Service manual revision
	<inp

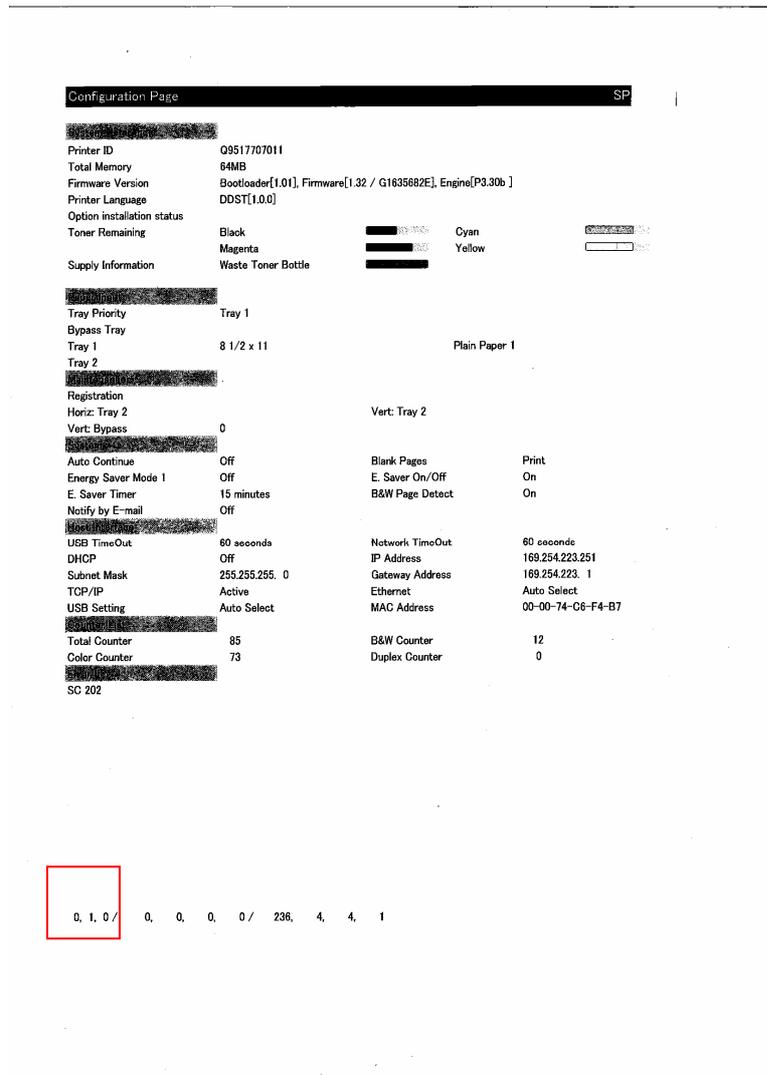
Printer version

First, print out the Configuration Page sheet and check the jam counters to see which kinds of jams are occurring most frequently.

Jam Counters:
 X,X,X :Tray jam counter, inner jam counter, duplex jam counter

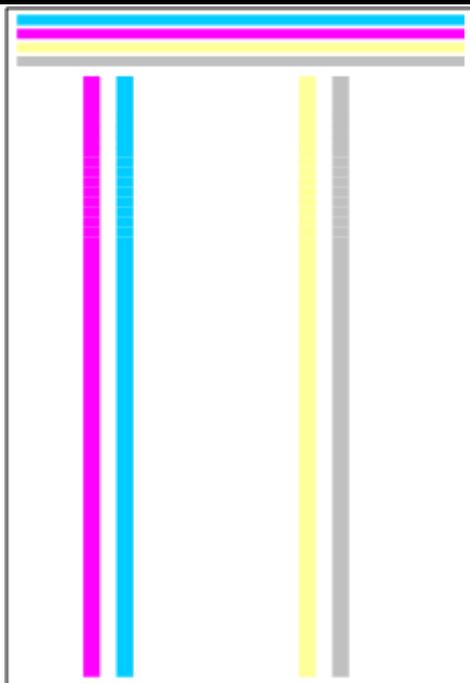
g165c502

Print out a mono-color pattern (all K, C, M, or Y) to clarify if the cause is a problem with one of the print cartridges, image transfer belt, image transfer roller, or the fusing unit. This sample page is attached to the last page of this manual. If you have a PDF version of this manual, you can print this page. Before printing, you have to adjust the printer driver settings to make the problem become obvious. For details about adjusting the settings, refer to "Printer Driver Setting for Printing a Sample" described below.

- Occurs with 1-3 colors: print cartridge(s) failure
- Occurs with all four colors: Image transfer belt, transfer roller or fusing unit failure

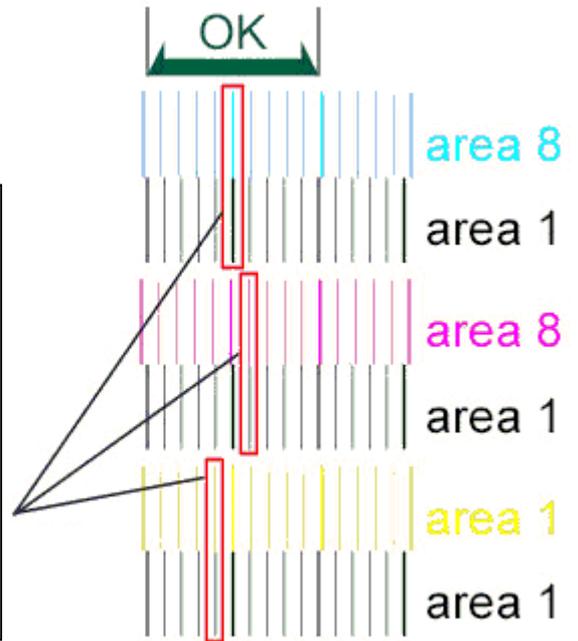
In each region/area, at least one set of vertical lines is aligned.

If MUSIC has not been performed successfully, do the following:

1. Open the upper cover and check the lot number of the laser optics housing unit.
2. Check to see if this lot number is listed in any of the Excel files attached below.
