Model: Model PE-MF2	Date: 16-Feb-09	No.: RM018001f
---------------------	-----------------	----------------

Subject: Firmware History - Engine		Prepared by: H.K.	
From: 2nd Overseas Tech Support Sec., 2nd PQM Dept.			
Classification:	<input type="checkbox"/> Troubleshooting	<input type="checkbox"/> Part information	<input type="checkbox"/> Action required
	<input type="checkbox"/> Mechanical	<input type="checkbox"/> Electrical	<input type="checkbox"/> Service manual revision
	<input type="checkbox"/> Paper path	<input type="checkbox"/> Transmit/receive	<input type="checkbox"/> Retrofit information
	<input type="checkbox"/> Product Safety	<input checked="" type="checkbox"/> Other (Firmware)	<input checked="" type="checkbox"/> Tier 2

Model: Model PE-MF2		Date: 16-Apr-09	No.: RM018004
Subject: Scanner Lock Error		Prepared by: H.K.	
From: 1st Tech. Support Sec. Service Support Dept.			
Classification:	<input checked="" type="checkbox"/> Troubleshooting	<input checked="" type="checkbox"/> Part information	<input type="checkbox"/> Action required
	<input type="checkbox"/> Mechanical	<input type="checkbox"/> Electrical	<input checked="" type="checkbox"/> Service manual revision
	<input

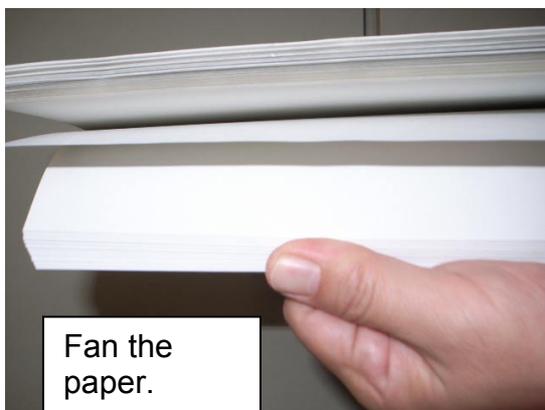
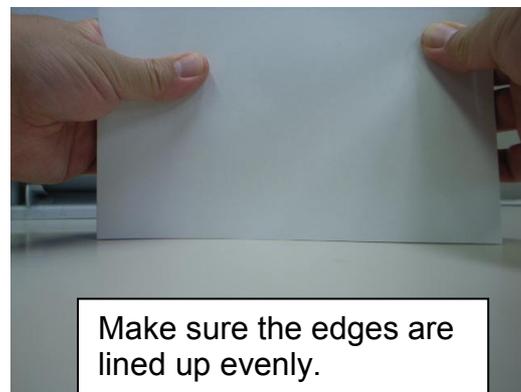
Paper jam by double or multi-feed (Tray jam, Internal jam, or Printer output bin jam)

Fan the paper well before loading it in the tray. Also, make sure that the edges are lined up evenly by tapping the stack on a desk or other flat surface. Only add paper when there is none left in the tray.

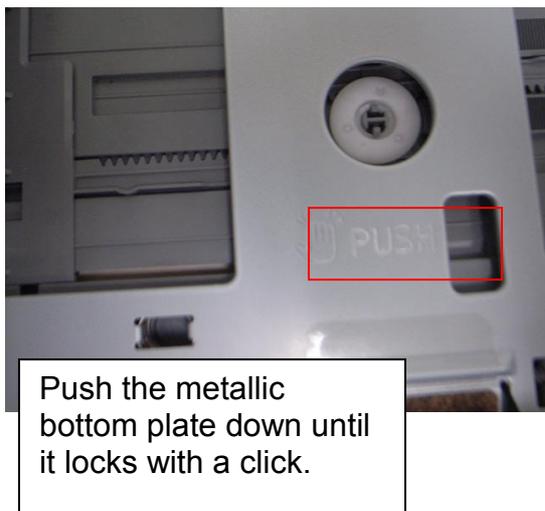
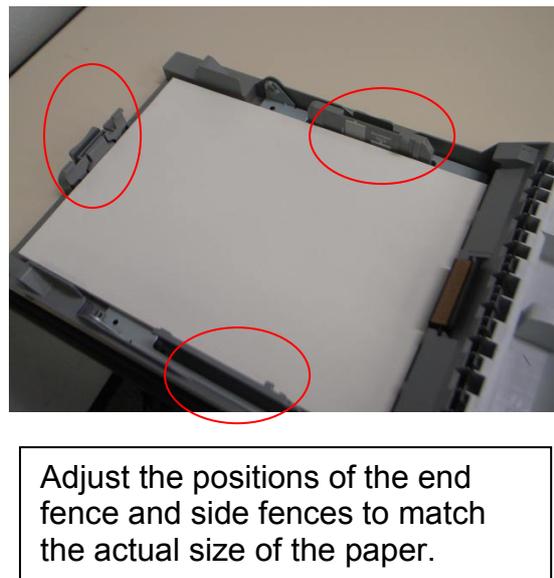
Paper jam by non-feed (Tray jam)

Make sure to push the metallic bottom plate down all the way (until it locks with a click) before you load the paper in the tray. Also, make sure the end fence and side fences are not too close together, compared to the paper size. (If they are, adjust their positions to match the edges of the paper).

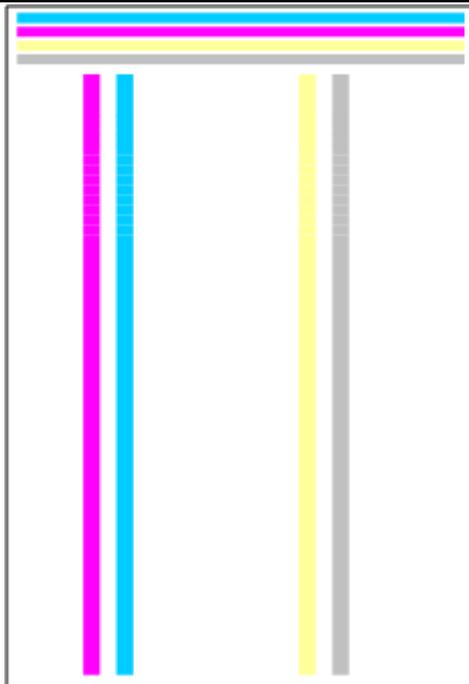
g165c502

Print out a mono-color pattern (all K, C, M, or Y) to clarify if the cause is a problem with one of the print cartridges, image transfer belt, image transfer roller, or the fusing unit. This sample page is attached to the last page of this manual. If you have a PDF version of this manual, you can print this page. Before printing, you have to adjust the printer driver settings to make the problem become obvious. For details about adjusting the settings, refer to "Printer Driver Setting for Printing a Sample" described below.

- Occurs with 1-3 colors: print cartridge(s) failure
- Occurs with all four colors: Image transfer belt, transfer roller or fusing unit failure

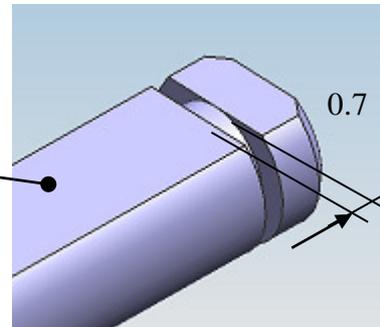
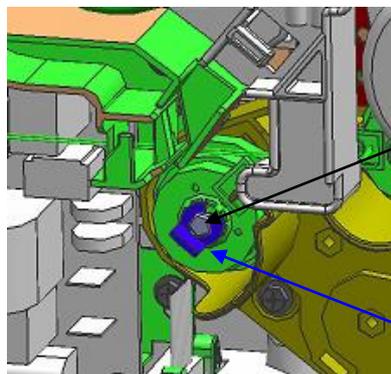
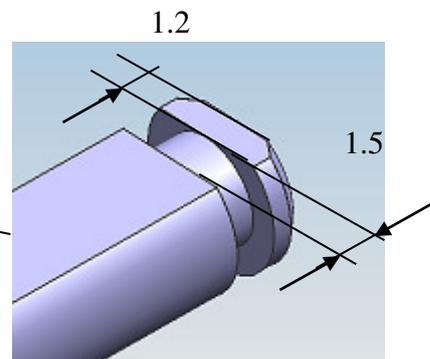
G1662580 Paper Feed Roller Shaft

08050089 E-ring

M1982580 Paper Feed Roller Shaft

H5213355 C-ring

08050089 → H5213355

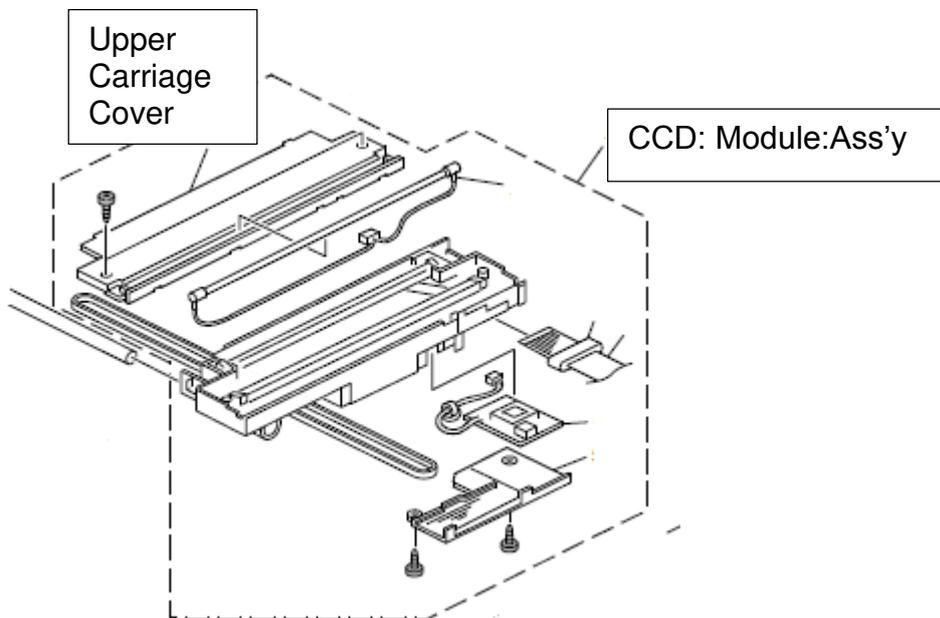
Reason: The manufacturer of the CCD modules has mistakenly modified the cover without notification. As a result, there is no interchangeability between the old and new covers, and both cannot be supplied.

Change: The Upper Carriage Cover service part was deleted and replaced with the CCD Module Assembly.
