Model: Kaiser1	Date: 29-Feb-00	No.: RH306001a
----------------	-----------------	----------------

Subject: ROM History (Kaiser 1)		Prepared by: M. Mano	
From: Technical Services Dept., GTS Division			
Classification:	<input type="checkbox"/> Troubleshooting <input type="checkbox"/> Part information <input type="checkbox"/> Action required		
	<input type="checkbox"/> Mechanical <input type="checkbox"/> Electrical <input type="checkbox"/> Service manual revision		
	<input type="checkbox"/> Paper path <input type="checkbox"/> Transmit/receive <input checked="" type="checkbox"/> Retrofit information		
	<input type="checkbox"/> Other (       )

Firmware history for the Kaiser1 (USA Model)

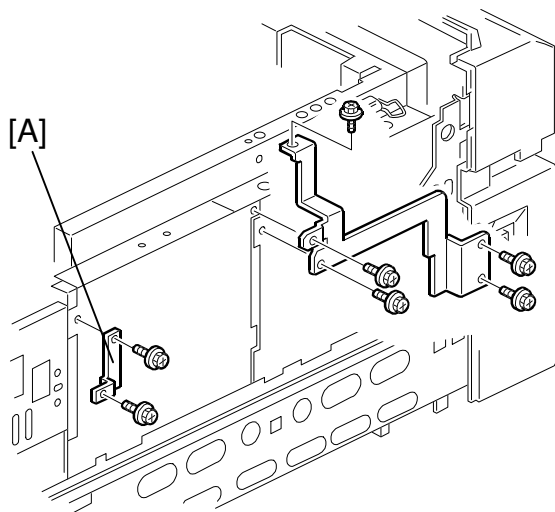
[Fig. 1]

The PIF option grounding plate [A] (P/N: H3064662) in the following 15 units will bend slightly when you attach it, as shown in figure 2.

However, the plate will function normally and the slight bending will not affect the operations of the printer unit or mainframe in any way.
