RIGOH	Technical E	Bulletin	No.	BRO-001
SUBJECT: Service Manual U	pdate			<b>DATE:</b> Jan 15, 1996
PREPARED BY: Y. Okunishi CHECKED BY: M. Iwasa		FROM: Qu	ality Ass	surance Center
CLASSIFICATION:			MODE	L:
Action Required     Traublachapting	Revision of servi	ice manual	B	RO, BR1
Retrofit Information	Other

SUBJECT: Incomplete Cover Closing			<b>DATE:</b> Feb. 15, 1996
PREPARED BY: Y. Okunishi CHECKED BY: M. Iwasa	FRO	M: Quality As	ssurance Center
CLASSIFICATION:	·	MOD	EL:
Action Required Rev Troubleshooting Info	sion of service ma mation only er	anual E	BRO/BR1

SUBJECT: Printer Cover Catch	<b>DATE:</b> Feb. 15, 1996
PREPARED BY: Y. Okunishi CHECKED BY: M. Iwasa	FROM: Quality Assurance Center
CLASSIFICATION:	MODEL:
Action Required Revision of Troubleshooting Information Other	of service manual BRO/BR1 on only

SUBJECT: Document Senso		<b>DATE:</b> Mar. 15, 1996		
PREPARED BY: Y. Okunisl CHECKED BY: M. Iwasa	hi	FROM: Qu	ality Ass	surance Center
CLASSIFICATION:			MODE	L:
Action Required	Revision of servi	ice manual	Bł	RO, BR1
Troubleshooting	Information only			
Retrofit Information	Other

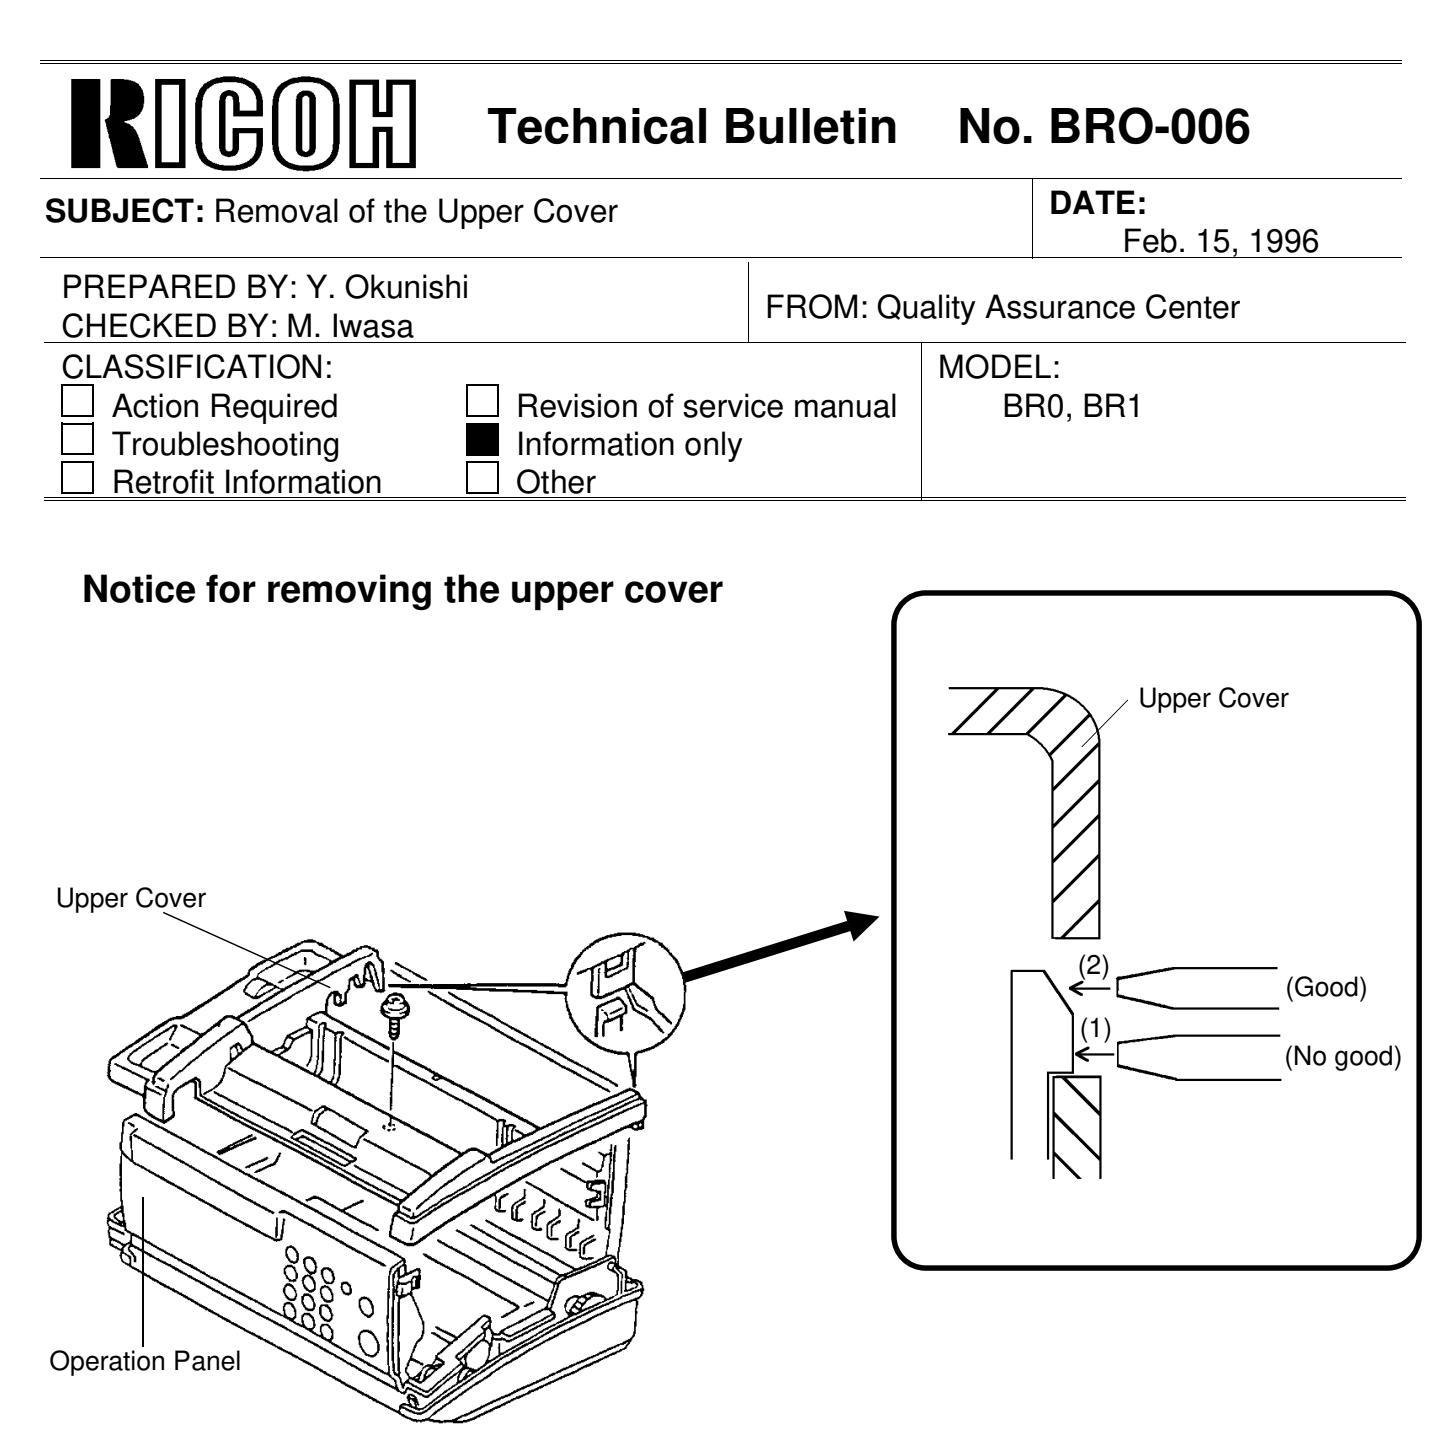
\* Do not push the lower side of the tab (1), because the tab may break. Push the sloping side of the tab (2) and the tab will release.
