# Technical Bulletin

## No. Barbara-001

### Parts List Corrections

FAX RF01/02, FAX240

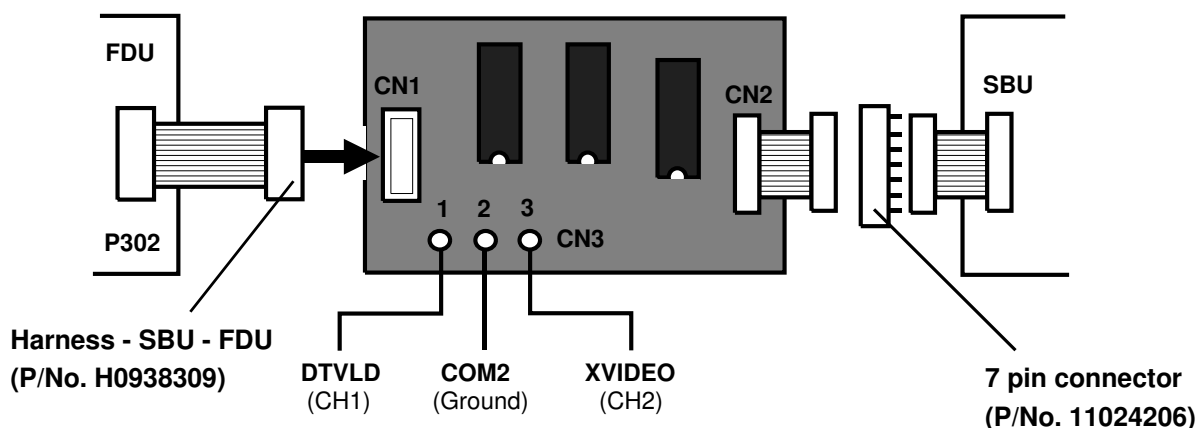
Connect the harness from the FDU (P302) to CN1 on the test PCB, then connect the harness from the test PCB (CN2) to the harness from the SBU through a 7 pin connector (P/N: 11024206).

**Note:** Make sure that the test PCB is connected as shown in the diagram below.  
The SBU may be damaged if the test PCB is connected the other way around.
