**SUBJECT:** Service Manual Correction

MODEL: CRO Europe and Asia  
Version

## Technical Bulletin

No. CRO-002

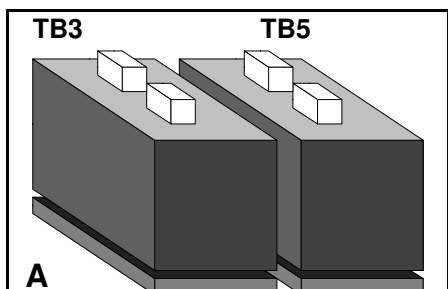
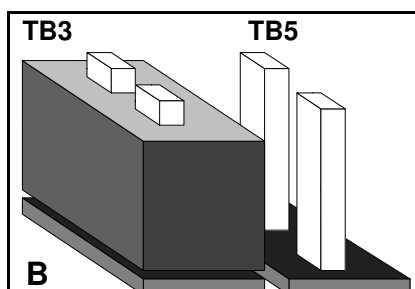
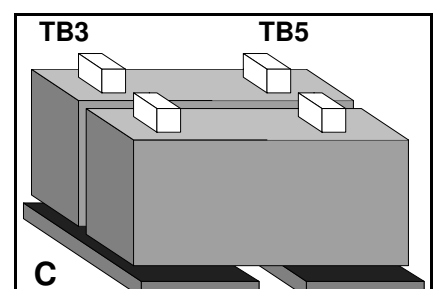
S. Africa	H	H	L	H	H	L	O	S	C	S	O	S	S	
Australia	L	H	L	H	H	L	O	S	A	S	O	O	S	
New Zealand	L	H	L	H	H	L	O	S	A	S	O	S	S	
Singapore	H	H	L	H	H	L	O	S	A	S	O	S	S	
Malaysia	L	H	L	H	H	L	O	S	A	S	O	S	S	
Turkey (U.K.)	L	H	L	H	H	L	O	O	A	S	O	S	S	
Keys	H = High; L = Low						O = Open; S = Short. For "A", "B" and "C" in the TB3/TB5 columns, refer to the following diagrams.
