Software problem

Model(s): FAX3000L

RIGOH	Technic	al Bulletin CSO-003	lssued	d on February 1	5, 1992
Subject: AFO/A	F2/CSO Softwa	re problem			
Model(s): AFO/AF2/C	SO				
Classification		FAX T.S. Se Assistant Ge <u>H. Motojima</u> Control No.	ction T.S. D neral Mana for Each Ar	epartment ger ea	
		R.C.		Asia	002
Betrofit Information		SAVIN		LAM	002
Revision of Service N	Manual	Europe	002	AT&T	
☐ Information Only	handa	HCS	002		
Others

## AFO/AF2/CSO Software problem

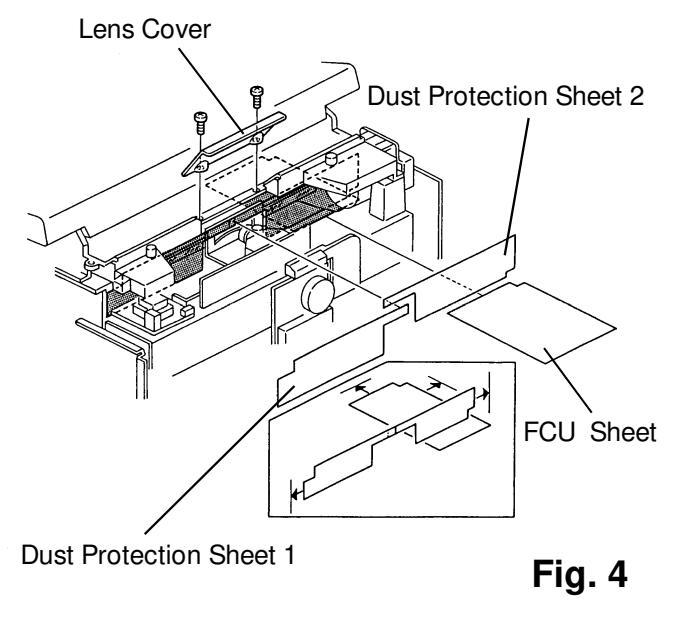
In the field, the scanner mirrors may become dusty (poor scanning quality). In this case, we recommend that you do procedures 1 and 2.

### [FCU Sheet Installation]

- (1) Remove the rear/ left/ right/ lens covers.
- (2) Insert the FCU sheet under the mirrors, then attach the sheet to the right side and interior of the ADF base. (Fig. 4)

[Dust Protection Sheet 1 and 2 Installation]

- Attach the dust protection sheet 1 to the left side of the scanner and the upper side of the shading plate. (Fig. 4)
- (2) Attach the dust protection sheet 2 to the right side of the scanner and the upper side of the shading plate. (Fig. 4)
