Technical Bulletin No. CFO-001

SUBJECT: Service Manual Correction

MODEL: CFO

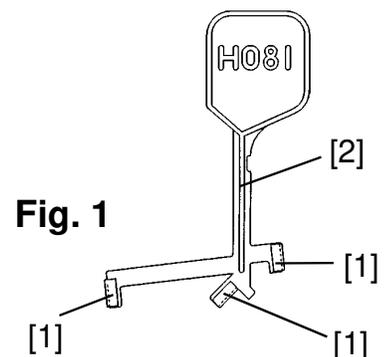
In the field, the scanner mirrors may become dusty (poor scanning quality).
In this case, we recommend that you do procedures 1 and 2.

Attach the cleaning felts [1] to the mirror cleaning tool [2]. (Fig. 1)
(With one set of felts, you can clean the mirror up to 10 times)

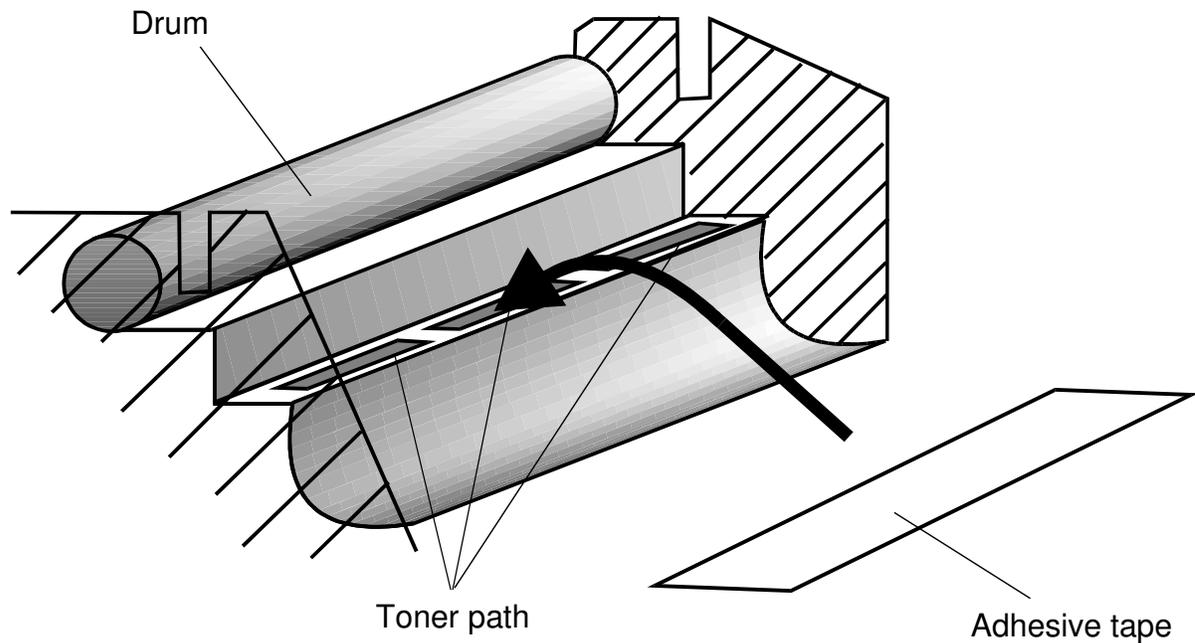
Inside of FX6 and LSO

Cause: Toner leaked from the development unit, the toner cartridge, or somewhere in the toner path during transportation.

Note: Adhesion of the tape should not be strong. Otherwise, it may not be taken off cleanly from the machine, or the toner path may be damaged when it is taken off.
