# Technical Bulletin

# No.CGO-001

**SUBJECT:** Service Manual Correction

FAX5600L

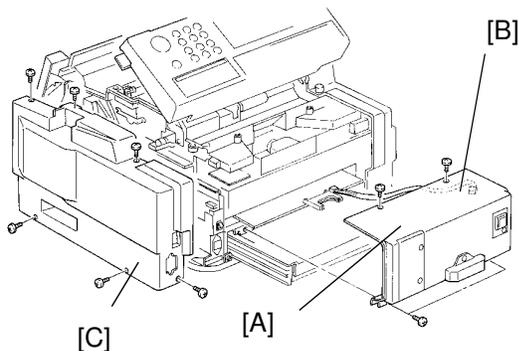
**Problem :** Damage to the SBU harness

**Reason :** Pin edges of the HD Interface Board and the Printer Interface Board damage the harness if the harness is not re-located correctly, causing it to be pinched between the base mold and the board. When the HD Interface Board or Printer Interface Board is installed.

2. Remove the rear cover [A], and disconnect the monitor speaker harness [B].
3. Take off the right cover [C].

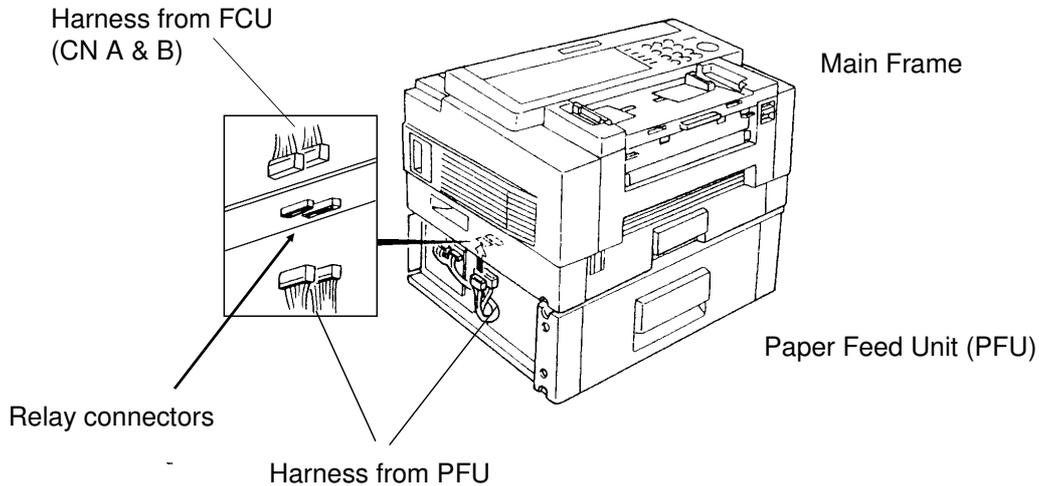
**Cause:** Wires of the harness (H511 5528) from the FCU to the relay connectors for the paper feed unit (PFU) are not allocated properly.

The harness should be checked before the start of the PFU installation because the FCU or the PFU PCB may become damaged.

1. Remove the Rear Cover and Left Cover.
2. Unplug the connector CN28 on the FCU.
3. Unplug the connectors CN A and CN B on the relay connector board located at the bottom of Main Frame.

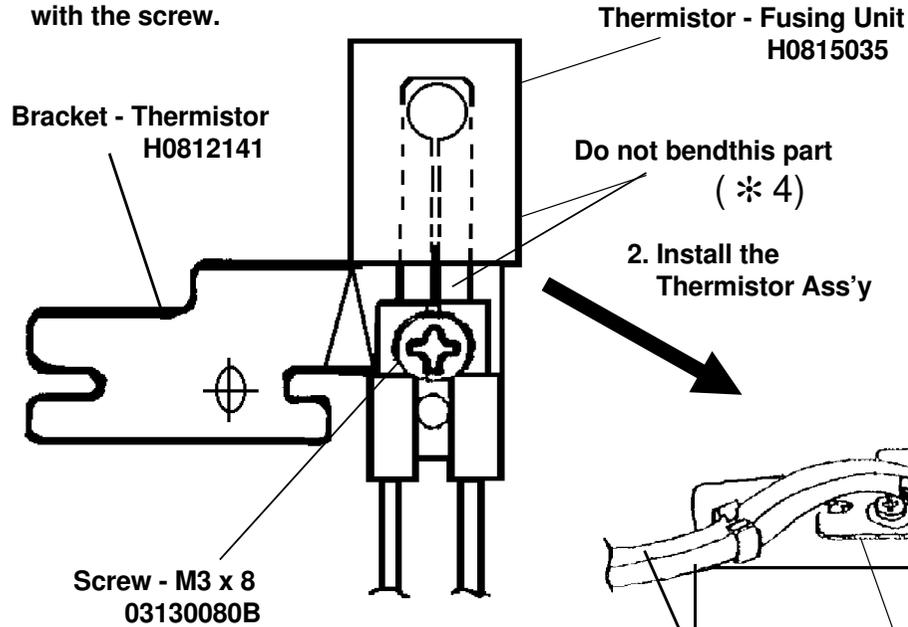
Hot Roller failure as a result of not changing the Cleaning Pad at the 10K PM. Failure to change the Cleaning Pad results in dirty Strippers and Thermostat and then Hot Roller failure.

Do not bend this part (\* 4)

- Note: \* 1 Place the thermostat harness under the part of the bracket.
- \* 2 Do not cross the thermostat harness and the thermistor harness.
- \* 3 Push the thermistor head (sensor) gently against the hot roller with a finger to make sure that the thermistor head touches the hot roller surface. Do not push it strongly.
- \* 4 Do not bend the thermistor neck (spring plate) when installing or cleaning it .  
If the thermistor is bent, replace it.

1. Assemble the thermistor and the bracket with the screw.
