RIGOH	Technical B	Bulletin	No.	F/L Series-001
SUBJECT: Introduction of the New	Tools for ROM/RAM [	Data Change		<b>DATE:</b> Apr. 30, 1995
PREPARED BY: Y. Okunishi CHECKED BY: M. Iwasa FROM: 2nd		d T.S. Section		
CLASSIFICATION:	_		MODE	L:
Action Required Revision of service manual		FX	(6, FX4, LSO	
Troubleshooting	Information only			
Retrofit Information	Other

**SUBJECT:** Introduction of the New Tools for ROM/RAM Data Change

## Technical Bulletin No. F/L series-005

SUBJECT: Paper size sense		<b>DATE:</b> Aug. 31, 1995		
PREPARED BY: T. Kimura CHECKED BY: M. Iwasa	l	FROM: 2nd	d T.S. S	ection
CLASSIFICATION:		L	MODE	L:
Action Required	Revision of servi	ice manual	M	V310 / FX6
Troubleshooting				
Retrofit Information	Other

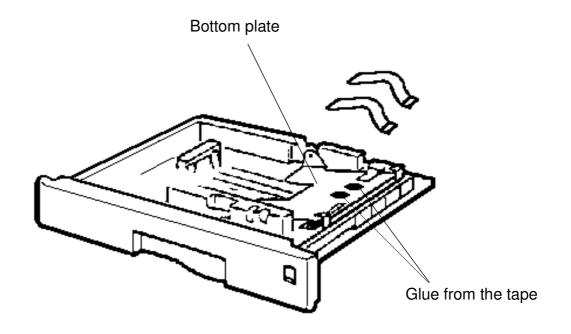
When peeling off tapes, in particular for the paper cassette, please check if the glue from the tape has been completely removed from the paper cassette bottom plate.

If not, a paper misfeed may occur when the last sheet is fed, since it sticks to the bottom plate.

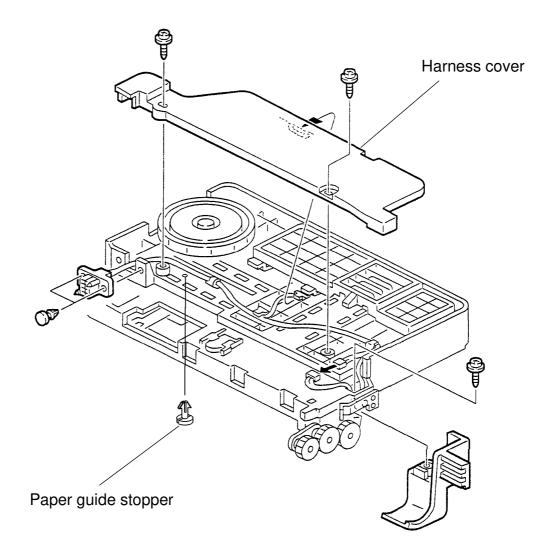
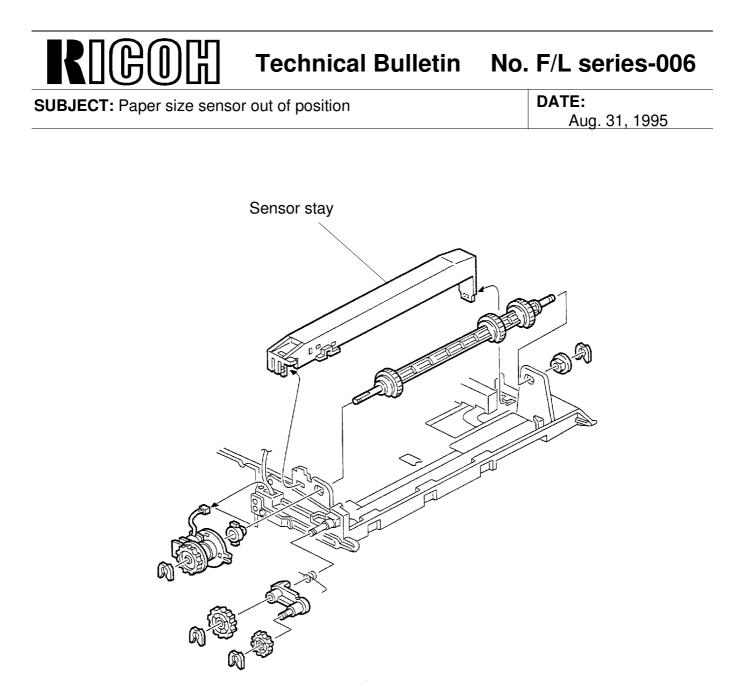
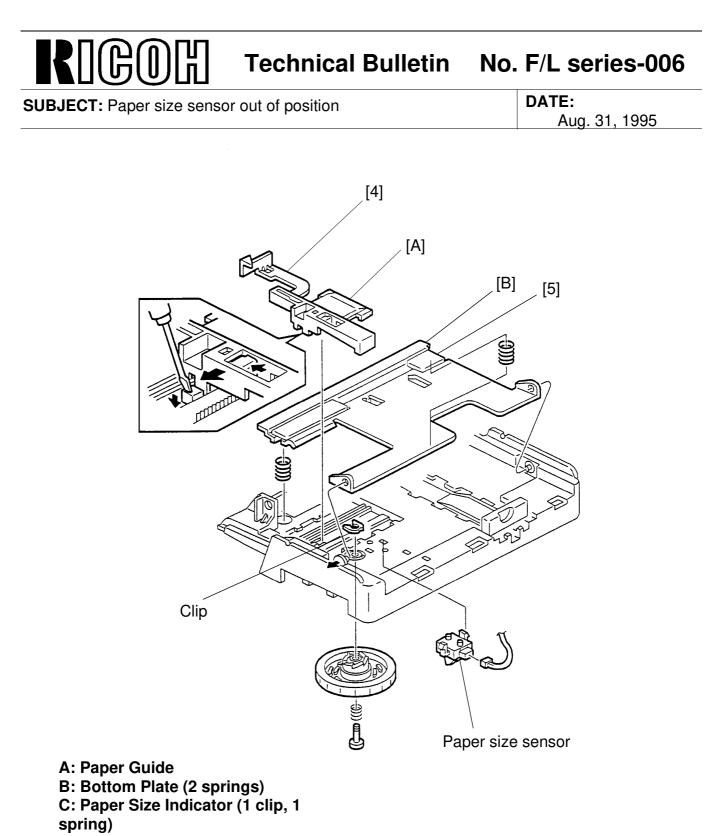
#### < Attachment >

After installing the side cassette, it may be found that the paper size cannot be set properly in spite of setting the paper size indicator dial. If this problem occurs, the machine cannot detect any size other than LT/LEGAL.

In this case, it is assumed that the paper size sensor is out of position because of transportation damage.

- 1. Remove the two screws and take off the harness cover.
- 2. Remove the paper guide stopper.

3. Remove the sensor stay.

- 4. Remove the paper guide.
- 5. Remove the bottom plate.
- 6. Take off the clip and remove the paper size indicator.
- 7. Reinstall the paper size sensor.

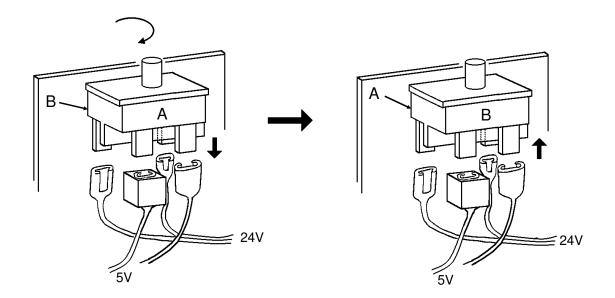
Auto Service Call 0-05 (Fusing Unit Failure; see page 6-26 of the Service Manual)

There are two switches, for the 5V line and the 24V line, in the Safety Switch (Index no.133 on page 1-16 of Parts Catalog). If the Top Cover or Front Cover is not closed completely, there is a possibility that the 5V switch will turn on but the 24V switch will not. In this case, "Cover Closed" is detected but the fusing lamp is not turned on, and this is the cause of the Auto Service Call.

- 1) Remove the Right Cover.
- 2) Disconnect the 5V lines and the 24V lines.
- 3) Remove the Safety Switch.
- 4) Turn the Safety Switch 180 degrees.
- 5) Connect the 5V lines and 24V lines.

RAM reset is required to escape from the Auto Service Call.

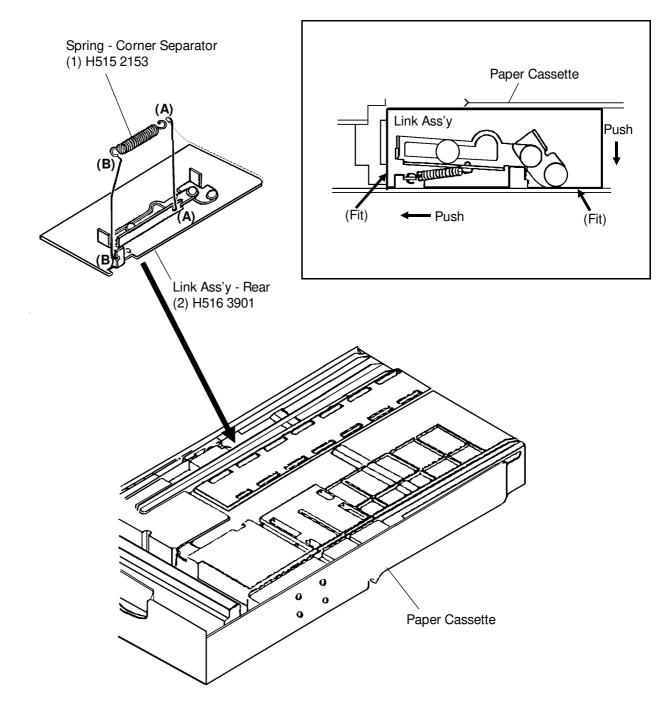
- Action Required Revision of service manual Paper Feed Unit Type 140F Troubleshooting Information only Retrofit Information Other
- Problem: Multi-sheet feeding and/or paper skew when the paper is fed from the paper feed unit Type140F which is a option for FX6MII and FX4. No problem happens when the paper feed unit type 140S is used.
- Leading corners of the paper in the paper feed unit move from the corner separator Cause: when the paper cassette of the paper feed unit is pushed back into the machine after the paper is set in the cassette.

- 1. Assemble the spring (1) with the Rear Link Ass'y (2).
- 2. Bend the hook of the spring at side B to prevent the hook from coming off.
- 3. Attach the Rear Link Ass'y with the spring onto the back side of the paper cassette.

Note: Clean the spot where the Rear Link Ass'y is attached.

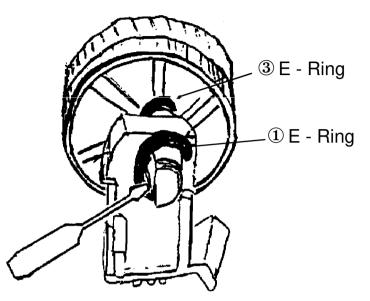
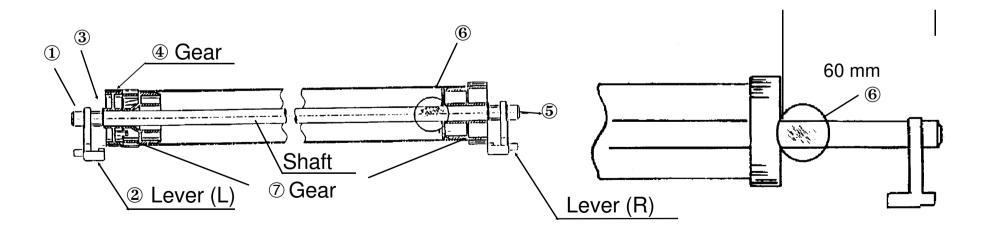
Cause : Evaporated material from the glue which is used to fix the gear (O) to the inside of the drum attaches to the drum shaft and creates a thin layer (O) on the shaft. It causes incomplete flow of charge from the drum to the ground through the shaft and causes white bands on copies.

#### **Repair Procedure for Defective Drums**

- 1.Cover the drum surface with packing material (or paper).
- 2.Remove E Ring 1 .
- 3.Remove Green Lever 2.
- 4.Remove E Ring 3.
- 5.Remove Gear ④
- 6.Pull the drum shaft out about 60 mm. (5)
- 7.Clean the dull-colored part (<sup>®</sup>) on the shaft with a cloth (with alcohol if available).
- 8.Assemble the drum.

#### Note : Do not touch the drum surface directly.

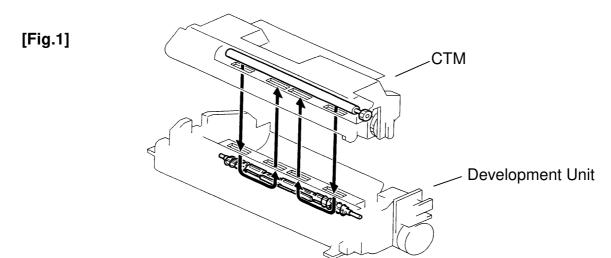
The development units are modified to improve the flow of toner in the development unit. See Fig.1 on the attached page. This modification reduces the following problems.

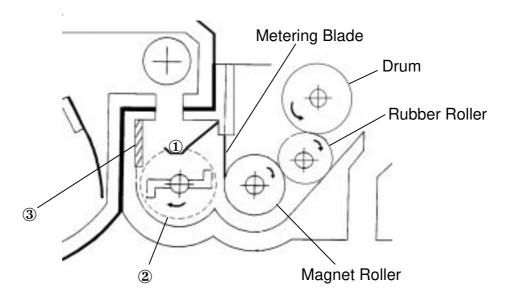
[Fig.2]

See Fig. 2

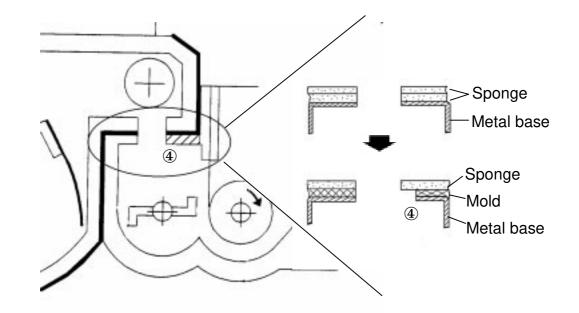
[Fig.3]

See Fig. 3

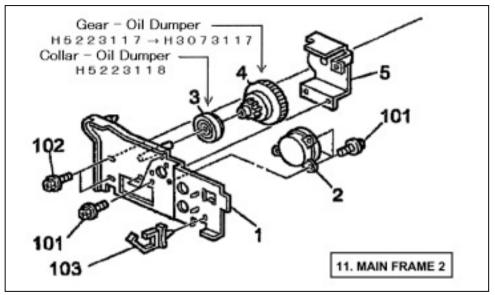
#### [Figure 1]

On the current machine, if the gear is replaced without the new collar, the gear will push up against the bracket (#5 in fig. 1), causing the bracket to deform and the symptom above to reoccur, as the gear teeth will break more easily from the increased friction.

1. The Gear and Collar (H3073117 and H5523118) must be replaced <u>together as a set</u> (see "New" in fig. 2 below).
