Model: FR6		Date: 31-Oct-97	No: 001	1/35
Subject: New Model FR6 Release			Prepared by: K. Misugi	
From: Technical Service Department			Checked by: S. Fujii	
Classification:	<input type="checkbox"/> Troubleshooting	<input type="checkbox"/> Part information	<input type="checkbox"/> Action required	
	<input type="checkbox"/> Mechanical	<input type="checkbox"/> Electrical	<input type="checkbox"/> Service manual revision	
	<input type="checkbox"/> Paper path	<input type="checkbox"/> Transmit/receive	<input type="checkbox"/> Retrofit information	
	<input checked="" type="checkbox"/> Other ( )

The new model FR6 (FAX3800L) has been released as a successor model to the FX6 (FAX2700L).

This technical bulletin contains information on differences between the FR6 and the FX6. They are listed in order of sections that appear in the service manual.

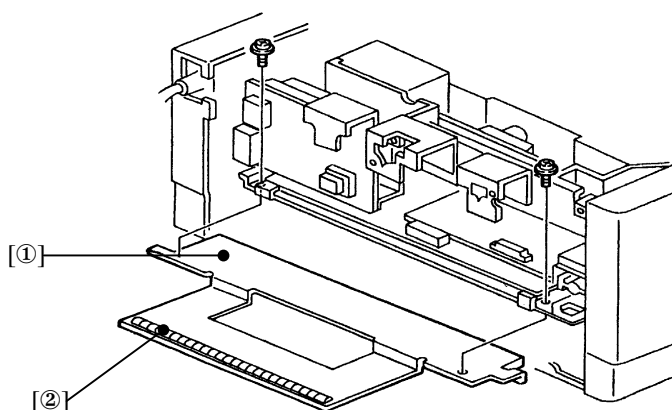
\*This modification prevents the Kattsumari problem (vertical gray bands on print outs) caused by blocked toner in the middle of the development unit. The blocked toner bends the toner metering blade. The toner enters the drum area through the gap made by the bent blade. Once in the drum area, the toner collects on the drum and causes the gray bands on the print out.

- ① H515 3185 : Grounding Plate
- ② H515 3188 : Gasket

2) Two screws

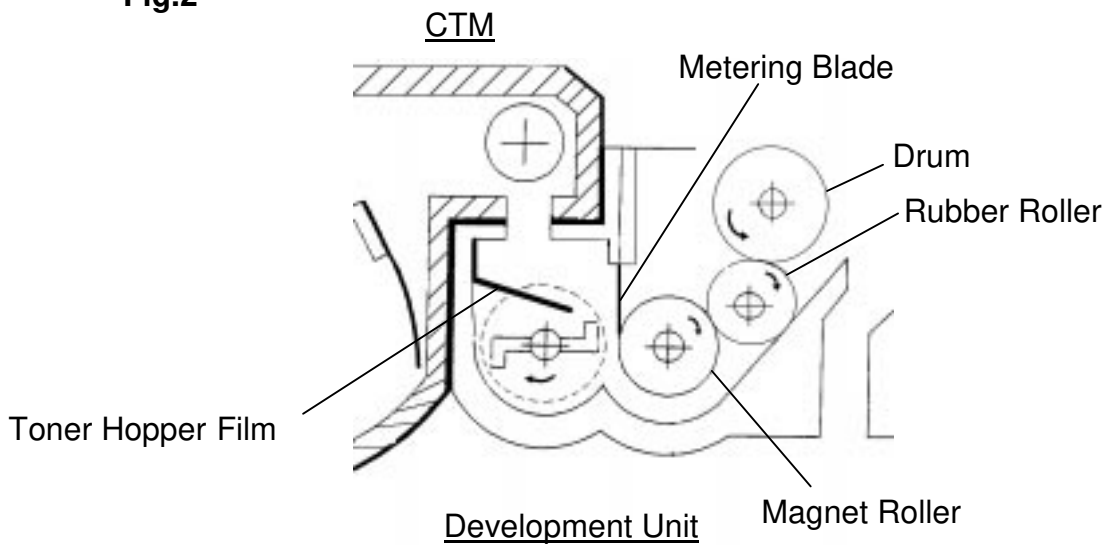
**Fig.2**

- 1) The toner entrance becomes smaller to prevent too much toner from dropping into the development unit. [Fig.1]
- 2) Toner Hopper Film, mentioned in MB no. F/L Series – 91B, has been strengthened to push more toner up to the CTM. [Fig 2]

- Length of the toner entrance (A) becomes smaller. (30mm → 18mm)
