Model : FAX 77/80/85/84
i-6212/6213/6215
Nashua 1040/1045
SAVINFAX 301/331
AT&T 9020FX/9022FX

RTB No. C-017

Subject: Changing the software

Subject: RX MOTOR

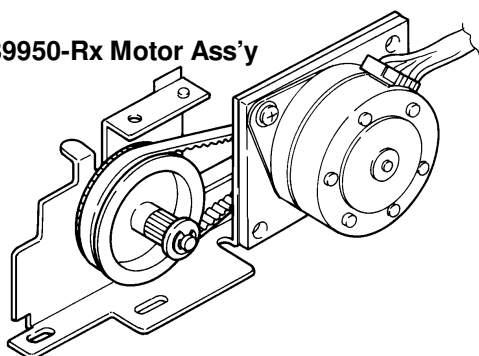
H0539950-Rx Motor Ass'y

The Rx motor ass'y consists of the motor, bracket, belt and gears. It makes serviceability easier, i.e. to minimize adjustment.

Replace the Rx motor with a modified Rx motor.

The service parts ass'y is available for replacing the Rx motor. Please refer to the following.
