RIGOH	Technical B	ulletin	No.	IFO-001
SUBJECT: Dial Tone Detection	on in the Netherland	ls		<b>DATE:</b> Feb. 29, 1996
PREPARED BY: K. Ugaeri CHECKED BY: M. Iwasa		FROM: Qua	ality Ass	urance Center
CLASSIFICATION:  Action Required Troubleshooting Retrofit Information	Revision of servi Information only Other	ce manual	MODE IF	
<b>NL</b> only

SUBJECT: Gear 3 of Paper Tray Came out			<b>DATE:</b> MAR.15.1996
PREPARED BY: K,Ugaeri CHECKED BY: M. Iwasa	FROM: QA	Center	
CLASSIFICATION:		MODE	L:
<ul><li>■ Action Required</li><li>□ Troubleshooting</li><li>□ Retrofit Information</li><li>□ Other</li></ul>		IF	0

RIGOH	Technical E	Bulletin	No.	IFO - 006
SUBJECT: Gear 3 of Paper	Tray (2)			DATE: Sep. 15, 1996
PREPARED BY: K.Ugaeri CHECKED BY: S.Fujii		FROM: Qu	ality Ass	urance Center
CLASSIFICATION:			MODE	L:
Action Required	Revision of servi	ce manual	IF	0
Troubleshooting	Information only			
Retrofit Information	Other

Technical Bulletin	No.	IFO - 007
SUBJECT: "Unable Use Print	er" (Error Codes 5-51,54,55,a	nd 5F)	DATE: REVISED Sep.30,1996
PREPARED BY: K.Ugaeri CHECKED BY: S.Fujii	FROM: Qu	ality Ass	surance Center
CLASSIFICATION:	·	MODE	L:

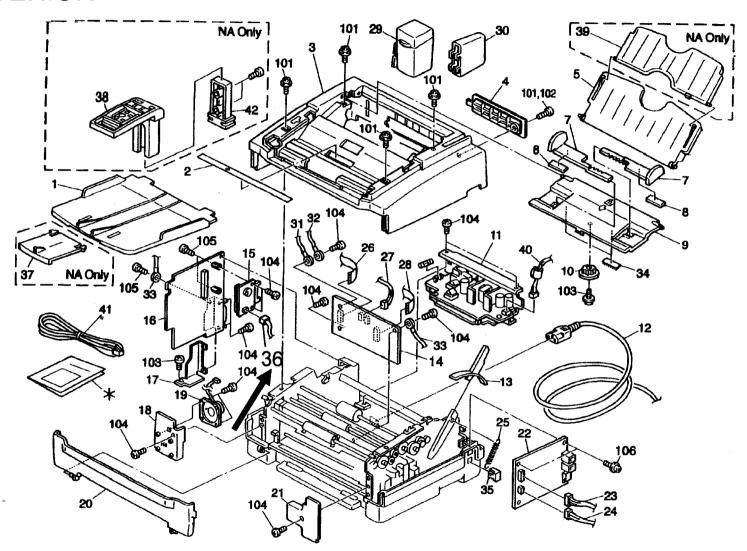
## 1.EXTERIOR

\* When the operator opens the ADF from the rear side, the hook of the operation panel cover may be broken.

- \* This kit consists of a Release Lever ① and a cover for the release lever ②.
- \* The cover must be changed with the release lever because it must be broken when the lever is changed.

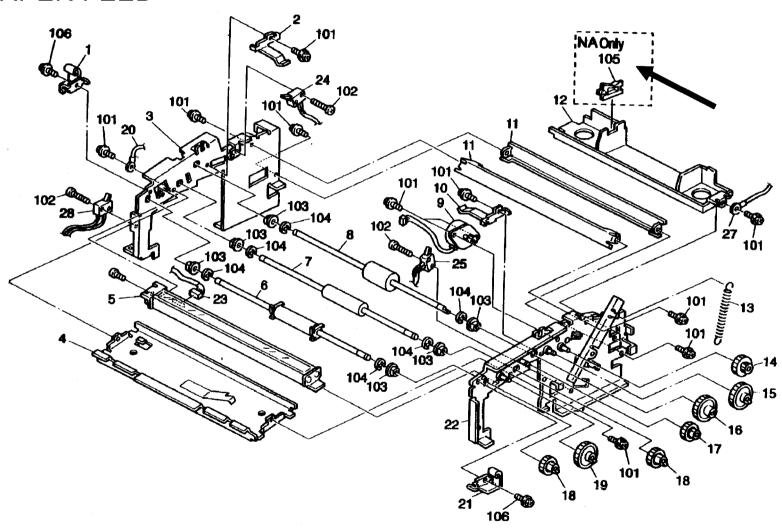
## 4.PAPER FEED

Symptom: Paper non-feed

Cause: This is caused by operator mistakes.

If the paper is added in the paper tray without pulling up

the release lever, the paper will be set over the corner separator.

This causes the paper to be multifed and jammed. (Fig 2)

direction and Gear3 and/or Gear2 will come out. (Fig 3)
