Model: Multi Bypass Tray BY5000 (B833)		Date: 25-Mar-11	No.: RB833001
Subject: Part change – Push Switch and Harness		Prepared by: T. Komori	
From: PP Service Planning Department 1G			
Classification:	<input type="checkbox"/> Troubleshooting <input type="checkbox"/> Mechanical <input type="checkbox"/> Paper path <input type="checkbox"/> Product Safety	<input checked="" type="checkbox"/> Part information <input type="checkbox"/> Electrical <input type="checkbox"/> Transmit/receive <input type="checkbox"/> Other ()	<input type="checkbox"/> Action required <input type="checkbox"/> Service manual revision <input type="checkbox"/> Retrofit information <input type="checkbox"/> Tier 2

Model: Multi Bypass Tray BY5000 (B833)		Date: 16-Dec-11	No.: RB833002
Subject: Part Changes		Prepared by: A. Takada	
From: PP Tech Service Dept., 1st PP Tech Service Sect.			
Classification:	<input type="checkbox"/> Troubleshooting <input type="checkbox"/> Mechanical <input type="checkbox"/> Paper path <input type="checkbox"/> Product Safety	<input checked="" type="checkbox"/> Part information <input type="checkbox"/> Electrical <input type="checkbox"/> Transmit/receive <input type="checkbox"/> Other ()	<in

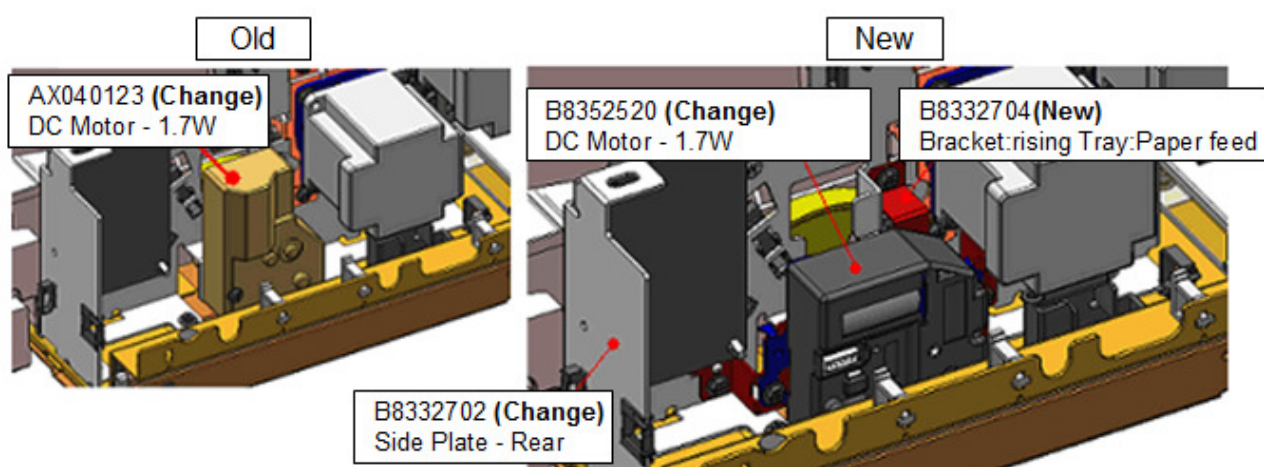
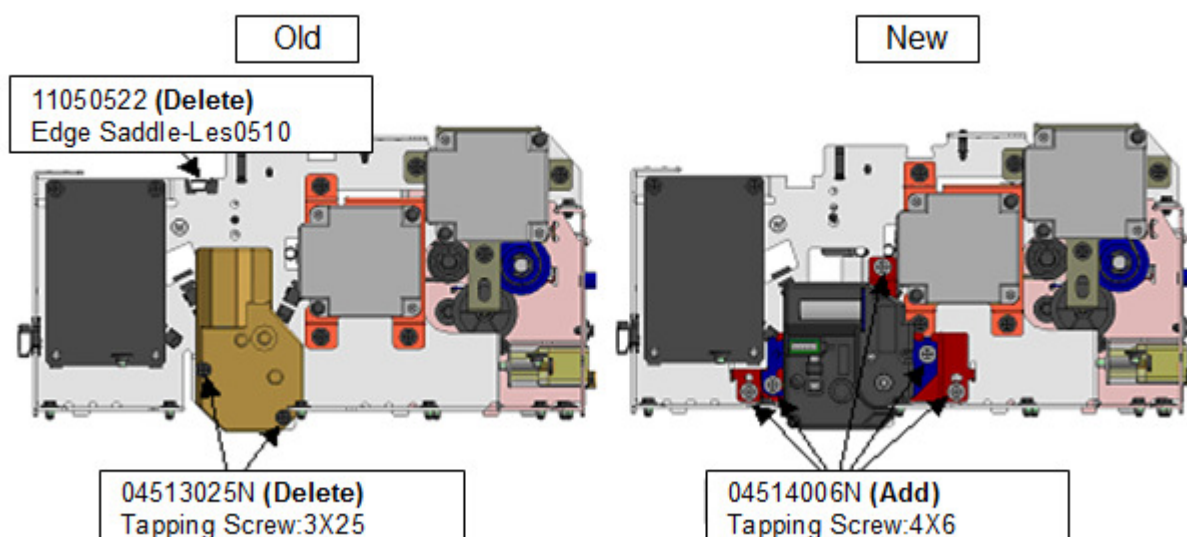
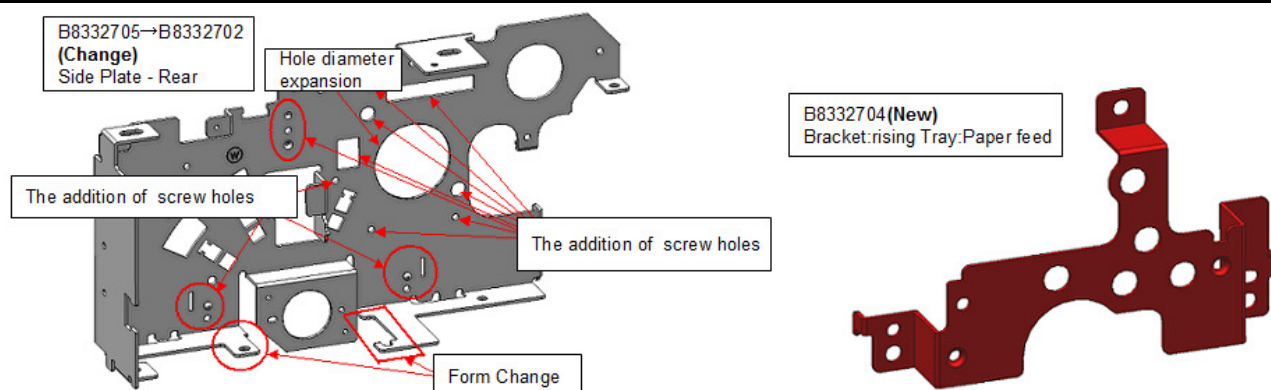
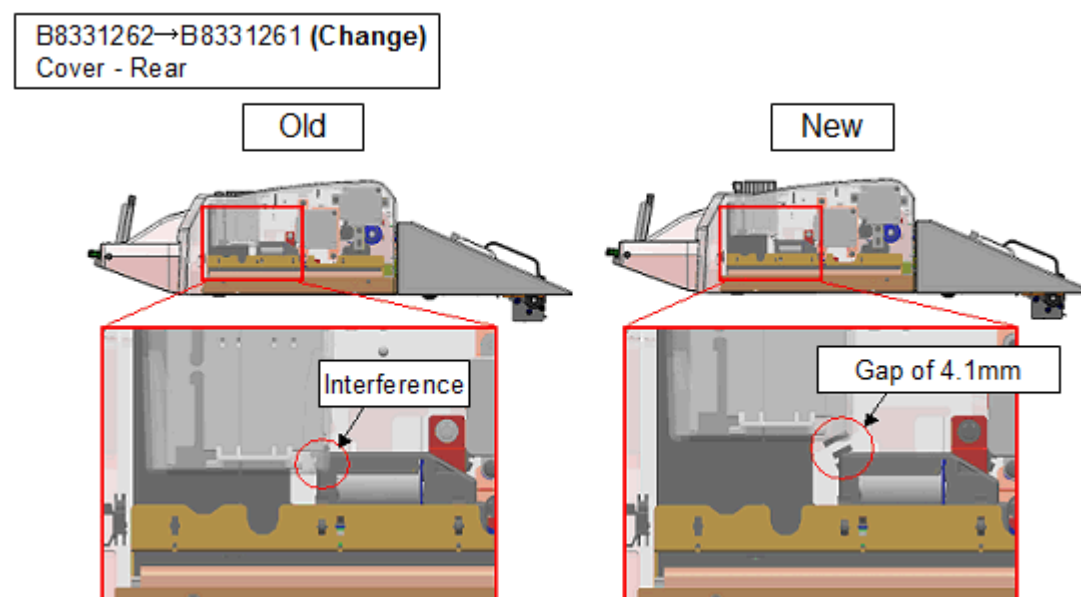
Change: DC Motor-1.7W and its accompanying parts

Reason: Change in the vendor of the motor

When replacing any of the above parts, replace all 6 parts as a set using the following screw:

04514006N Tapping Screw 4X6 (Q'ty: 5)
