Model: Model-J CF		Date: 4-Mar-02	No.: RG570001
Subject: Language Software History		Prepared by: H. Someya	
From: Technical Services Dept., GTS Division			
Classification:	<input type="checkbox"/> Troubleshooting <input type="checkbox"/> Part information <input type="checkbox"/> Action required <input type="checkbox"/> Mechanical <input type="checkbox"/> Electrical <input type="checkbox"/> Service manual revision <input type="checkbox"/> Paper path <input type="checkbox"/> Transmit/receive <input type="checkbox"/> Retrofit information <input checked="" type="checkbox"/> Other (      )

Language software history for the Model-J CF.

Model: Model-J CF		Date: 15-Mar-02	No.: RG570002
Subject: Remarks at firmware update		Prepared by: T. Itoh	
From: Technical Services Dept., GTS Division			
Classification:	<input type="checkbox"/> Troubleshooting <input type="checkbox"/> Part information <input checked="" type="checkbox"/> Action required <input type="checkbox"/> Mechanical <input type="checkbox"/> Electrical <input type="checkbox"/> Service manual revision <input type="checkbox"/> Paper path <input type="checkbox"/> Transmit/receive <input type="checkbox"/> Retrofit information <input t

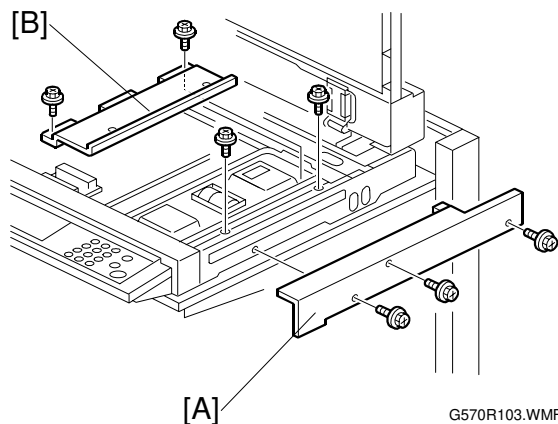
1. Open the ARDF/platen cover
2. Exposure glass
3. Rear cover
4. Right cover [A] (⌀ x 3)
5. Inner cover [B] (⌀ x 4)

Retrofit parts (lens block assemblies) will be provided to the field FOC for all affected units. Therefore, at the next service visit or when the issue is reported, please replace with P/N B1169455.

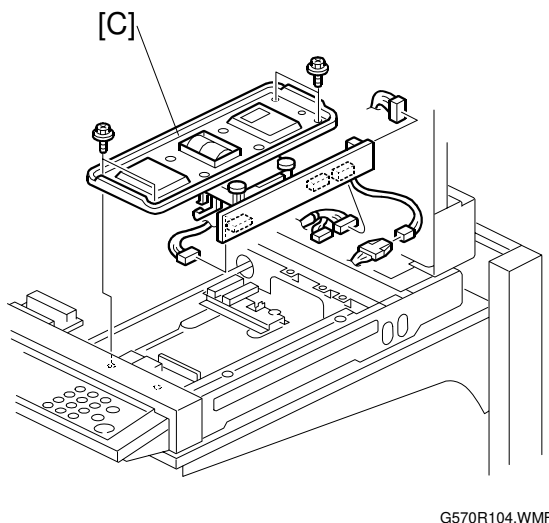
6. Lens block assembly (Sensor board unit) [C] (⌀ x 4, ⌀ x 4)

Note: Do not remove the paint-locked screws.

7. After replacing the lens block assembly (Sensor board unit), adjust the following SP modes according to the scanner adjustment procedure on the following page.
  - SP4-008 (Scanner leading edge magnification)
  - SP4-010 (Scanner leading edge registration)
  - SP4-011 (Scanner side-to-side registration)

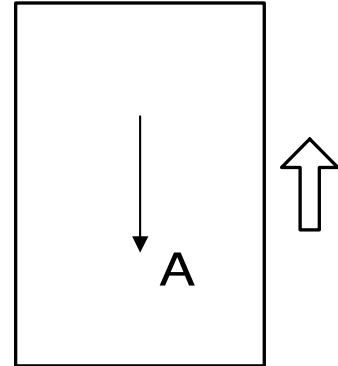
G570R910.WMF

A: Sub-scan magnification

1. Place the test chart on the exposure glass and make a copy from one of the feed stations.
2. Check the magnification ratio. Use SP4-008 to adjust if necessary.  
Standard:  $\pm 1.0\%$ .

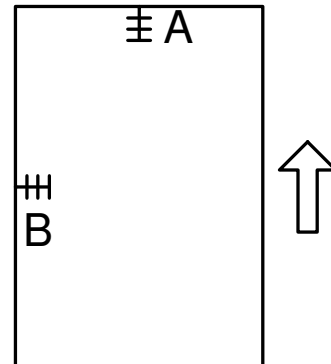
G570R908.WMF

A: Leading Edge Registration

1. Place the test chart on the exposure glass and make a copy from one of the feed stations.
2. Check the leading edge and side-to-side registration, and adjust them with the following SP modes if necessary.  
Standard:  $0 \pm 2\text{mm}$ .

SP mode
Sub-scan	SP4-010
Main-scan	SP4-011

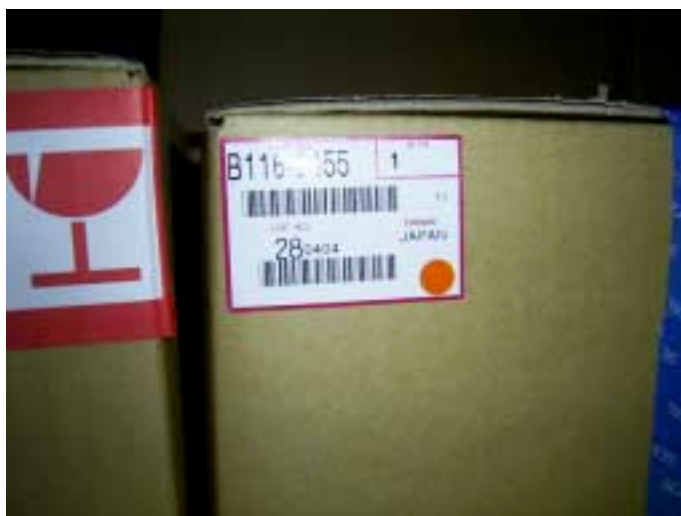
***Step 7 on pg. 4 below, i.e. checking to make sure SP4-205 is at 70, is necessary due to a RAM data error with the retrofit lens block assemblies (#B1169455) discovered at the manufacturer's side. Specifically, one of the several special tools used by the manufacturer was defective, causing a limited amount of assembly RAMs to contain a value of 8 instead of the normal 70. Therefore, please ensure that this value is at 70 in Step 7 below, as dirty background in ADS mode may occur if this value is 8.***

***Please note that all boxes bearing the seal shown below contain lens block assemblies with the correct data (70).***

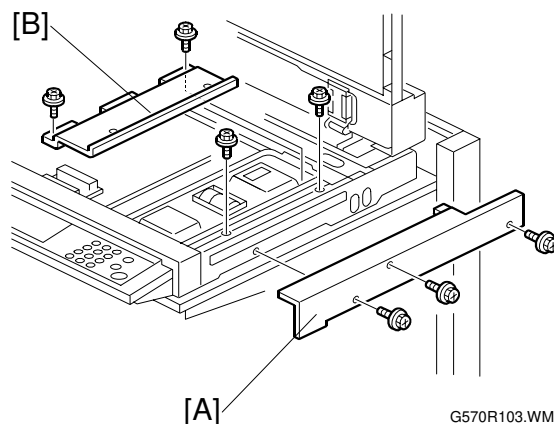
1. Open the ARDF/platen cover
2. Exposure glass
3. Rear cover
4. Right cover [A] (⌀ x 3)
5. Inner cover [B] (⌀ x 4)

Retrofit parts (lens block assemblies) will be provided to the field FOC for all affected units. Therefore, at the next service visit or when the issue is reported, please replace with P/N B1169455.

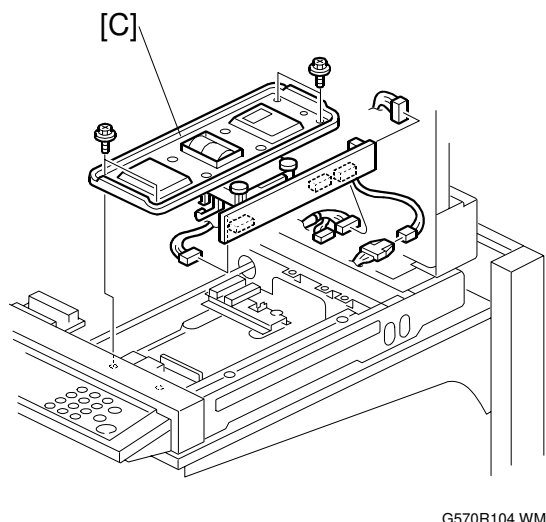
6. Lens block assembly (Sensor board unit) [C] (⌀ x 4, ⌀ x 4)

Note: Do not remove the paint-locked screws.

7. After replacing the lens block assembly (Sensor board unit), **check that the current setting of SP4-205 (Black ADS Level) is at its default of 70.**
  - ***If this SP is at a value of 8, this can cause incorrect background detection in ADS mode and lead to dirty background.***
8. Adjust the following SP modes according to the following scanner adjustment procedure.
  - SP4-008 (Scanner leading edge magnification)
  - SP4-010 (Scanner leading edge registration)
  - SP4-011 (Scanner side-to-side registration)

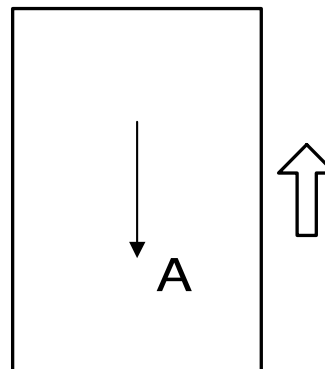
A: Sub-scan magnification  
G570R910.WMF

1. Place the test chart on the exposure glass and make a copy from one of the feed stations.
2. Check the magnification ratio. Use SP4-008 to adjust if necessary.  
Standard:  $\pm 1.0\%$ .

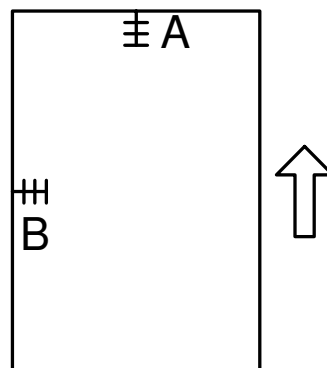
G570R908.WMF

A: Leading Edge Registration  
B: Side-to-side Registration

1. Place the test chart on the exposure glass and make a copy from one of the feed stations.
2. Check the leading edge and side-to-side registration, and adjust them with the following SP modes if necessary.  
Standard:  $0 \pm 2\text{mm}$ .

SP mode
Sub-scan	SP4-010
Main-scan	SP4-011
