| Model: General RTB | Date: 4-Feb-03 | No.: RGene013b |

| Subject: Service remarks at installation | | Prepared by: T. Itoh | |

| Model: Model J-P2CF | | Date: 30-Apr-03 | No.: RG367001 |

| Subject: SC142 due to defective CCD | | Prepared by: H.Taguchi | |

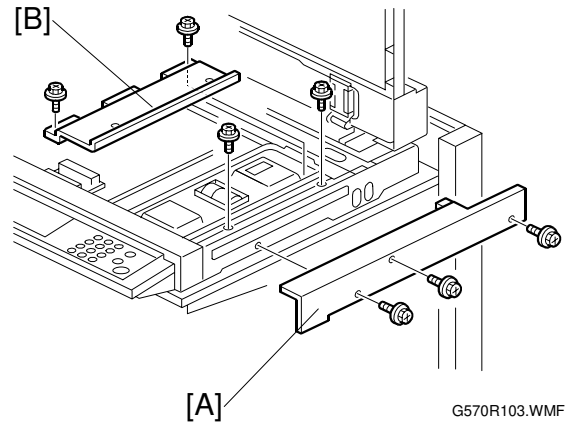
1. Open the ARDF/platen cover
2. Exposure glass
3. Rear cover
4. Right cover [A] (⌘ x 3)
5. Inner cover [B] (⌘ x 4)

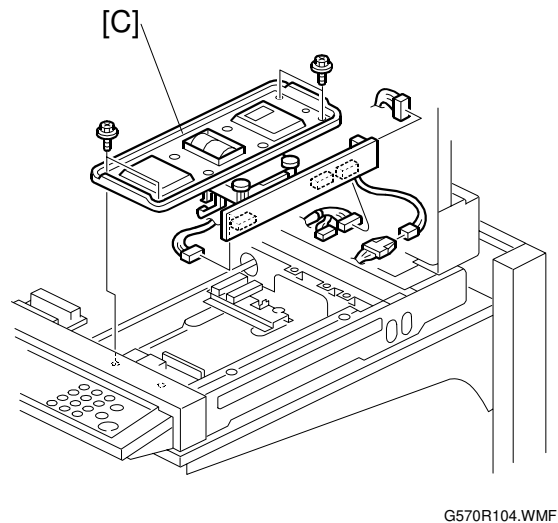
6. Lens block assembly (Sensor board unit) [C] (⌘ x 4, ⌘ x 4)

Note: Do not remove the paint-locked screws.

7. After replacing the lens block assembly (Sensor board unit), adjust the following SP modes according to the scanner adjustment procedure on the following page.
  - SP4-008 (Scanner leading edge magnification)
  - SP4-010 (Scanner leading edge registration)
  - SP4-011 (Scanner side-to-side registration)

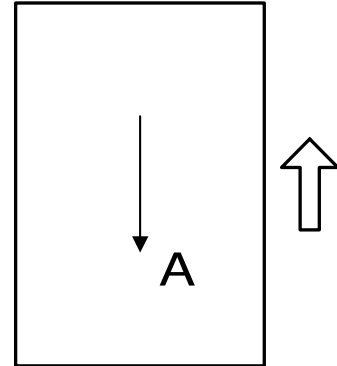
G570R910.WMF

1. Place the test chart on the exposure glass and make a copy from one of the feed stations.
2. Check the magnification ratio. Use SP4-008 to adjust if necessary.  
Standard:  $\pm 1.0\%$ .

A: Sub-scan magnification

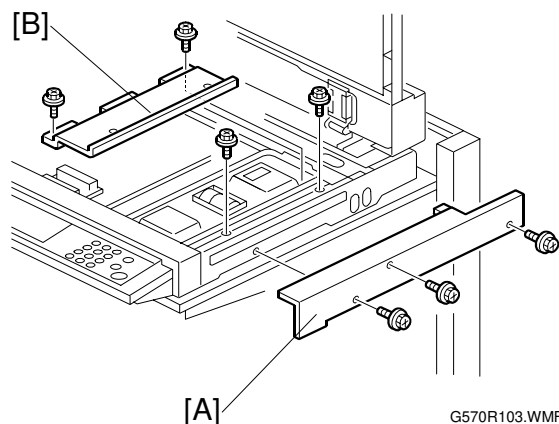
1. Open the ARDF/platen cover
2. Exposure glass
3. Rear cover
4. Right cover [A] (⌀ x 3)
5. Inner cover [B] (⌀ x 4)

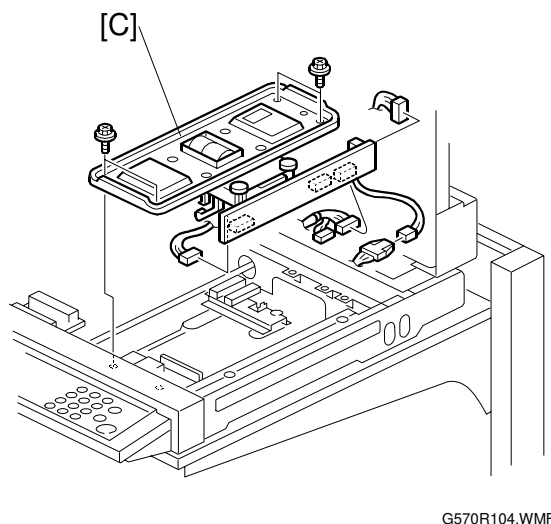
6. Lens block assembly (Sensor board unit) [C] (⌀ x 4, ⌀ x 4)

Note: Do not remove the paint-locked screws.

7. After replacing the lens block assembly (Sensor board unit), **check that the current setting of SP4-205 (Black ADS Level) is at its default of 70.**
  - ***If this SP is at a value of 8, this can cause incorrect background detection in ADS mode and lead to dirty background.***
8. Adjust the following SP modes according to the following scanner adjustment procedure.
  - SP4-008 (Scanner leading edge magnification)
  - SP4-010 (Scanner leading edge registration)
  - SP4-011 (Scanner side-to-side registration)
