Model: Decurl Unit DU5000 (D457)	Date: 09-Sep-09	No.: RD457001a
----------------------------------	-----------------	----------------

RTB Reissue

Subject: Undetected roller unit due to deformed feeler		Prepared by: K. Tsutsui	
From: PPMC Service Planning Department 1G			
Classification:	<input type="checkbox"/> Troubleshooting <input type="checkbox"/> Mechanical <input type="checkbox"/> Paper path <input type="checkbox"/> Product Safety	<input type="checkbox"/> Part information <input type="checkbox"/> Electrical <input type="checkbox"/> Transmit/receive <input type="checkbox"/> Other ()	<input checked="" type="checkbox"/> Action required <input type="checkbox"/> Service manual revision <input type="checkbox"/> Retrofit information <input type="checkbox"/> Tier2

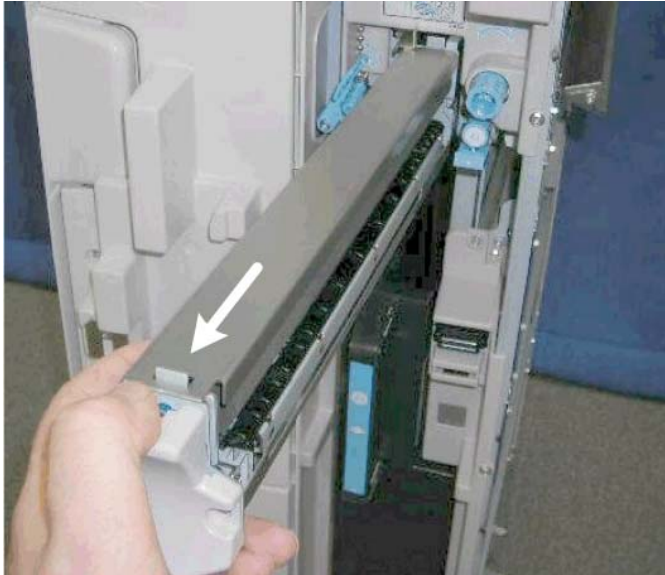
1. Pull out the Decurl Unit.

Please replace the Decurl Unit Ass'y with the modified Decurl Unit (P/N: **D4579901** MODIFICATION :DECURA) on your next service visit.

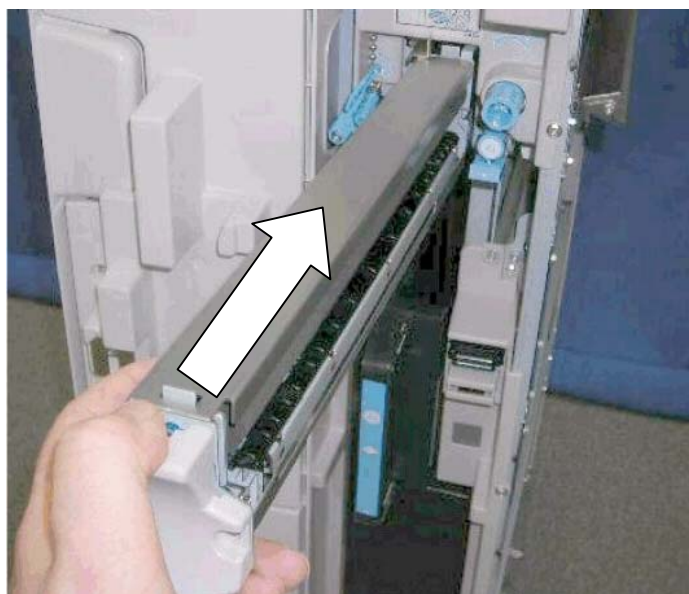
Jam occurs after approximately 5000k. (Based on the APV of 300k, the jam is expected to occur approximately 16.6 months after installation.)

Replace with the modified unit if the “NOT Modified” version is installed.

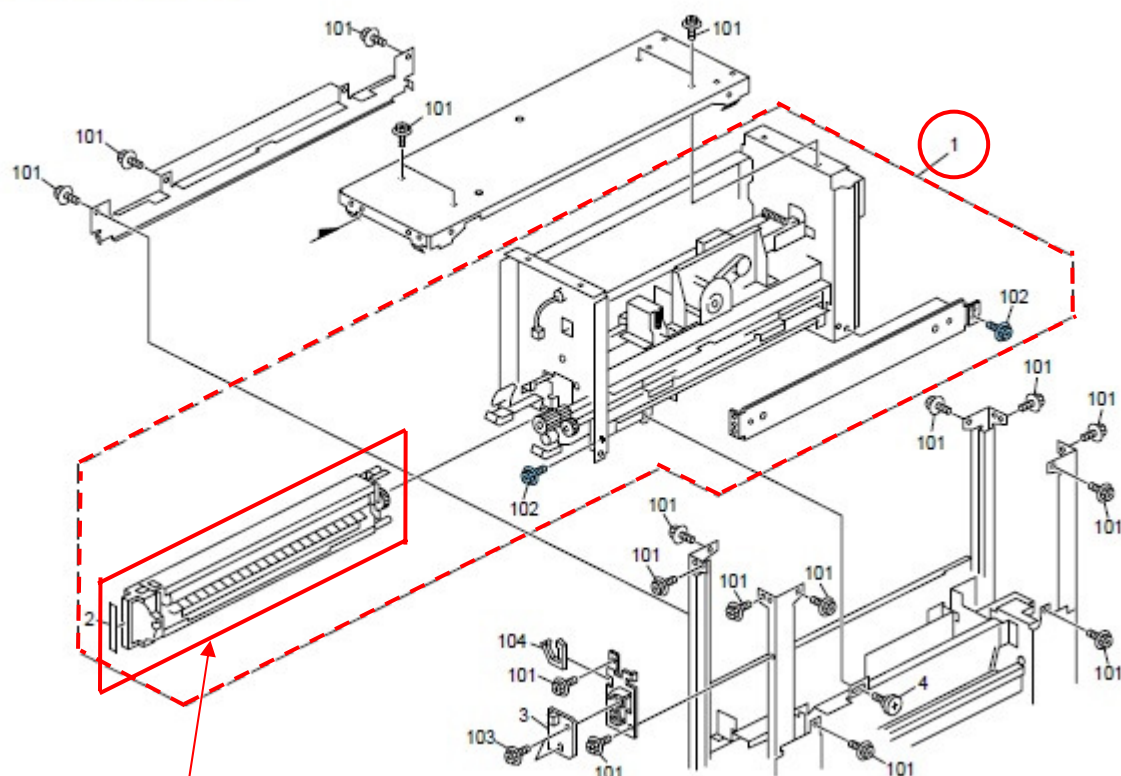
3.Decurl Section 1 (D457)

Change: The roller in the transport unit was modified.

Reason: Higher reliability; longer life of the roller

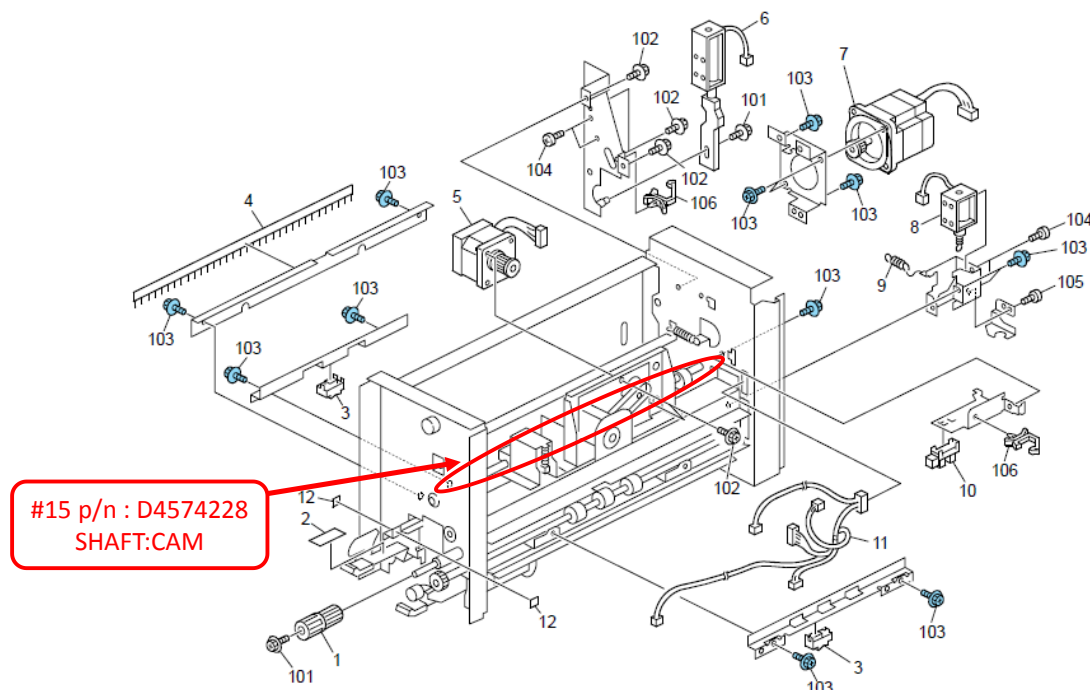
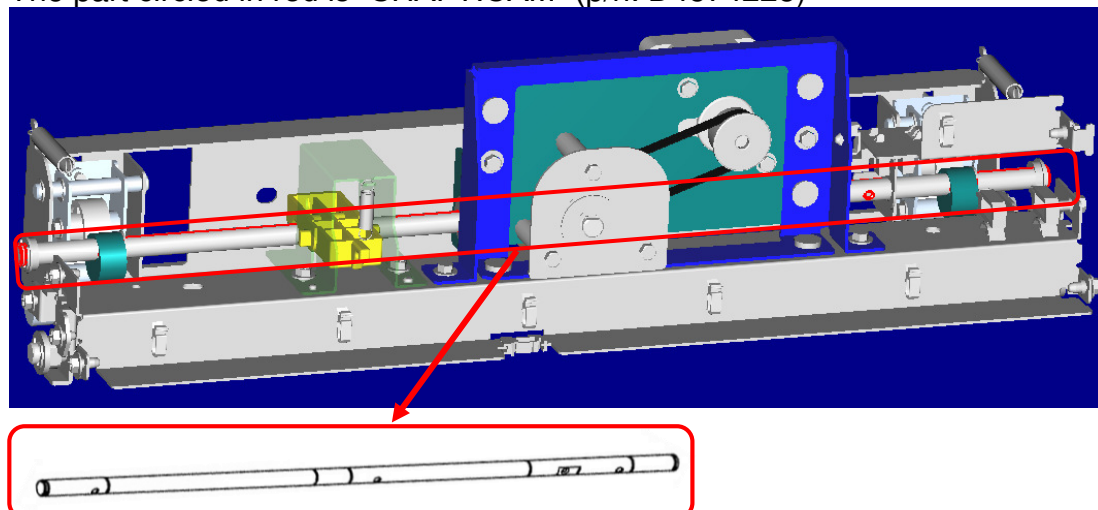
4.Decurl Section 2 (D457)

The part circled in red is “SHAFT:CAM” (p/n: D4574228)
