| Model: DI-C1 Internal Finisher Type C2550 | Date: 24-Dec-09 | No.: RD429001a |

| Subject: Parts Catalog Correction | | Prepared by: M.Saiki | |

| Subject: SC742 (stapler motor error) | | Prepared by: M.Saiki | |

| Subject: RoHS Compliance Issue (Stapler) | | Prepared by: T. Nihei | |

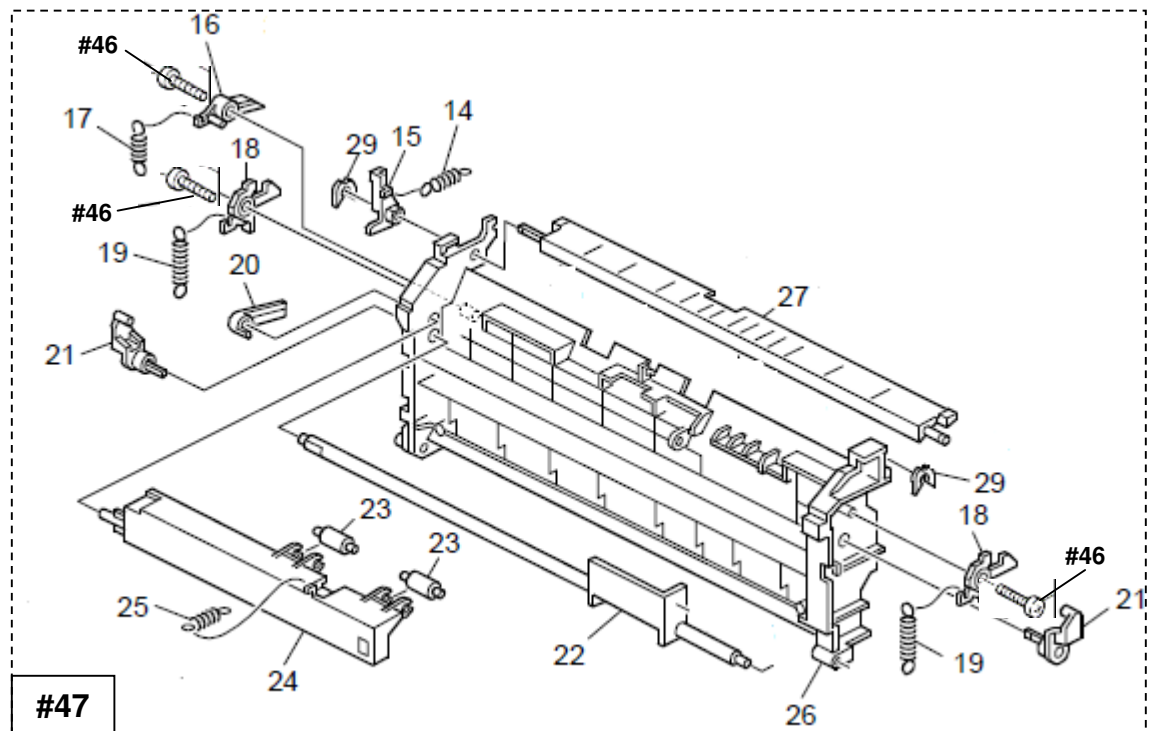
| Incorrect part number | Correct part number | Description | Q'ty | Int | Page | Index | Note |
|---|---|---|---|---|---|---|---|
| B7920001 | | TAPPING SCRER:030060FWTP | 14 - 13 | | 7 | 33 | |
| | D4292105 | TAPPING SCRER:PF4143P338A1 | 0 - 1 | X/O | 7 | #44 | |
| D4292147 | D4292106 | DC SOLENOID:PF4160K150A | 1 - 1 | X/O | 7 | 8 | |
| D4292150 | D4292108 | CONNECTOR:PF4160K326A1 | 1 - 1 | X/O | 7 | 12 | |
| D4292151 | | SHEET:GATE PAWL:PF4160P329 | 4 - 3 | | 7 | 42 | |
| | D4292155 | GATE PLATE:PF4160P335B1 | 0 - 1 | X/O | 7 | #45 | |
