Model: Ring Binder RB5000	Date: 20-June -08	No.: RD392001a
---------------------------	-------------------	----------------

Subject: Firmware Release Note: Ring Binder_B1		Prepared by: T.Tadokoro	
From: PPBG QA/Service Planning Dept.			
Classification:	<input type="checkbox"/> Troubleshooting <input type="checkbox"/> Mechanical <input type="checkbox"/> Paper path <input checked="" type="checkbox"/> Other (      )	<input type="checkbox"/> Part information <input type="checkbox"/> Electrical <input type="checkbox"/> Transmit/receive	<input type="checkbox"/> Action required <input type="checkbox"/> Service manual revision <input type="checkbox"/> Retrofit information

Model: Model: Ring Binder RB5000		Date: 8-Jun-09	No.: RD392003a
Subject: Bracket:Coupling:Main:Ass'y		Prepared by: Nobuo iida	
From: PPBG QA/Service Planning Dept.			
Classification:	<input type="checkbox"/> Troubleshooting <input type="checkbox"/> Mechanical <input type="checkbox"/> Paper path <input type="checkbox"/> Product Safety	<input checked="" type="checkbox"/> Part information <input type="checkbox"/> Electrical <input type="checkbox"/> Transmit/receive <input type="checkbox"/> Other (     )	<input type="checkb

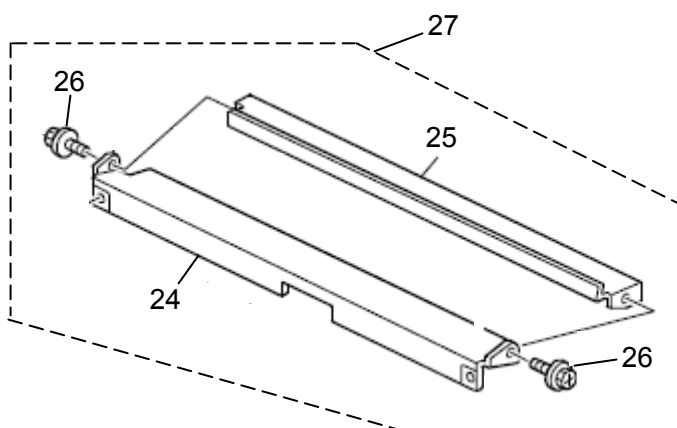
The following parts have been added to support the Venus-C2.

New part number	Description	Q'ty	Int	Page	Index	Note
B4082191	GUIDE PLATE:CONNECTING:LOWER	1	-	2	24	Add
B4682196	GUIDE PLATE:CONNECTING:UPPER	1	-	2	25	Add
08025276	TAPPING SCREW:ROUND POINT:M3X6	2	-	2	26	Add
B468T021	GUIDE PLATE:CONNECTING:ASS'Y	1	-	2	27	Add

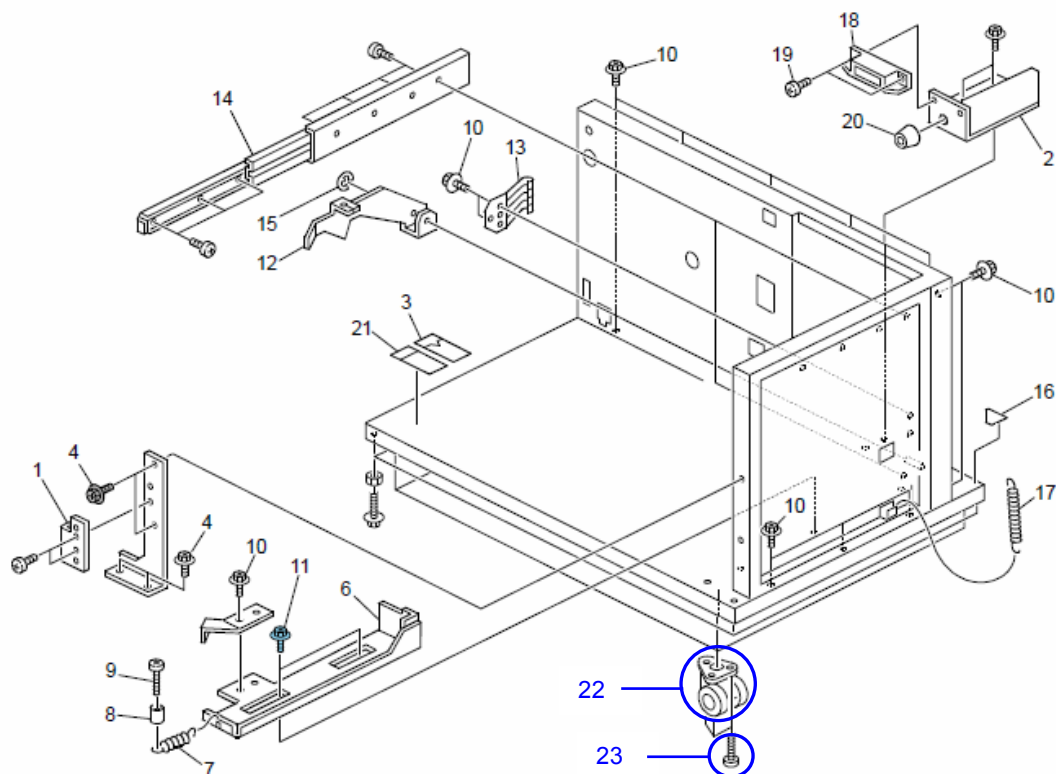
## 28.Frame Section (D392)

New part number	Description	Q'ty	Int	Page	Index	Note
D3921325	CASTER:BWP-50N:MB10506	4	-	57	22	Add
D3923164	PAN HEAD SCREW:M5X10:AA03513	12	-	57	23	Add

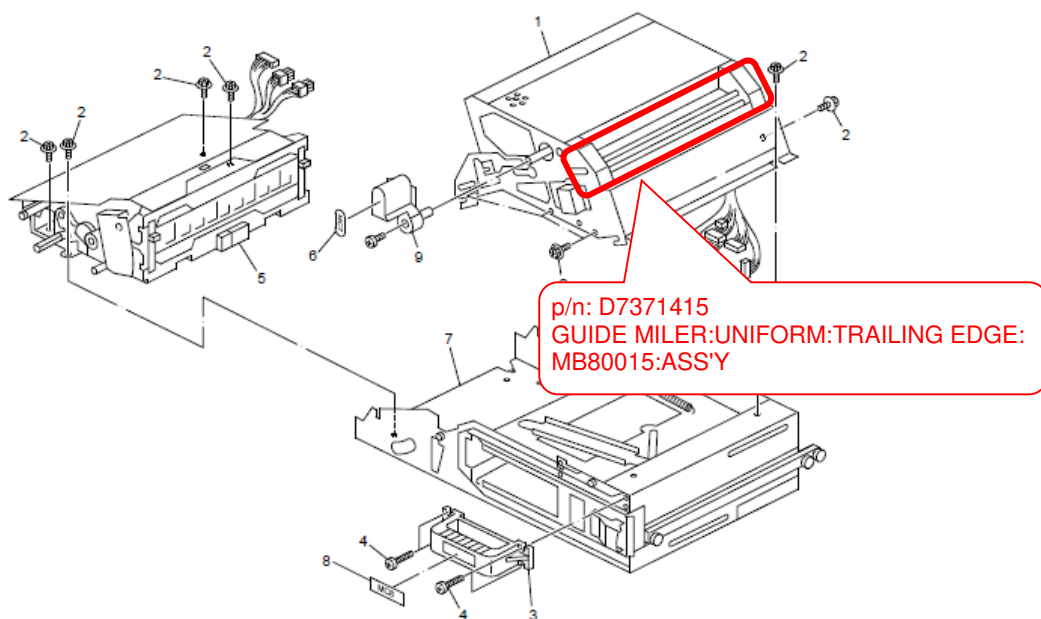
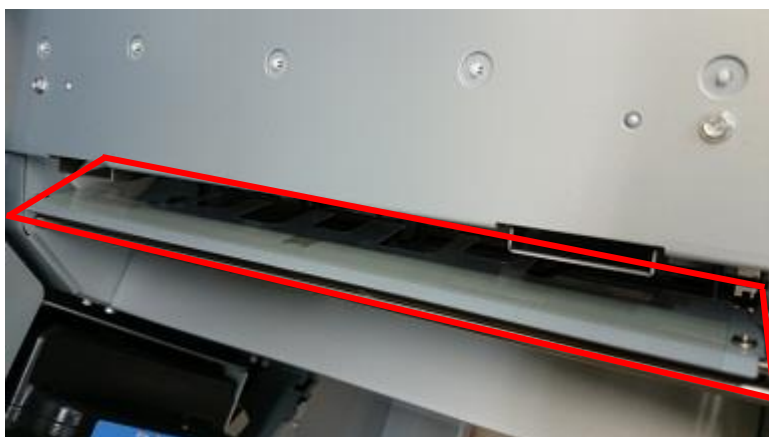
## 9.Ring Binder Unit 1 (D392)

Old p/n	New p/n	Description	Q'ty	Int	Page	Index	Note
-	D7371415	GUIDE MILER:UNIFORM:TRAILING EDGE:MB80015:ASS'Y	1	-	19	10	Add
