Model: Katana		Date:14-Jul-06	No.: RB234015
Subject: Service Manual Revision		Prepared by: S. Ishizu	
From: 2nd Tech Support Sec. Service Support Dept.			
Classification:	<input type="checkbox"/> Troubleshooting <input type="checkbox"/> Mechanical <input type="checkbox"/> Paper path <input type="checkbox"/> Product Safety	<input type="checkbox"/> Part information <input type="checkbox"/> Electrical <input type="checkbox"/> Transmit/receive <input type="checkbox"/> Other ()	<input type="checkbox"/> Action required <input checked="" type="checkbox"/> Service manual revision <input type="checkbox"/> Retrofit information

This document summarizes the corrections in the Service Manual for “Katana” (Machine Code: B234/235/236).

Model: Katana-C1 LCIT RT5010 (B834)		Date: 18-Nov-10	No.: RB834001
Subject: Improvement of the bracket for postcards		Prepared by: T. Komori	
From: PP Service Planning Department 1G			
Classification:	<input type="checkbox"/> Troubleshooting	<input checked="" type="checkbox"/> Part information	<input type="checkbox"/> Action required
	<input type="checkbox"/> Mechanical	<input type="checkbox"/> Electrical	<input type="checkbox"/> Service manual revision
	<input t

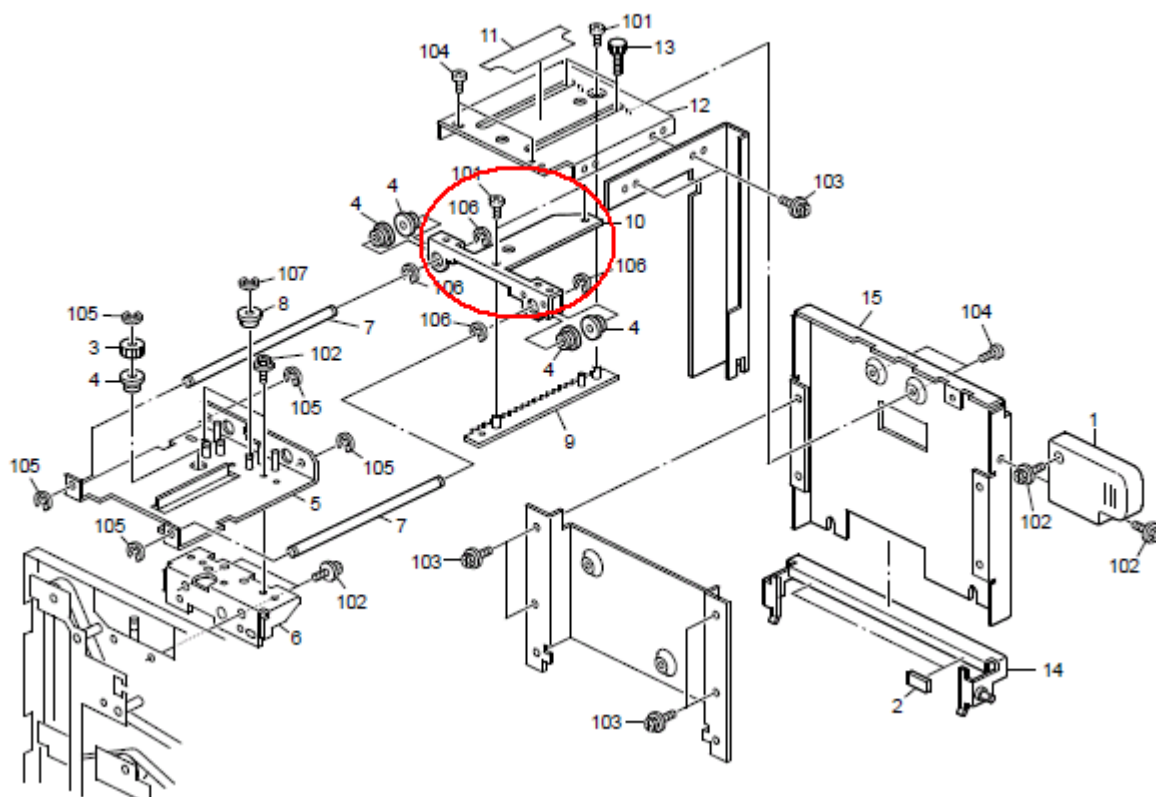
3.4TH/6TH PAPER TRAY 2 (B834)

Change: Shape of the parts

Reason: Parts standardization to enable usage of the following parts for other models

Old Part Number	New Part Number	Description	Q'ty	I/C		Page	Index
B8343349	B8343345	RACK:UPPER	2	X/X	O/O as a set	23 9	16 15
B8343334	B8343343	GUIDE:UPPER REAR	2	X/X		23 9	14 14
B8343332	B8343341	GUIDE:UPPER FRONT	2	X/X		21 7	10 10
B8343358	B8343356	COVER:UPPER REAR	1	X/X		9	10
B8343357	B8343355	COVER:UPPER FRONT	2	X/X		21 7	11 12
B8343339	B8343345	RACK:UPPER	2	X/X		21 7	9 9

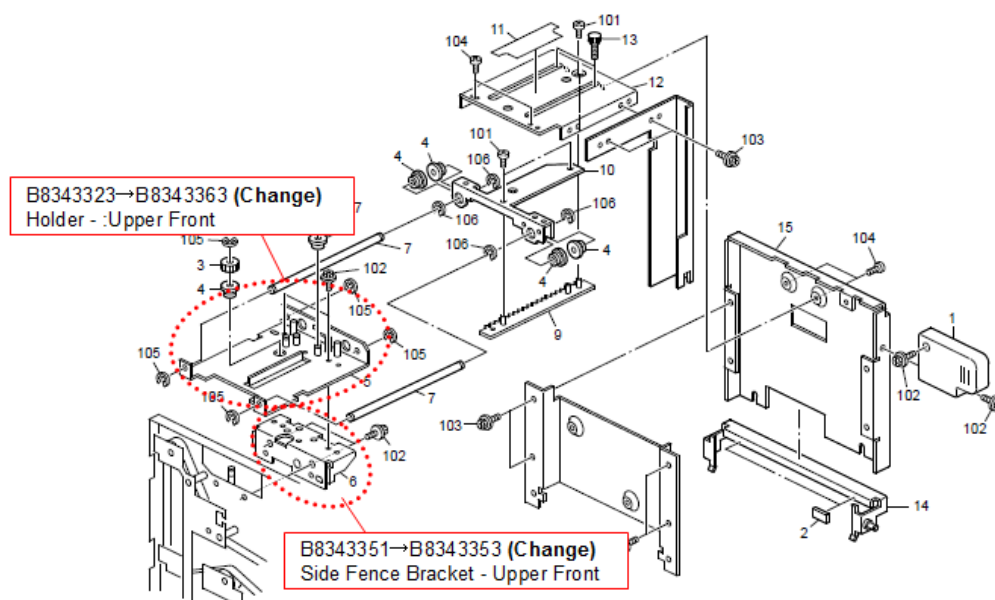
3.4TH/6TH PAPER TRAY 2 (B834)

Change: Holder and Side fence bracket

Reason: To allow usage of common parts for different products

Old Part Number	New Part Number	Description	Q'ty	Int	Page	Index	Note
B8343323	B8343363	Holder - :Upper Front	1	X/X	7	5	A
B8343329	B8343364	Holder - Upper Rear	1	X/X	9	21	A
B8343351	B8343353	Side Fence Bracket - Upper Front	1	X/O	7	6	A
B8343352	B8343354	Side Fence Bracket - Upper Rear	1	X/O	9	19	A

- **When replacing the above parts, replace all 4 parts as a set.**
- **The modification described in this bulletin also applies to Aegis-C1 (D016), LCIT RT4000 (D350), LCIT RT5020 (D355), LCIT RT5040 (D453).**
