Model: LCIT RT5040 (D453)		Date: 21-Aug-09	No.: RD453001
Subject: Service Manual Correction: CIS Image Position Adjustment		Prepared by: M. Abe	
From: PPMC Service Planning Department 1G			
Classification:	<input type="checkbox"/> Troubleshooting <input type="checkbox"/> Mechanical <input type="checkbox"/> Paper path <input type="checkbox"/> Product Safety	<input type="checkbox"/> Part information <input type="checkbox"/> Electrical <input type="checkbox"/> Transmit/receive <input type="checkbox"/> Other (     )	<input type="checkbox"/> Action required <input checked="" type="checkbox"/> Service manual revision <input type="checkbox"/> Retrofit information <input type="checkbox"/> Tier2

Model: LCIT RT5040 (D453)		Date: 14-Dec-2010	No.: RD453002
Subject: New P/N for Tray Indication Decals		Prepared by: K. Tsutsui	
From: PP Service Planning Department 1G			
Classification:	<input type="checkbox"/> Troubleshooting <input type="checkbox"/> Mechanical <input type="checkbox"/> Paper path <input type="checkbox"/> Product Safety	<input checked="" type="checkbox"/> Part information <input type="checkbox"/> Electrical <input type="checkbox"/> Transmit/receive <input type="checkbox"/> Other

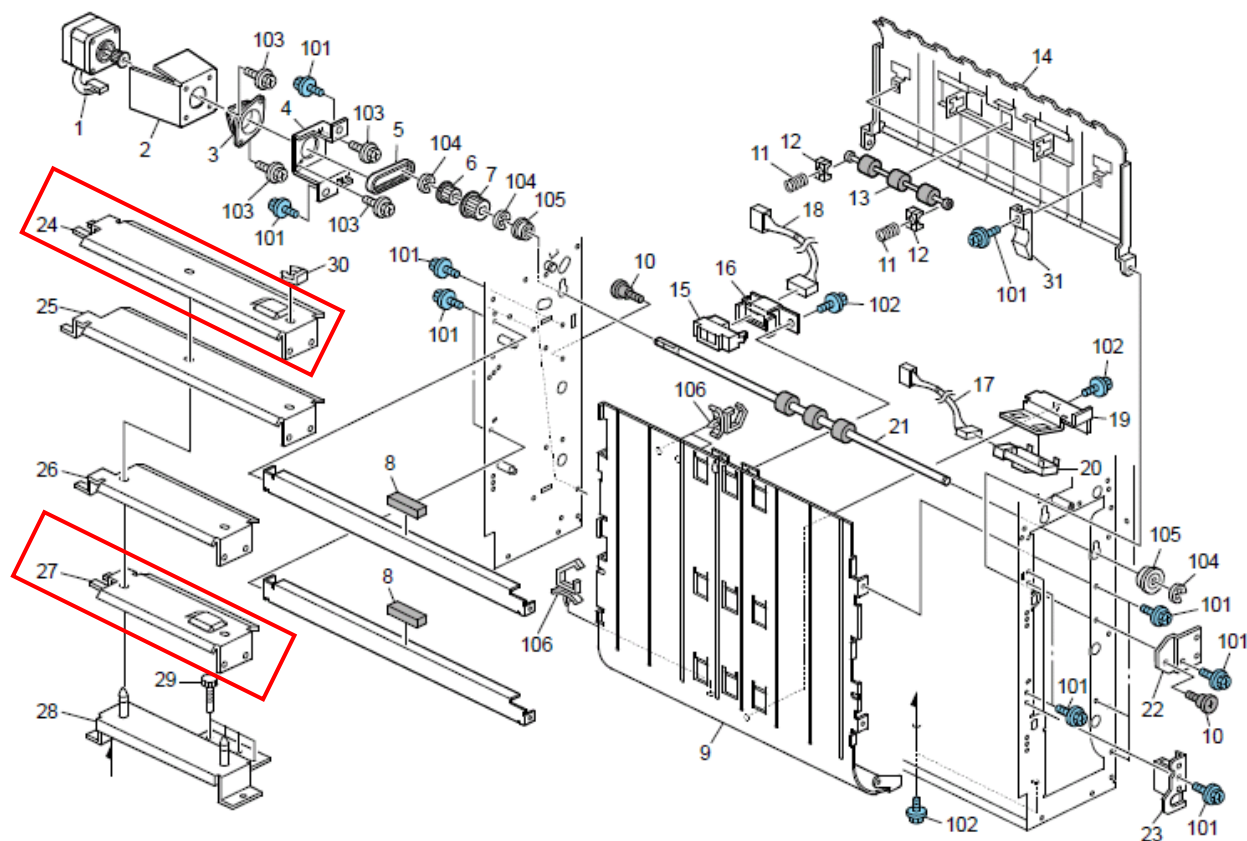
## 25.Paper Transfer 6 (D453)

**Change:** Shape of the postcard fence

**Reason:** For easier adjustment when changing paper size

Old P/N	New P/N	Description	Q'ty	Int	Page	Index
B8342711	<b>B8342719</b>	BRACKET:POSTCARD:NO.2:REAR:ADHESION	1	X/0	51	24
B8352713	<b>B8342717</b>	BRACKET:POSTCARD:NO.1:REAR:ADHESION	1	X/0	51	27

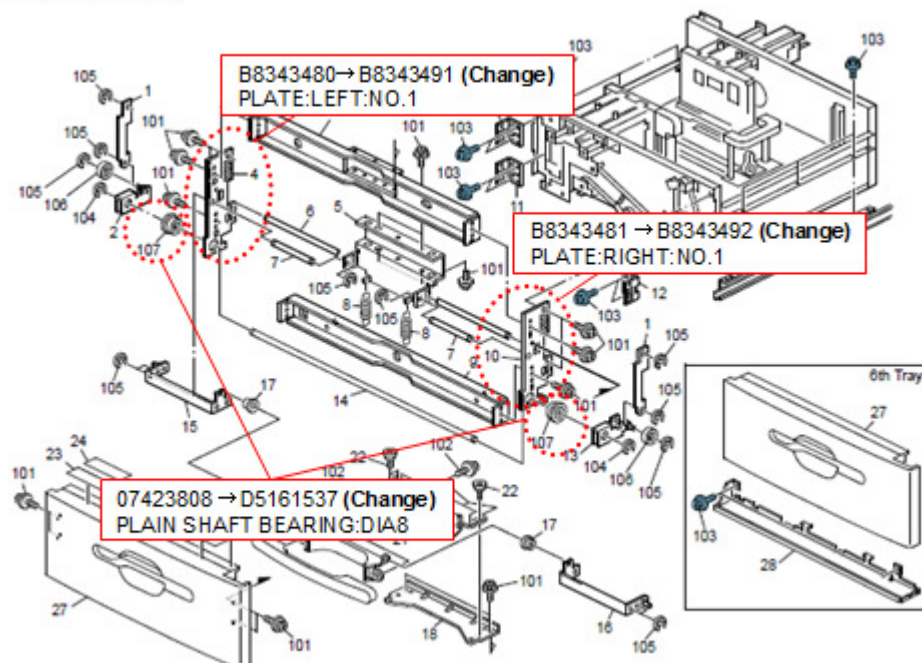
## 2.Tray 4/6 Unit 1 (D453)

**Change:** Bearing and the shape of the accompanying plates

**Reason:** To share common parts with the LCIT RT5060 (D516)

Old Part Number	New Part Number	Description	Q'ty	Int	Page	Index	Note
07423808	D5161537	PLAIN SHAFT BEARING:DIA8	4	X/O	4 18	107 105	
B8343395	B8343391	PLATE:LEFT:NO.2	1	X/O	18	3	
B8343396	B8343392	PLATE:RIGHT:NO.2	1	X/O	18	11	
B8343480	B8343491	PLATE:LEFT:NO.1	1	X/O	4	4	
B8343481	B8343492	PLATE:RIGHT:NO.1	1	X/O	4	10

- Make sure all 5 parts shown in the above table are replaced as a set.
- The modification described in this bulletin also applies to RT5010 (B834).

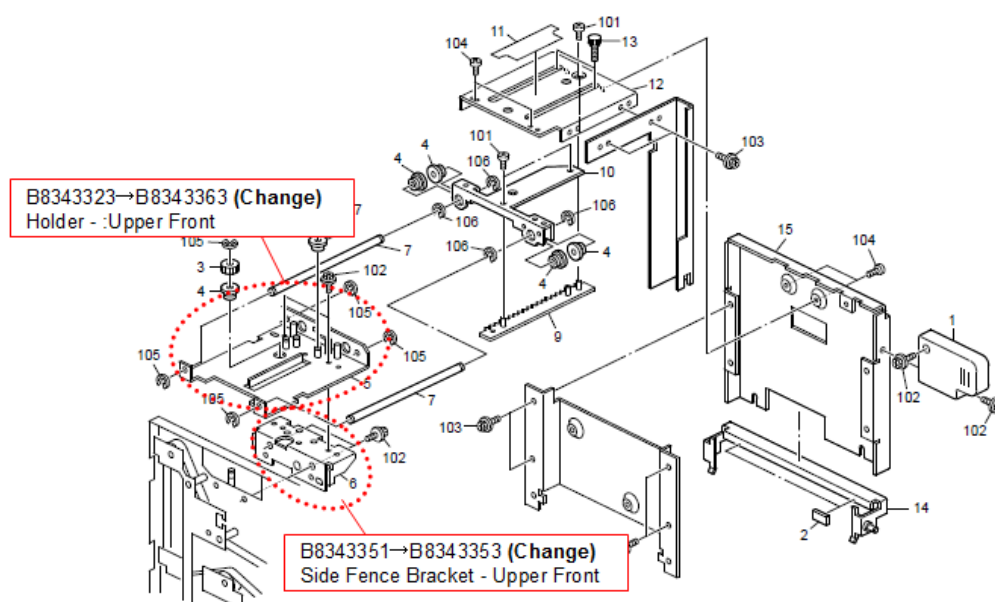
3.4TH/6TH PAPER TRAY 2 (B834)

**Change:** Holder and Side fence bracket

**Reason:** To allow usage of common parts for different products

Old Part Number	New Part Number	Description	Q'ty	Int	Page	Index	Note
B8343323	B8343363	Holder - :Upper Front	1	X/X	7	5	A
B8343329	B8343364	Holder - Upper Rear	1	X/X	9	21	A
B8343351	B8343353	Side Fence Bracket - Upper Front	1	X/O	7	6	A
B8343352	B8343354	Side Fence Bracket - Upper Rear	1	X/O	9	19	A

- **When replacing the above parts, replace all 4 parts as a set.**
- **The modification described in this bulletin also applies to Aegis-C1 (D016), LCIT RT4000 (D350), LCIT RT5020 (D355), LCIT RT5040 (D453).**

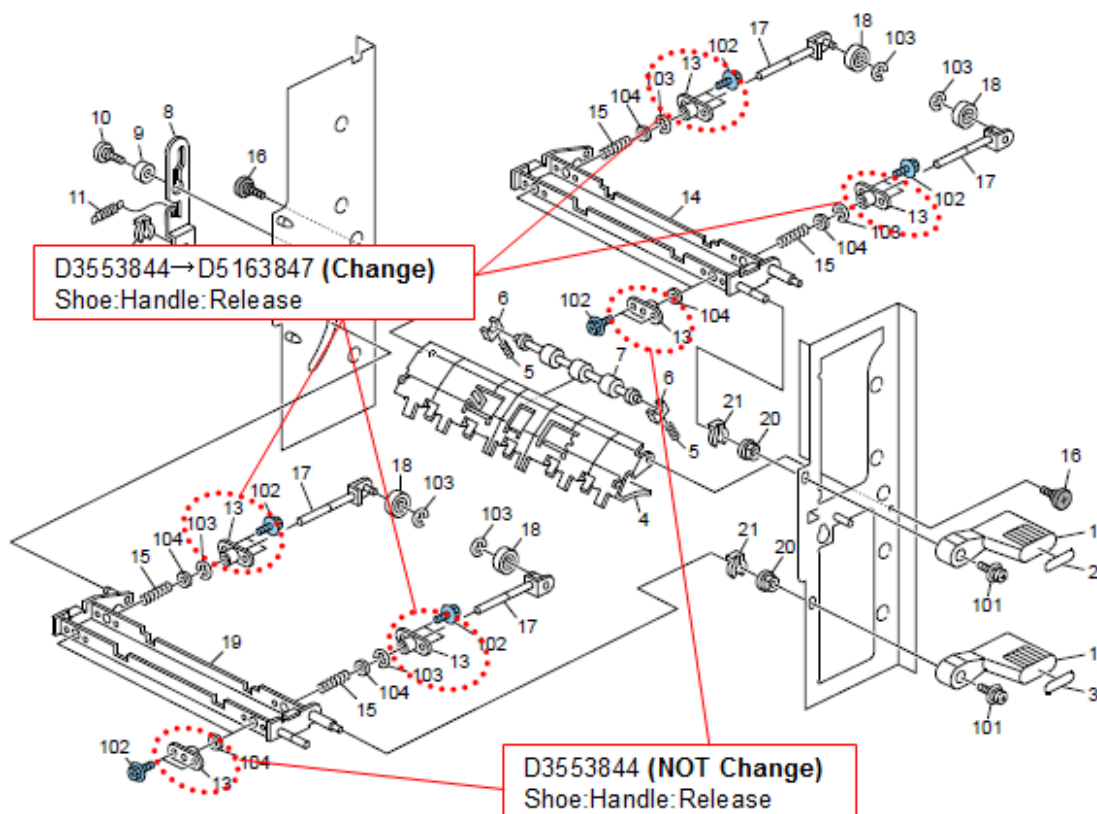
### 15.Paper Transfer 4 (D452)

**Change:** Shape of the Handle assembly and Shoe

**Reason:** To enable usage of common parts with different products

A : Shoe: Handle: Release

Shape of the Shoe was partially modified.

Old Part Number	New Part Number	Description	Q'ty	Int	Page	Index	Note
D3553844	D5163847	Shoe:Handle:Release	4	X/O	31	22	-

- The modification described in this bulletin also applies to LCT RT5040 (D453).

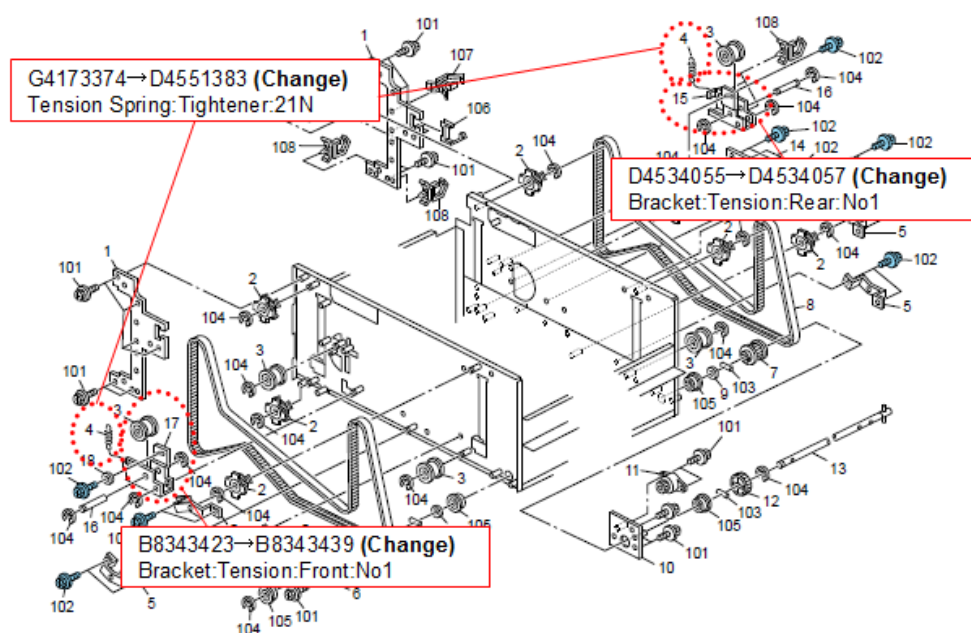
8.Tray 4/6 Unit 7 (D453)

**Change:** Modification 1 - Tension spring of the tray pulley

Modification 2 – Shapes of the tension brackets

**Reason:** To prevent slippage of the pulley which could occur due to the lack of tension applied to the tension springs installed in Tray 4 and Tray 6

Old Part Number	New Part Number	Description	Q'ty	Int	Page	Index	Note
G4173374	D5163374	TENSION SPRING: PULLEY: IDLER	4	X/X	17	4	Change
		Tension Spring:Tightener:21N					
B8343423	B8343439	Bracket: Tension:Front:No1	2	X/X	17	17	Change
D4534055	D4534057	Bracket:Tension:Rear:No1	2	X/X	17	15	Change

**NOTE:** When replacing the above parts, replace as a set.

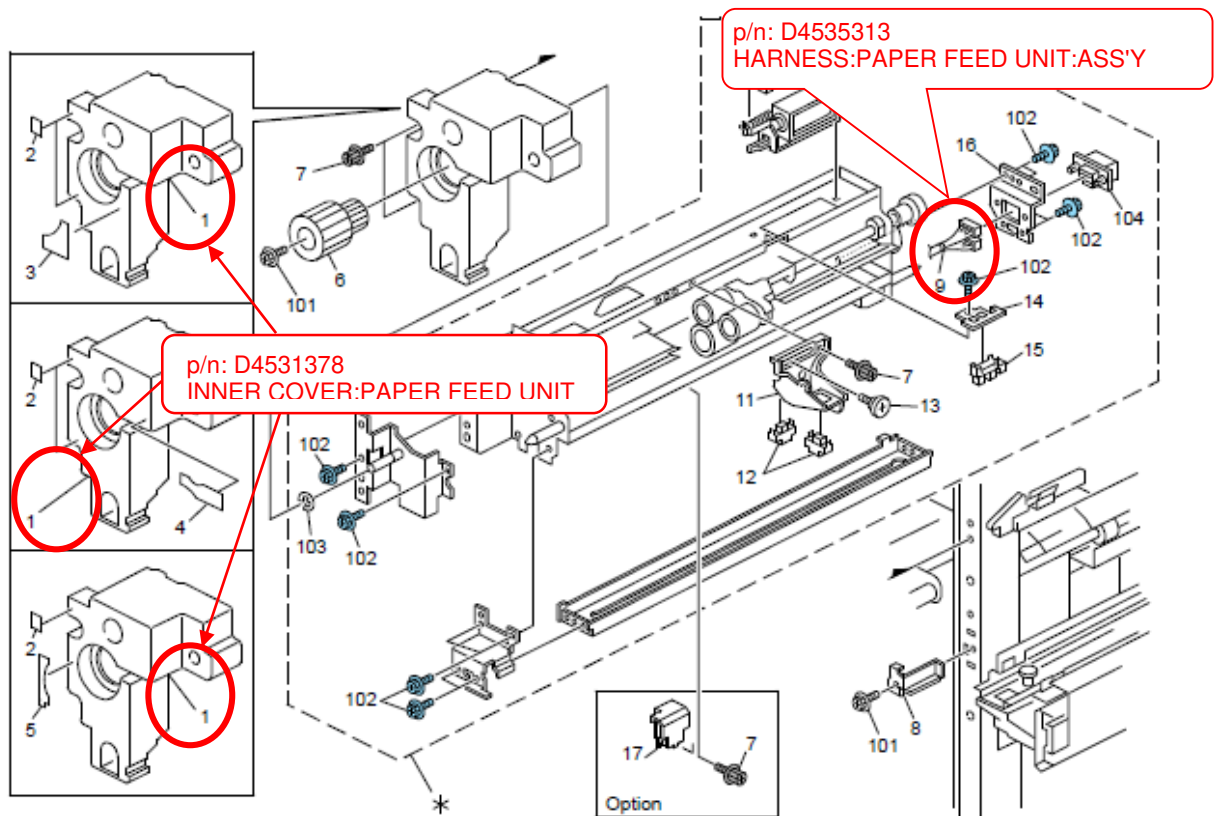
## 17.Paper Feed Unit 1 (D453)

The following parts were modified for easier jam removal.

Old p/n	New p/n	Description	Q'ty	Int	Page	Index	Note
D4535312	D4535313	HARNESS:PAPER FEED UNIT: ASS'Y	3	X/O	35	9	Change
D4531388	D4531378	INNER COVER:PAPER FEED UNIT	3	X/O	35	1	Change
B8322569	B8322579	STAY:FEED:PEEN	3	X/O	37	5	Change
