Model: Leo-C1a/C1b (D194/D195)	Date: 23-Feb-15	No.: RD777001b
--------------------------------	-----------------	----------------

Subject: Adjustments in Vacuum Feed LCIT to prevent no-feed and double-feed jams		Prepared by: Shinnosuke Sasaki	
From: 1st PP Tech Service Sec., PP Tech Service Dept.,			
Classification:	<input checked="" type="checkbox"/> Troubleshooting <input type="checkbox"/> Mechanical <input type="checkbox"/> Paper path <input type="checkbox"/> Product Safety	<input type="checkbox"/> Part information <input type="checkbox"/> Electrical <input type="checkbox"/> Transmit/receive <input type="checkbox"/> Other (     )	<input type="checkbox"/> Action required <input type="checkbox"/> Service manual revision <input type="checkbox"/> Retrofit information <input type="checkbox"/> Tier 2

Model: Vacuum Feed LCIT RT5100		Date: 29-Jul-15	No.: RD077002
Subject: Part Catalog Correction Vacuum Feed LCIT RT5100 – Joint bracket		Prepared by: Takezoh Miyamoto	
From: 1st PP Tech Service Sec., PP Tech Service Dept.,			
Classification:	<input type="checkbox"/> Troubleshooting <input type="checkbox"/> Mechanical <input type="checkbox"/> Paper path <input type="checkbox"/> Product Sa

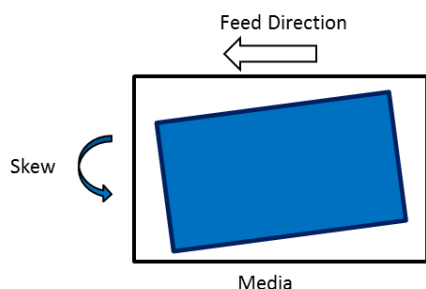
Skew occurs when a banner sheet is fed from the Vacuum Feed LCIT.

Thicker paper (Weight 5 or thicker) tends to be more affected by the skew.

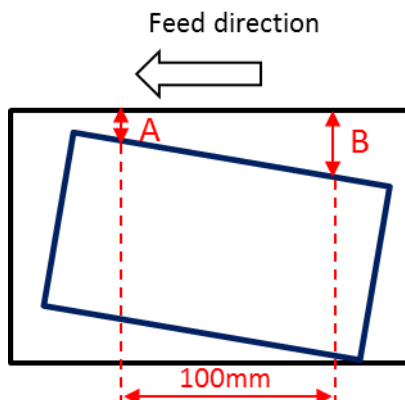
3-3. Check the skew direction and measure the distance A and B.

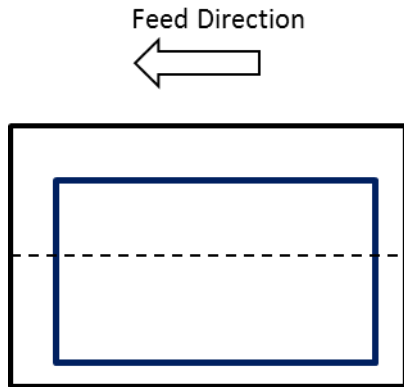
Note: Image position may be decentered after the skew adjustment plates are applied.

5. Print a trim pattern to check if the skew is corrected and check the image position.

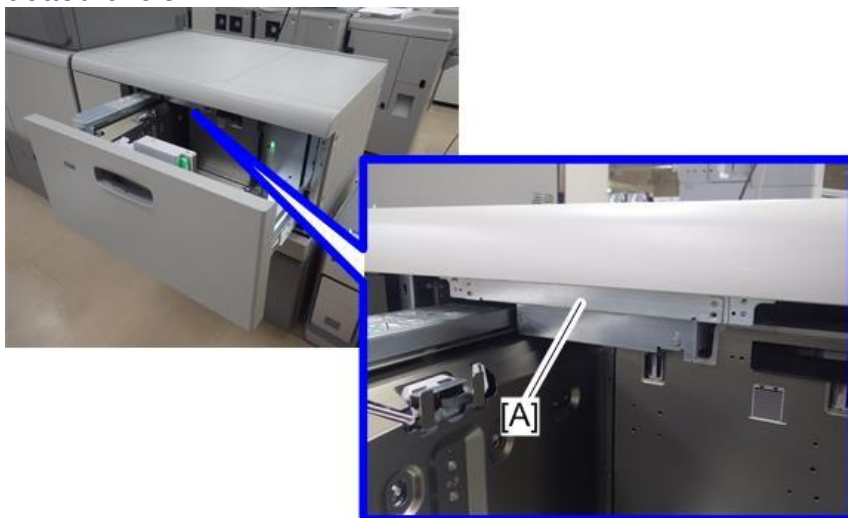
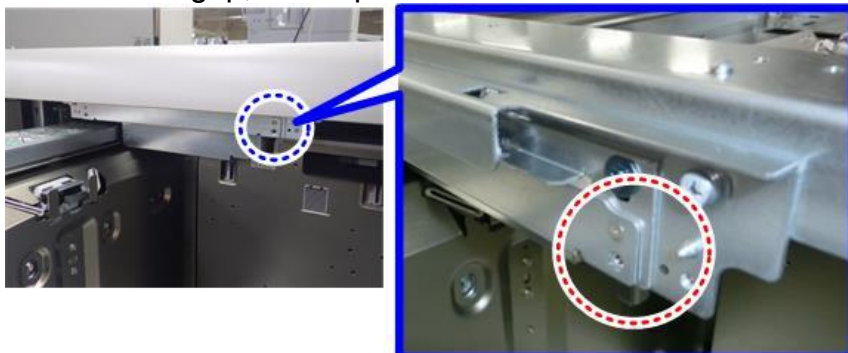
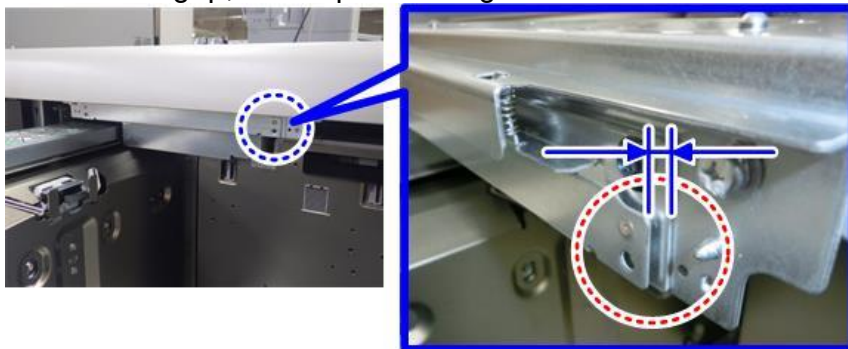
1. With the paper feed belt unit [A] installed, pull out the tray(s) showing the symptom and check if there is a gap between the frames at the location indicated with the red dotted circle.

If there is no gap, do Step 5.

If there is a gap, do Steps 2 through 5.

2. Close the tray.
3. Execute the SP for the tray(s) showing the symptom. This will rotate the paper feed belt for 5 seconds so that the spring pin connects with the coupling.
  - SP5-805-100 (Output Check: LCT1: Paper Feed Belt Motor: Tray3)
  - SP5-805-114 (Output Check: LCT1: Paper Feed Belt Motor: Tray4)
  - SP5-805-131 (Output Check: LCT2: Paper Feed Belt Motor: Tray5)
  - SP5-805-145 (Output Check: LCT2: Paper Feed Belt Motor: Tray6)
  - SP5-805-162 (Output Check: LCT3: Paper Feed Belt Motor: Tray7)
  - SP5-805-176 (Output Check: LCT3: Paper Feed Belt Motor: Tray8)
4. Pull out the tray and confirm that there is no gap between the frames.
5. Confirm that the two screws fixing the paper feed belt unit are tightly fastened.

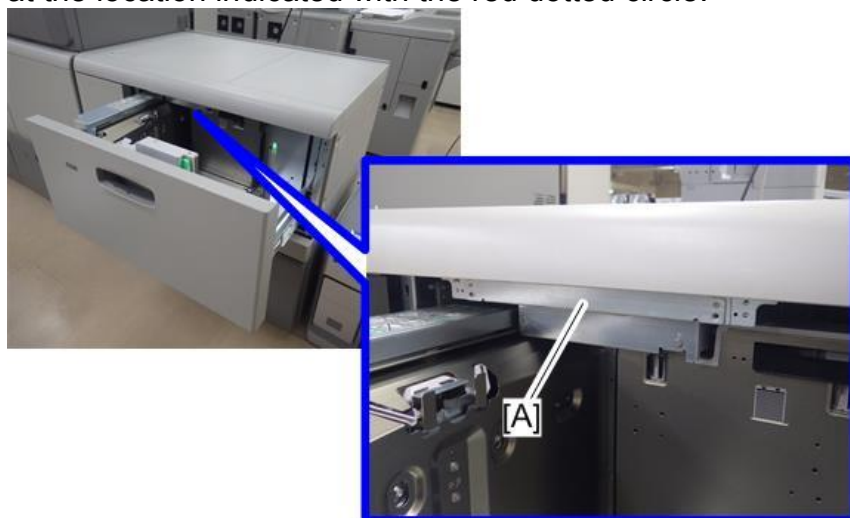
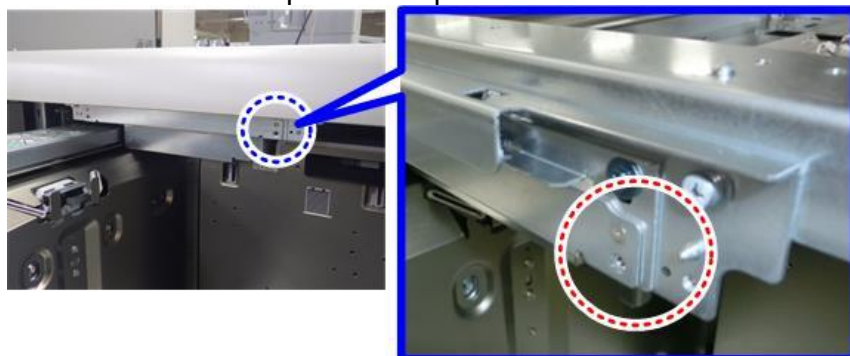
1. With the paper feed belt unit [A] installed, check if there is a gap between the frames at the location indicated with the red dotted circle.

If there is no gap, confirm that the two screws fixing paper feed belt unit are securely fastened. This completes the procedure.

If there is a gap, do Steps 2 through 4.

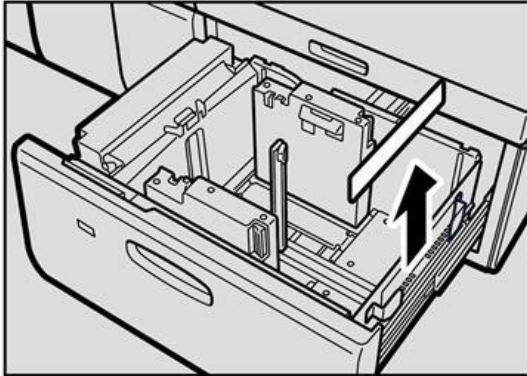
The above type of paper tends to get caught between the spring [A] of the end fence and the paper stopper plates [B], and does not float up.

1. Pull out the tray and take out the magnet sheet from the pocket on the right-hand side of the wide Large Capacity Tray.

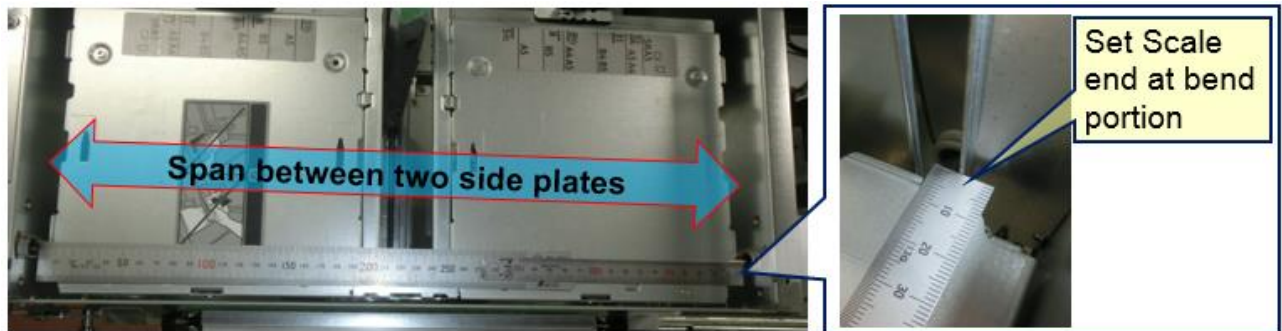
**Fig. 2**

- a. Span between the two side plates (Fig. 2, 3): **446.8 – 448.4 mm**
- b. Clearance (Fig. 4): **0.5 – 3.0 mm**

- Measure the distance (span) between the two side plates (Fig. 2).

**Important:** The scale ends should touch the bent portion of the side plates.

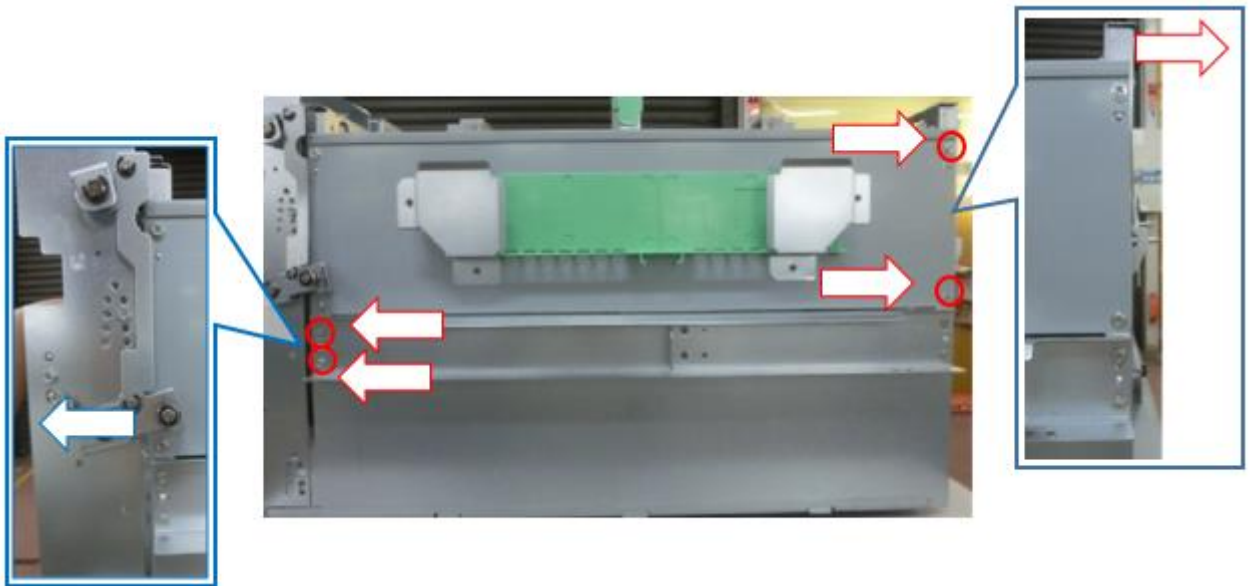
**Fig. 7**

There is a small clearance between the side plates and the bottom plate. This creates up-and-down movement of the bottom plate that is not smooth, and loosens the lift wire. As a result, the wire may become tangled with the pulley and create excessive tension in the wire.

- a. Loosen the 4 screws circled in red on the right side of the tray plate
- d. Shift the front & rear side plates in the direction of the white arrow as far as they will go, until each screw touches the inner edge of the screw hole.
- e. Tighten the 4 screws.

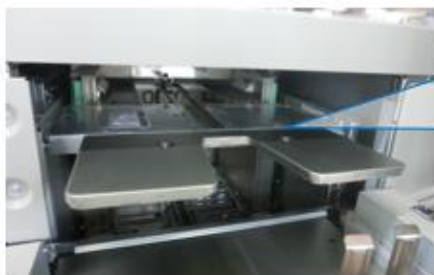
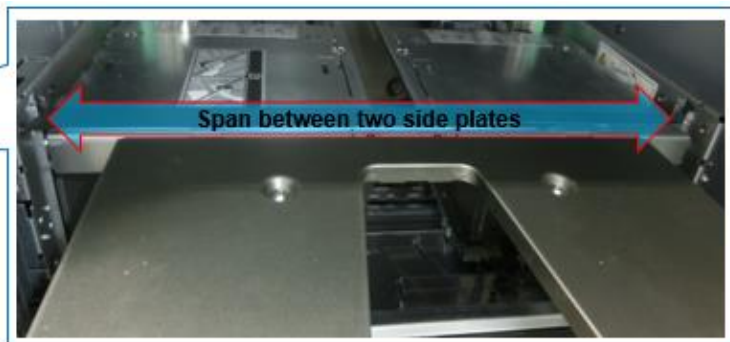
- a. Span between the two side plates (Fig.8, 9): **446.8 – 448.4 mm**
- b. Clearance (Fig. 10, 11): **0.5 – 3.0 mm**

1. Measure the distance between the two side plates
  - Set the scale in the same way as described above.
  - Measure the span as the distance between the two side plates at two positions, both Upper (Fig. 8) and Lower (Fig. 9).

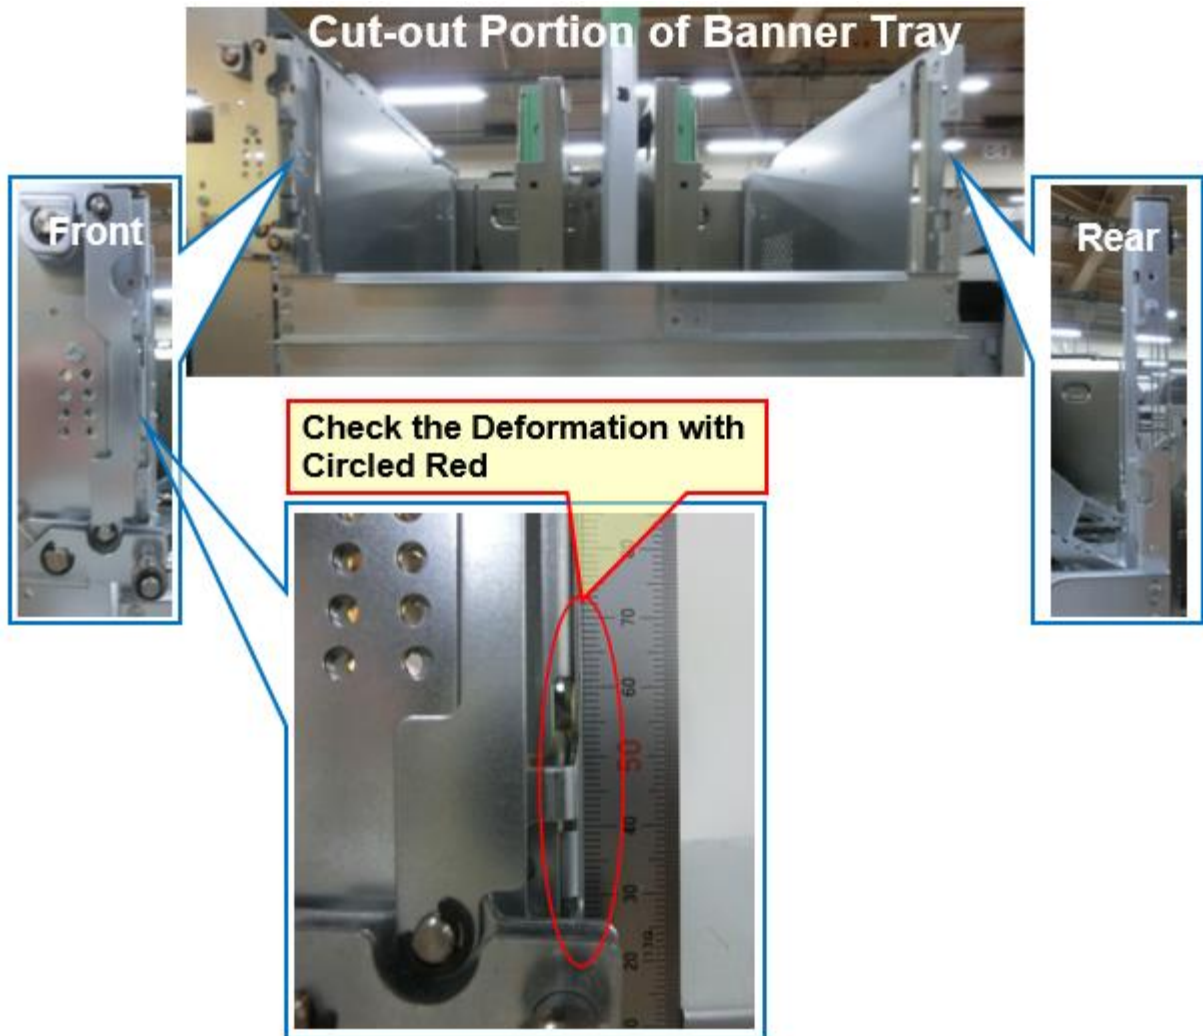
- 1) Put the scale in the cut-out portion, as shown in Fig. 13 below.
- 2) Check the deformation of the cut-out portion circled in red.  
If you can see the light in between the plate and scale, this portion may be deformed.

Replace the side plate as shown in Table 1 below if the span is not adjustable to within the target dimension and the cut-off portion is deformed.

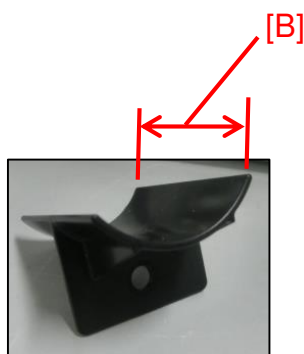
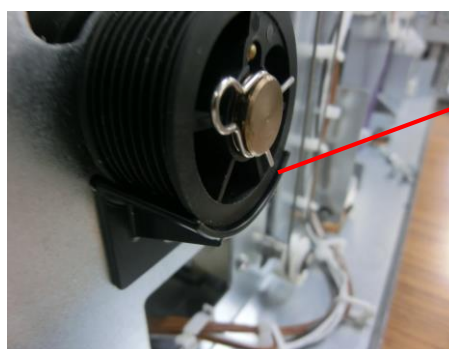
New type pulley cover

**NOTE:** The pulley used to stick out from the pulley cover with the old type cover, so the new type cover has been made wider [B] (37.4mm → 42.4mm) and covers the edge of the pulley as shown in [C].

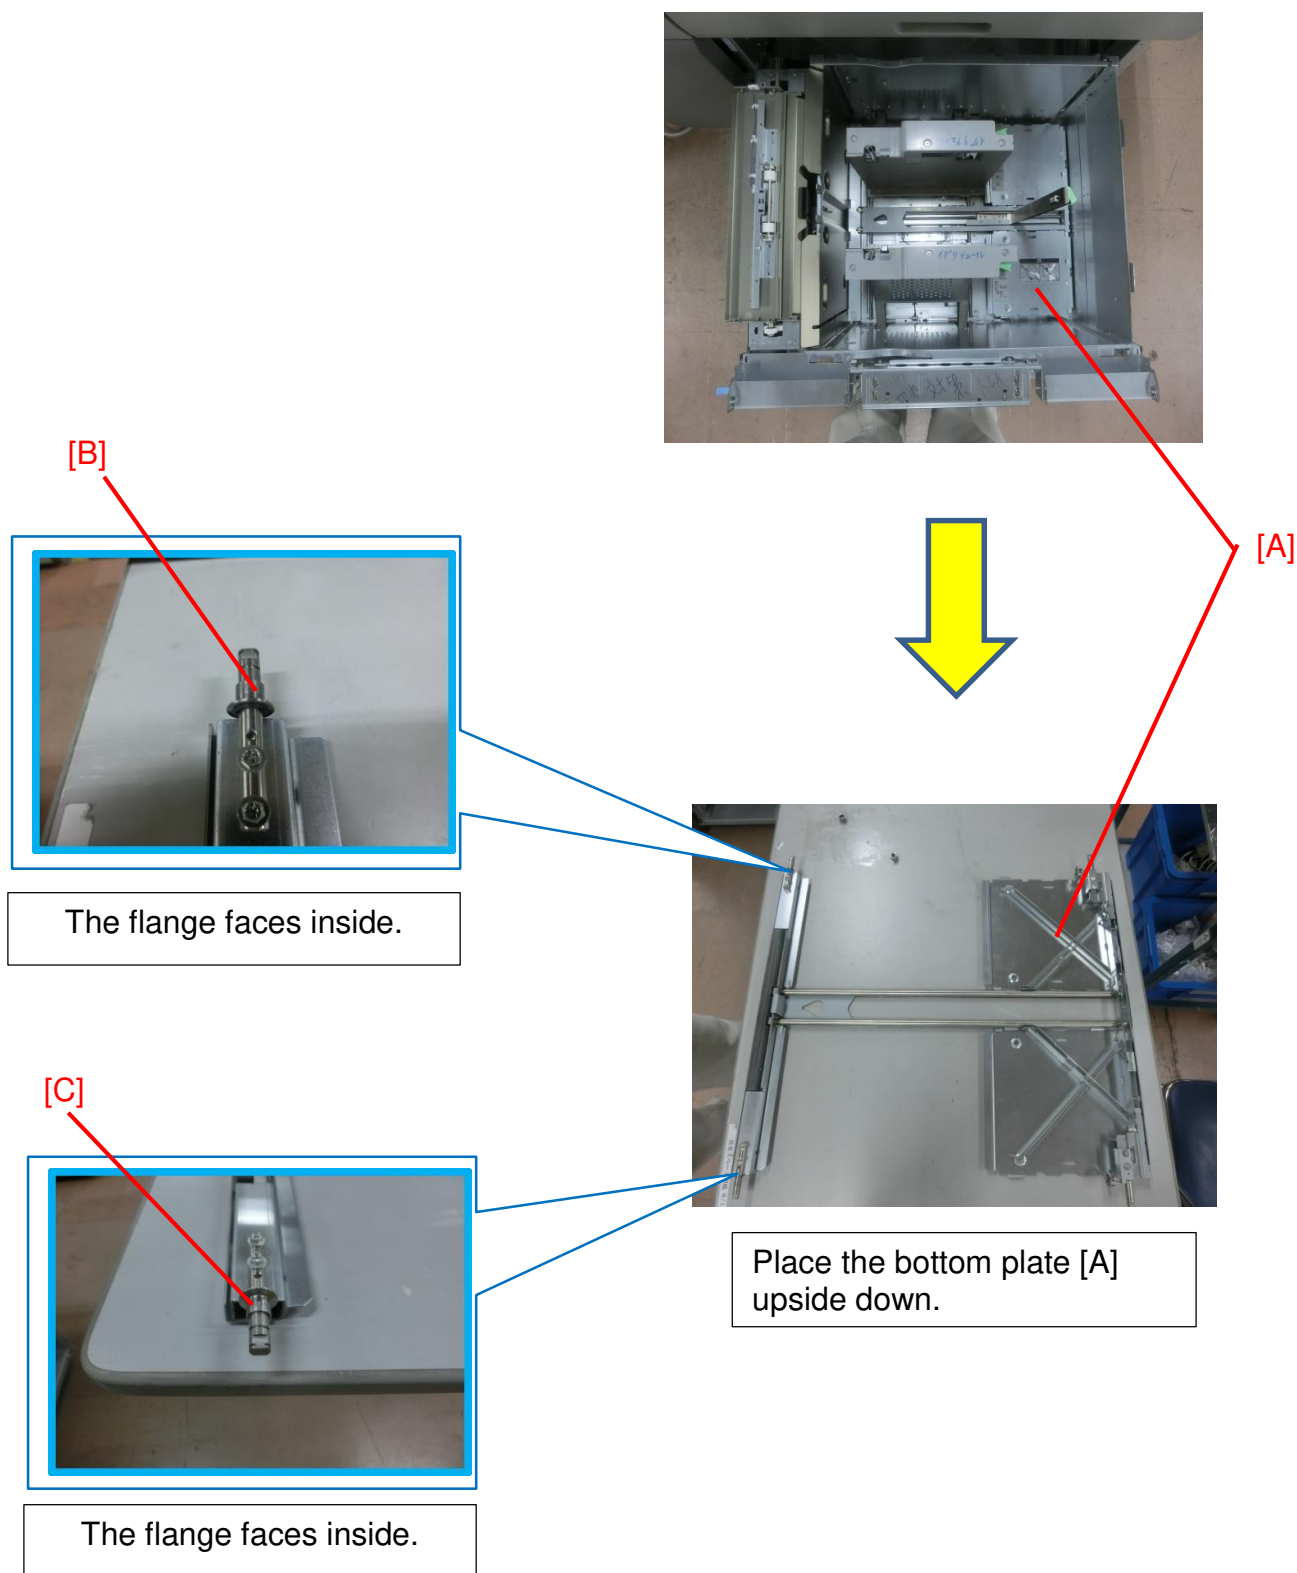
**NOTE:** The new type collars are tapered.

4. Remove the bottom plate [A] from the tray and place it upside down on a flat sturdy table or a bench, and then replace the collars [B] and [C] with the new type collars.

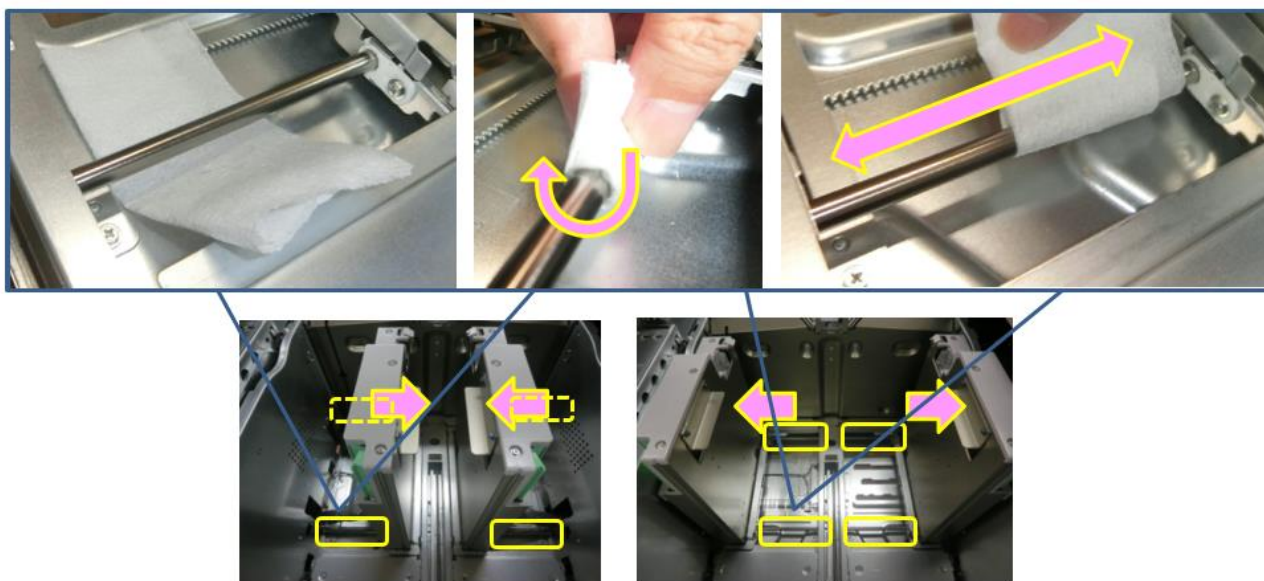
Fig. 1

The side fence cannot slide smoothly.

Paper dust gets on the surface of the slide shaft and inside the bearings.

1. Clean the shaft of the side fence with a cloth as shown.

**Important:** If you cannot clean off all the dust and foreign material with the cloth, use a vacuum cleaner.

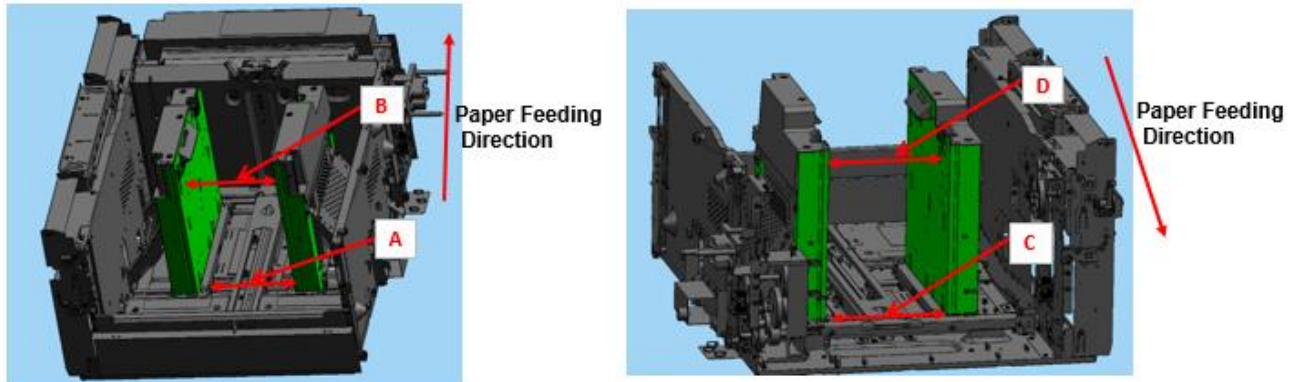
Fig. 2

The top/bottom and front/rear side fences are either deformed or tilted slightly. As a result, the span between the fences at the top/bottom is not the same as for the front/rear.

4. Measure the distances (spans **A**, **B**, **C**, **D**) between the two side fences as shown in Figs. 2 and 3.

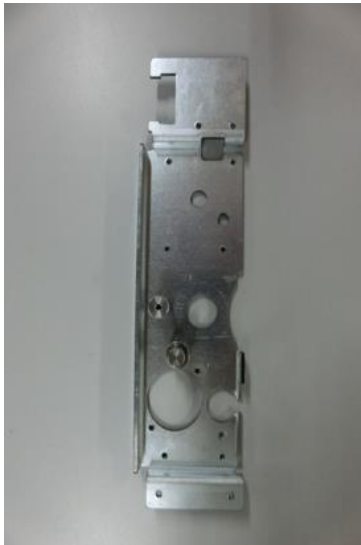
A tray loaded with A3/DLT or larger paper causes the shaft of the tray lift-up gear to slant over time due to the heavy load, preventing proper engagement of the gears.

10. Replace the bracket [A] removed in Step 9 with the new type bracket [B] (call-out [#1] in the table on page 1).
