Model: B-C4	Date: 04-Mar-09	No.: RD447001a
-------------	-----------------	----------------

Subject: Firmware Release Note: Stacker_LOIRE1		Prepared by: T. Tadokoro	
From: PPBG QA/Service Planning Dept.			
Classification:	<input type="checkbox"/> Troubleshooting <input type="checkbox"/> Mechanical <input type="checkbox"/> Paper path <input type="checkbox"/> Product Safety	<input type="checkbox"/> Part information <input type="checkbox"/> Electrical <input type="checkbox"/> Transmit/receive <input checked="" type="checkbox"/> Other ()	<input type="checkbox"/> Action required <input type="checkbox"/> Service manual revision <input type="checkbox"/> Retrofit information <input type="checkbox"/> Tier 2

Model: High Capacity Stacker SK5010		Date: 04-Des-09	No.: RD447003
Subject: Request for Replacement of Parts Containing RoHS Restricted Substances		Prepared by: K. Tsutsui	
From: PP Service Planning Department 1G			
Classification:	<input type="checkbox"/> Troubleshooting <input type="checkbox"/> Mechanical <input type="checkbox"/> Paper path <input type="checkbox"/> Product Safety	<input type="checkbox"/> Part information <input type="checkbox"/> Electrical <input type="checkbox"/> Tr

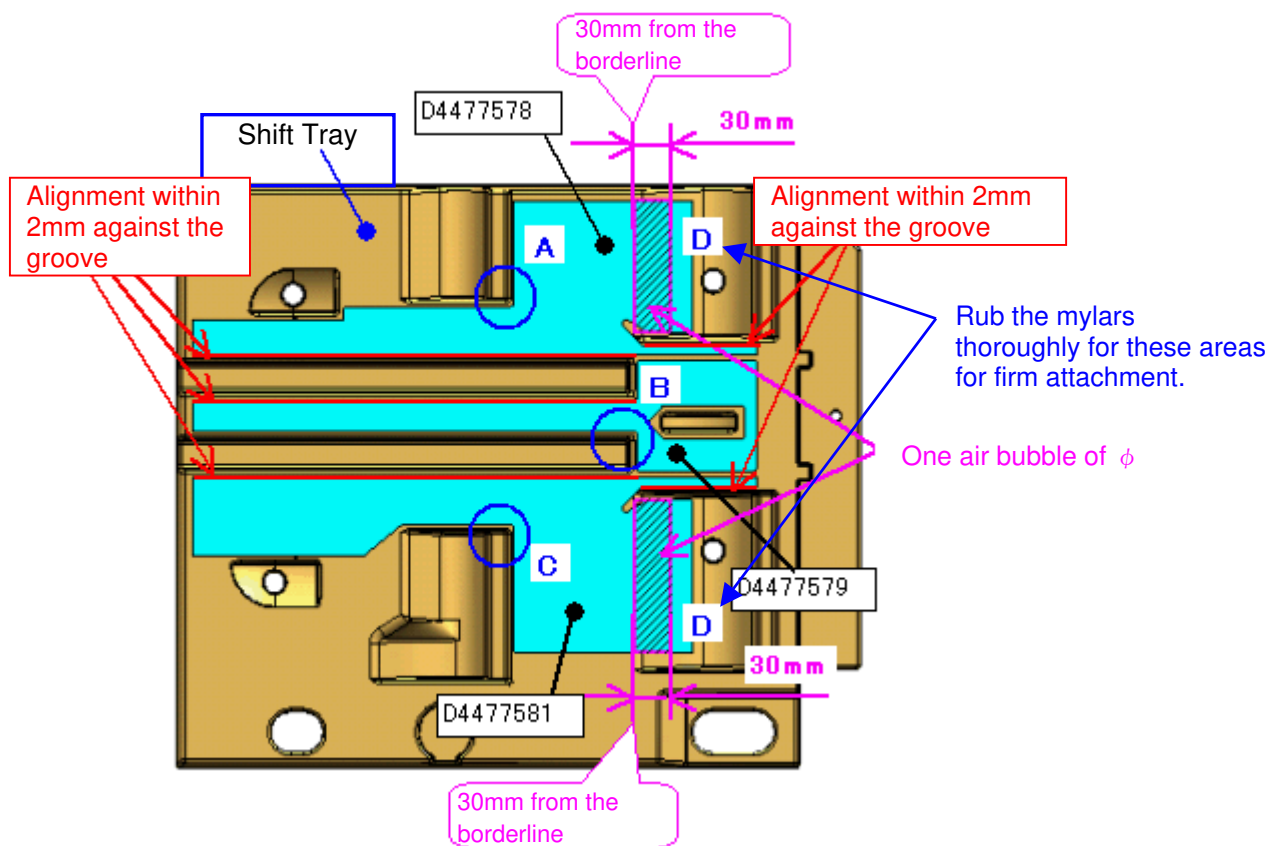
Notes on Attaching the Mylars

Static electricity could cause the first sheet to stick to the shift tray of the Stacker (indexed 4 in the diagram below) and the succeeding sheets to curl up. Three mylars have been added to discharge static electricity for better stacking.

- Wipe the area with alcohol before attaching the mylar.
- Work carefully to avoid air bubbles. If air bubbles cannot be avoided, the only areas permissible are the two areas indicated in pink in the diagram below.
- Align the corners "A", "B", and "C" so that the edges are positioned within 2mm from the grooves.
- The curved areas "D" should be double-checked. Rub the mylars thoroughly for firm attachment.
- Wipe the surface of the mylars with alcohol to complete the procedure. (Make sure alcohol does not leak in between the mylar and the tray.)

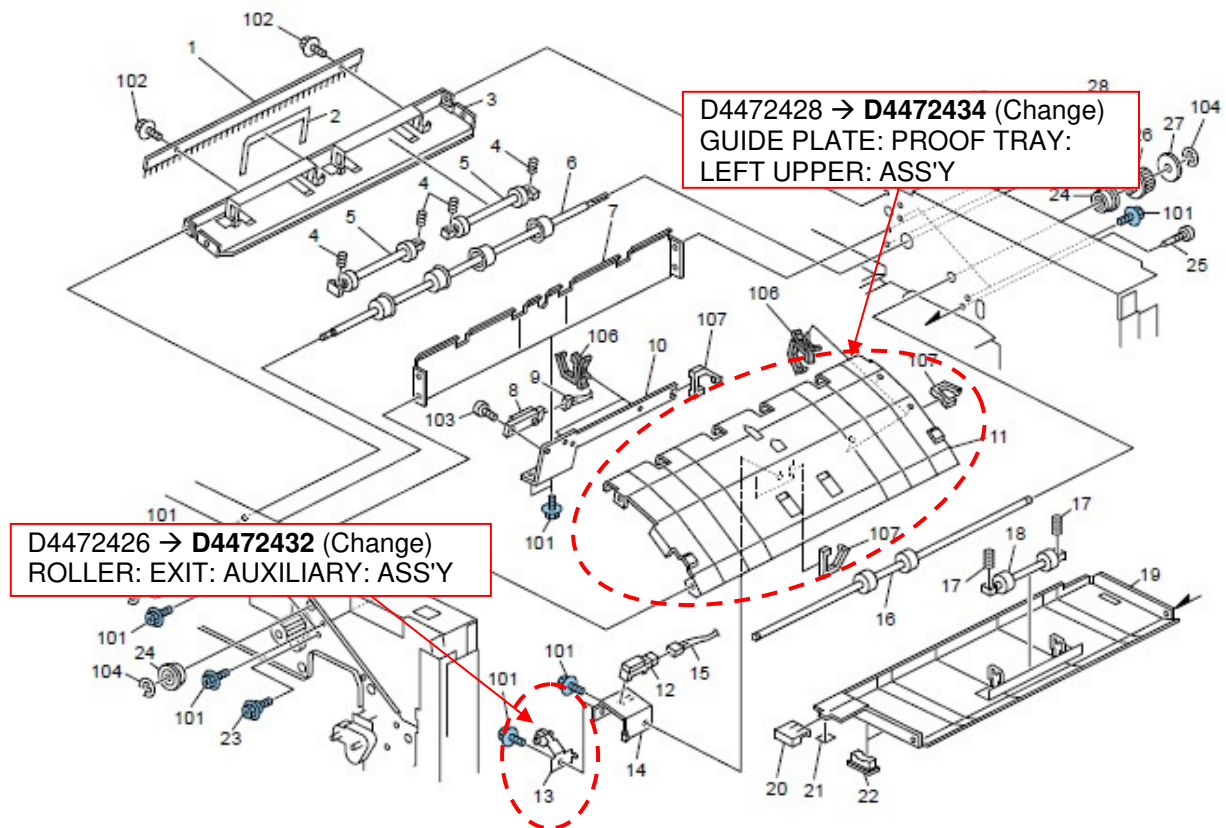
6.Proof Tray Exit Section (D447)

Note 1: When replacing the above parts, replace D4472434 and D4472432 as a set.

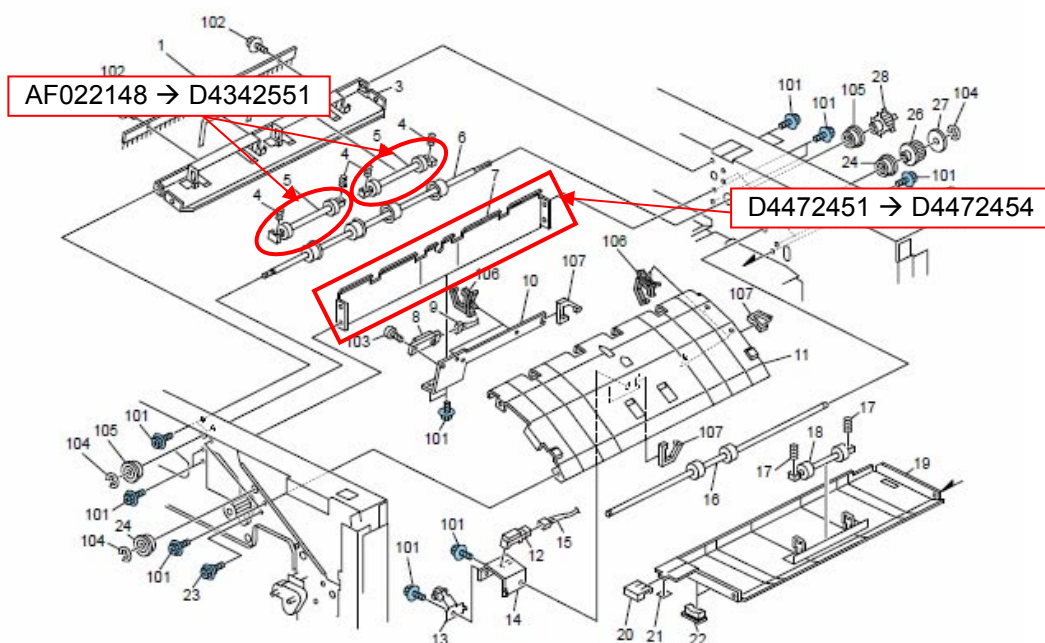
6.Proof Tray Exit Section (D447)

Change: Rollers that feed out paper to the Shift tray and the Proof tray were modified.

When replacing any of the above parts for the first time, replace as a set along with the following parts that were announced in RTB RD447008:

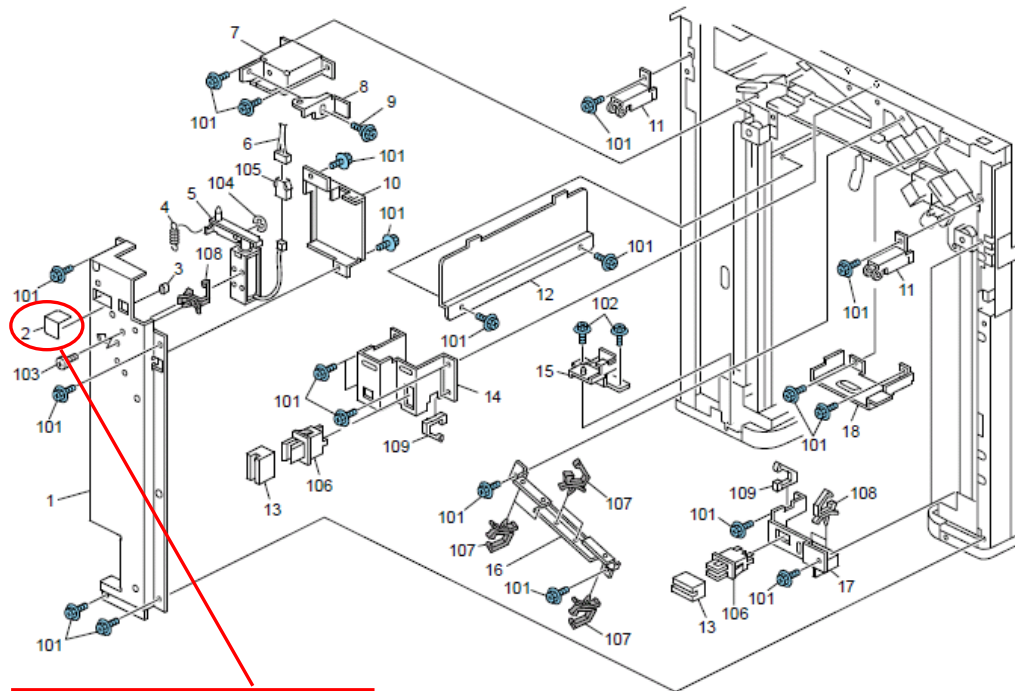
21. Electrical Section 3 (D447)

Change 1: The door-lock bracket was modified.

D447 6143 → D447 6150

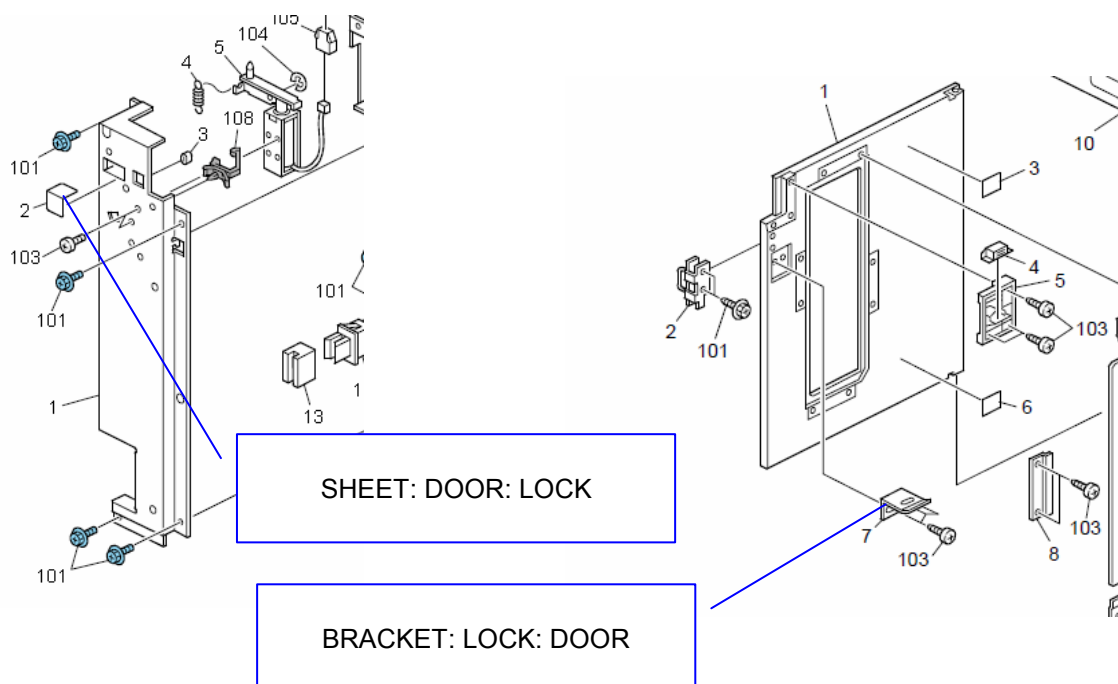
Opening and closing the front door many times could cause the Mylar Sheet, which is attached to the door-lock bracket to prevent friction between the door bracket and the mainframe bracket, to come off over time. When the Mylar Sheet comes off, the double-sided adhesive tape remains on the bracket, and causes the door to jam.

This photo shows the Bracket missing the Mylar Sheet, leaving only the double-sided adhesive tape.

Old part number	New part number	Old description	New description	Q'ty	Page	Index	Note
D4471176		SHEET:DOOR:LOCK	-	0	43	2	
D4476143	D4476150	BRACKET:LOCK:DOOR	←-	1	3	7
