Model: Stacker_SK5030		Date: 1-Mar-16	No.: RD776003
Subject: High Capacity Stacker SK5030: Label Paper Jams in the Straight Paper Path		Prepared by: T.Miyamoto	
From: 1st Tech Service Sect., PP Tech Service Dept.			
Classification:	<input checked="" type="checkbox"/> Troubleshooting <input type="checkbox"/> Mechanical <input type="checkbox"/> Paper path <input type="checkbox"/> Product Safety	<input type="checkbox"/> Part information <input type="checkbox"/> Electrical <input type="checkbox"/> Transmit/receive <input type="checkbox"/> Other ()	<input type="checkbox"/> Action required <input type="checkbox"/> Service manual revision <input type="checkbox"/> Retrofit information <input checked="" type="checkbox"/> Tier 2 <input type="checkbox"/> Tier 0.5

Model: Stacker_SK5030		Date: 2-Mar-16	No.: RD776004
Subject: High Capacity Stacker SK5030: Top most sheet separates from the stack when pulling out the cart		Prepared by: T.Miyamoto	
From: 1st Tech Service Sect., PP Tech Service Dept.			
Classification:	<input checked="" type="checkbox"/> Troubleshooting <input type="checkbox"/> Mechanical <input type="checkbox"/> Paper path <input type="checkbox"/> Product Safety	<input type="check

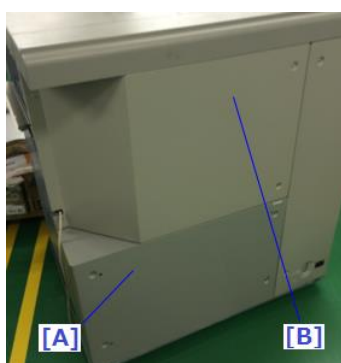
The tray is stuck and does not lift up/down properly, because the drive gear is broken and the tray bracket is slanted against the belts.

Grease applied to the drive components of the shift tray is dried up.

1. Remove the rear lower cover [A] and the rear upper cover [B]. (Screw x8; 4 each)

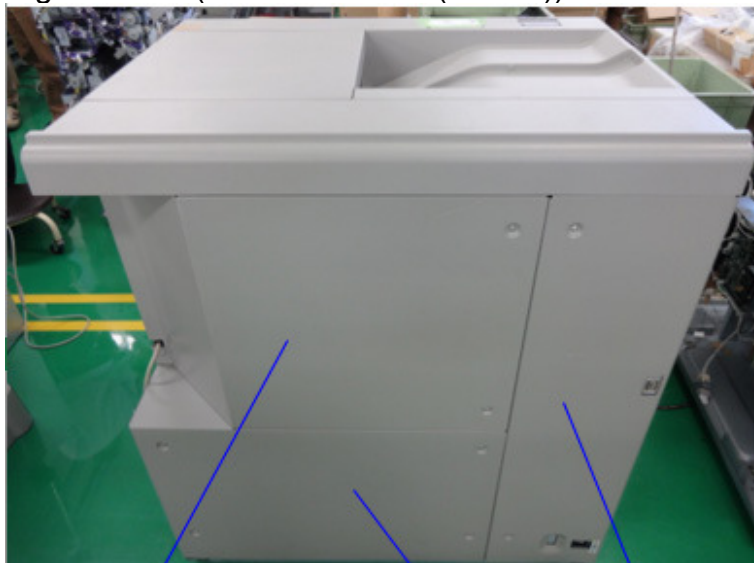
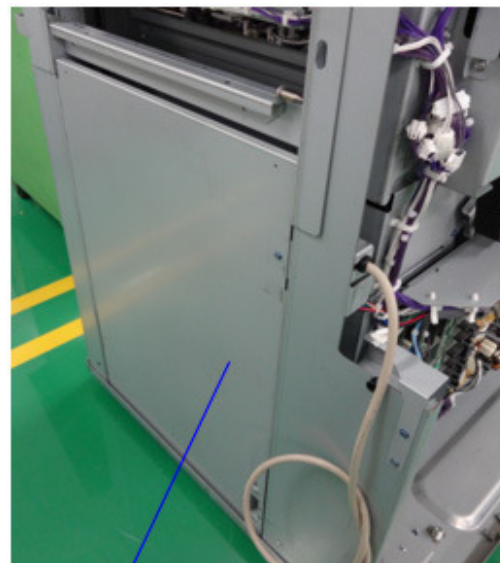
A loud noise is heard coming from the stacker, and the shift tray does not move.

The worm gear gets worn when the paper tray is full with relatively heavy paper.

1. Remove the "Rear Lower Cover", "Rear Upper Cover", "Rear Left Cover" and "Rear Right Cover" (M3 screws x 16 (4 each)).
