Technical Bulletin

Model: Finisher SR3140/SR3150

Subject: How to adjust paper skew in stapled sets			Prepared by: E.Hinata		
From: 1st Tech Service Sect., MFP/P Tech Service Dept.					
Classification:	Iroubleshooting	Part informat	tion	Action required	
	Mechanical	Electrical		Service manual revision	
	Paper path	Transmit/rec	eive	Retrofit information	
	Product Safety	Other ()	Tier 2

Model: Model Met-C1			Date: 29-Jul-14		No.: RD686004	
Subject: Finisher SR3140/SR3150 staple misalignment (3mm or more)			Prepared	by: M.K	umagai	
From: 1st Tech Service Sect., MFP/P Tech Service Dept.						
Classification:	 ☑ Troubleshooting ☐ Mechanical ☑ Paper path ☑ Product Safety 	Part info Electric Transm	ormat al it/rec	tion [cive [) [2	Action Center Ce	required e manual revision it information

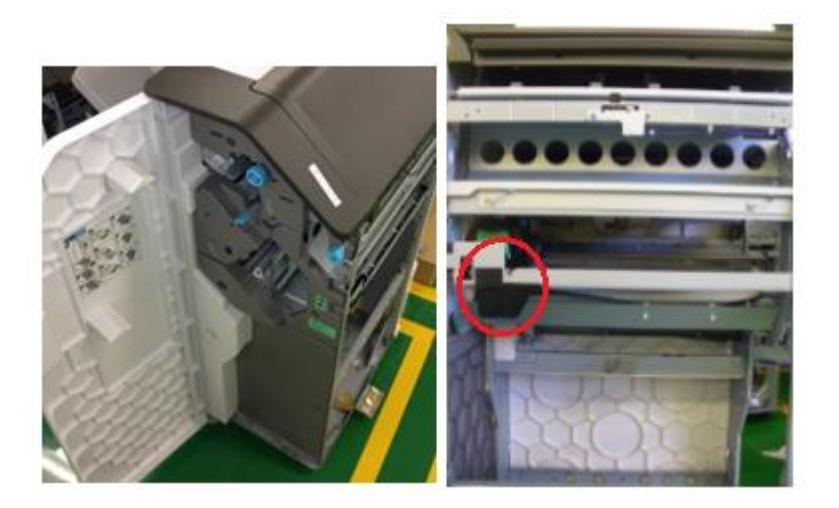
SR3140

Access the tray upper motor in the area circled in red (from underneath).

Attach the sheet (P/N: D6833644) between the frame and the side plate in the areas circled.

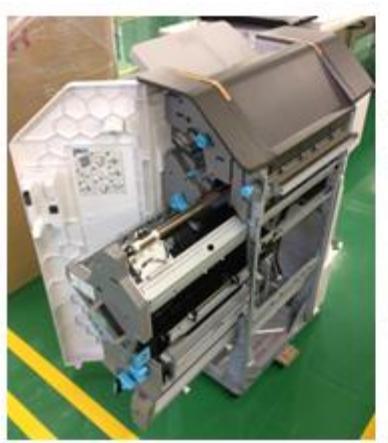
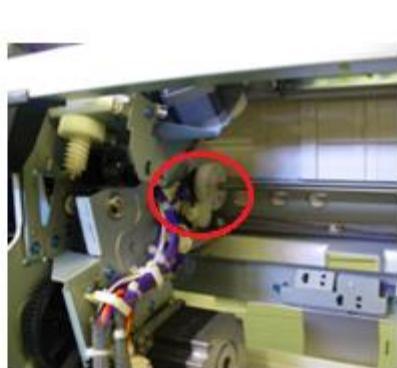
SR3150

Pull the booklet staple unit to access the motor.

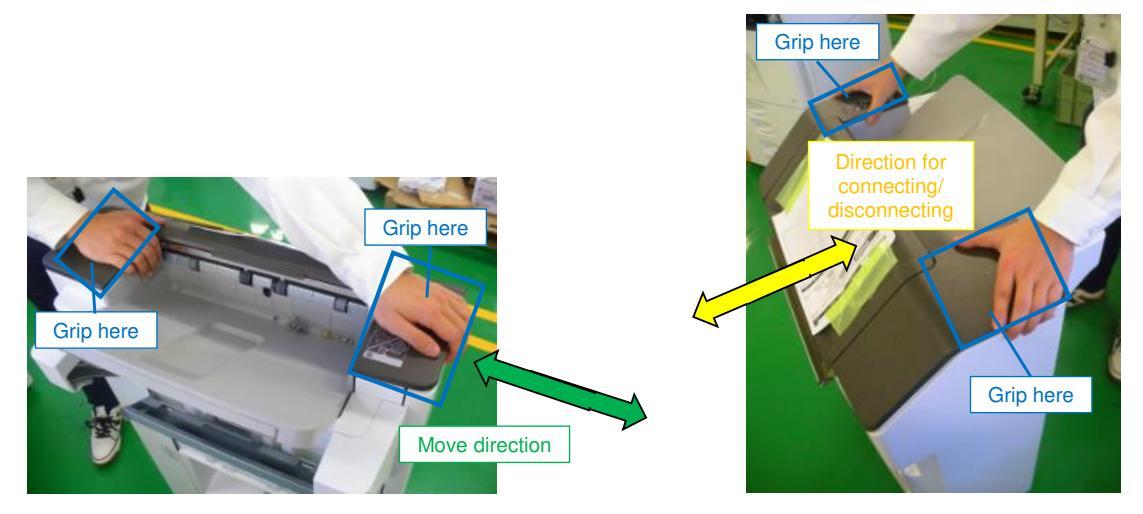
- As a general rule for moving the finisher, move it from the front to the rear of the machine as indicated with the arrows in green, by gripping the positions outlined in blue in the photo below.
- Make sure to grip both front and back of the finisher at the top to prevent the unit from tipping over.
- When connecting or disconnecting the finisher to or from the main frame, slightly move it in the direction indicated with the yellow arrow.

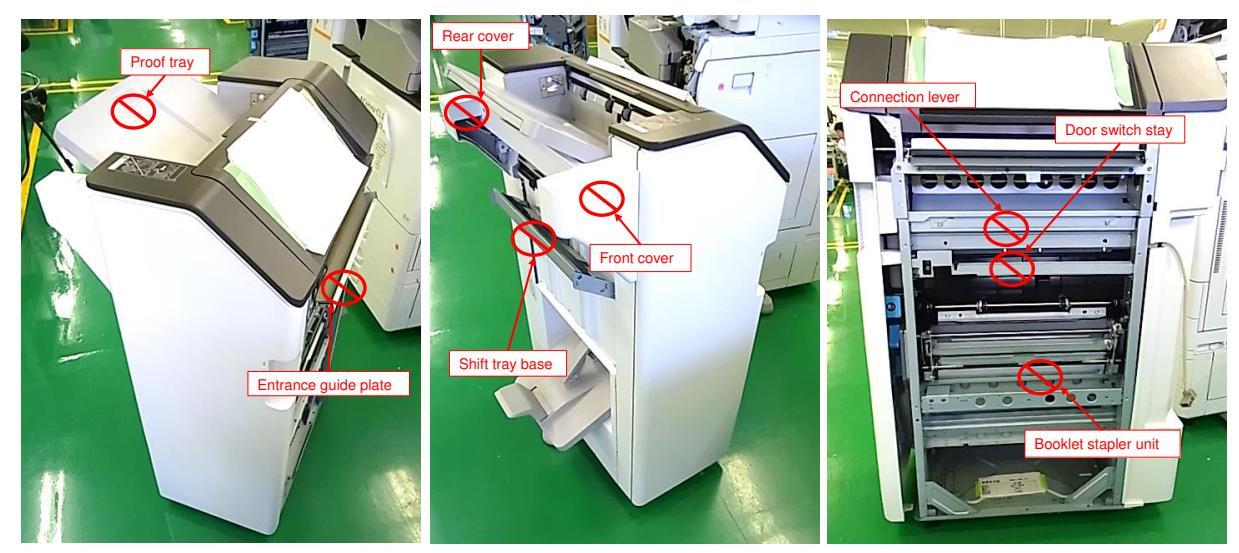
Do not grip the following locations when moving the finisher:

- Proof tray
- Entrance guide plate
- Front and rear covers
- Shift tray base
- Connection lever
- Door switch stay
- Booklet stapler unit (SR3150 only)
