Model: Booklet Finisher SR3160/SR3170	Date: 12-Nov-13	No.: RD688002b
---------------------------------------	-----------------	----------------

Subject: Staple misalignment (3 mm or more) occurs		Prepared by: Yuji Urushihara	
From: 1st Tech Service Sect. MFP/P Tech Service Dept.			
Classification:	<input checked="" type="checkbox"/> Troubleshooting	<input type="checkbox"/> Part information	<input type="checkbox"/> Action required
	<input type="checkbox"/> Mechanical	<input type="checkbox"/> Electrical	<input type="checkbox"/> Service manual revision
	<input type="checkbox"/> Paper path	<input type="checkbox"/> Transmit/receive	<input type="checkbox"/> Retrofit information
	<input type="checkbox"/> Product Safety	<input type="checkbox"/> Other ()	<input type="checkbox"/> Tier 2

Subject: JAM 157		Prepared by: Y. Urushihara	
From: 1st Tech Service Sect., MFP/P Tech Service Dept.			
Classification:	<input checked="" type="checkbox"/> Troubleshooting	<input type="checkbox"/> Part information	<input type="checkbox"/> Action required
	<input type="checkbox"/> Mechanical	<input type="checkbox"/> Electrical	<input type="checkbox"/> Service manual revision
	<input type="checkbox"/> Paper p

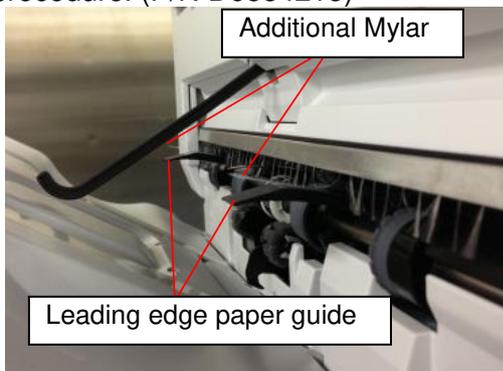
The stapled set touches the tray at an unexpected angle upon exit to the exit tray (due to paper curl or other factor)

Add Mylars to the leading edge paper guide (two at both front/back) in accordance with following procedure. (P/N D6884218)

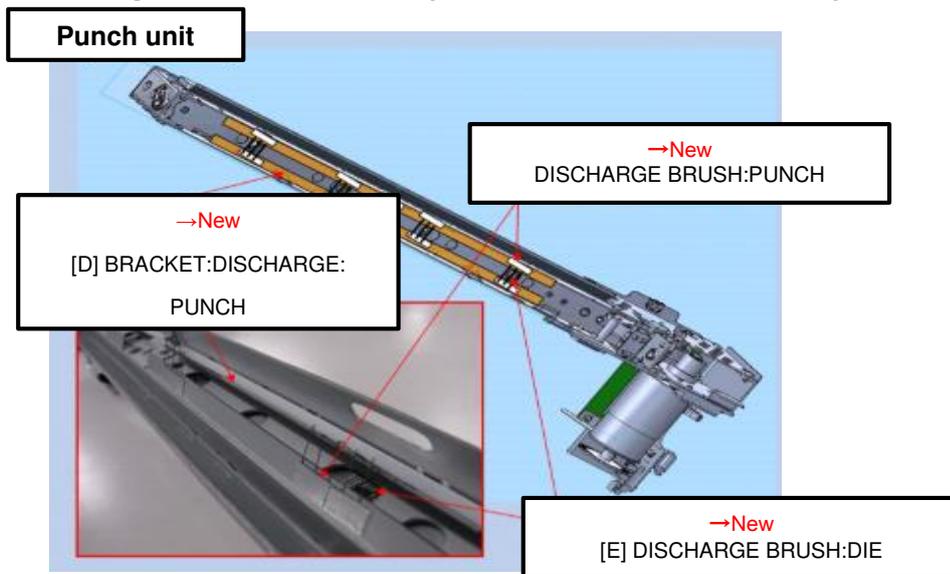
The chads stick to the toner hopper punch guide [C], causing the sensor to mistakenly detect the hopper full condition.

The punch unit, the punch unit stay, and the hopper were modified.

- Punch unit
A bracket [D] was added with a discharge brush [E] to the stay of the punch unit to discharge the static electricity from the chads immediately after holes are punched.

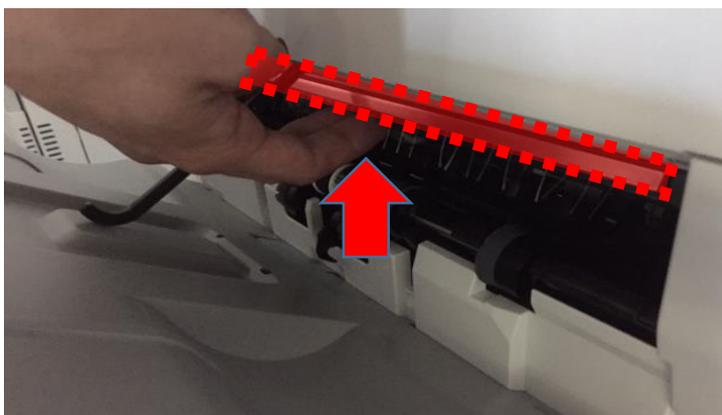
The Mylar is damaged after repeated contact with the paper. As a result, a crack forms and gradually expands.

6. Lift the guide plate and remove the Mylars at the front and rear.

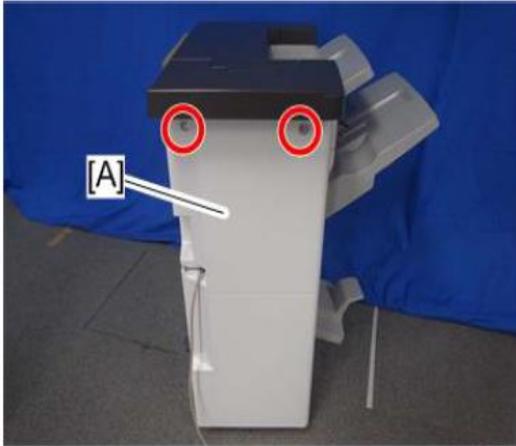
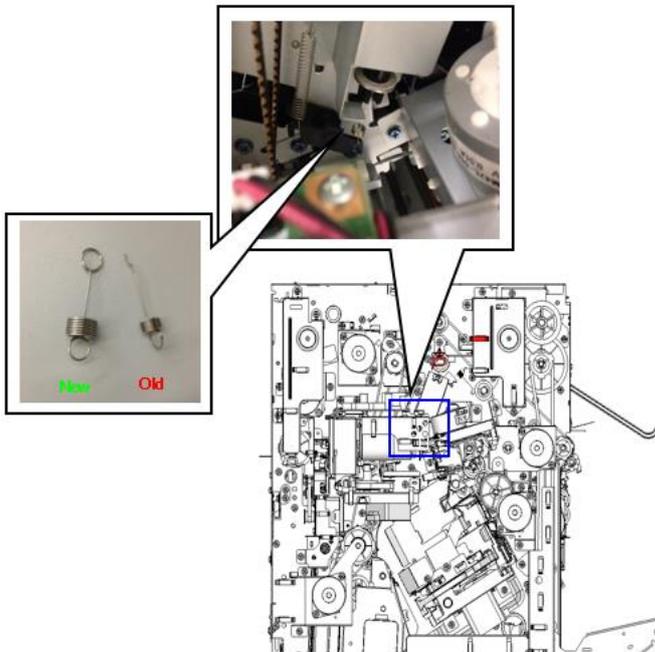
- 1. The spring and bracket for the gate solenoid break.

The small bend radius causes stress to concentrate on the spring.

Replace the solenoid (P/N D6882115)

1. Remove the rear upper cover (2 screws).
2. Check the solenoid spring.

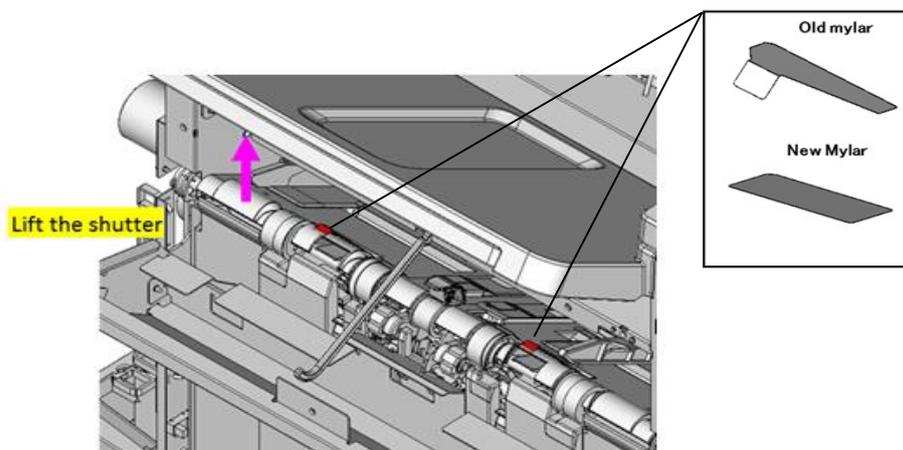
2. The Mylar is worn down by contact with the paper and eventually breaks.

The Mylar is gradually worn down by sliding friction produced by contact with the transported paper. This friction and the resulting stress are concentrated along the edge of the bending part of the Mylar.

Replace the Mylar (P/N D6884119)

5. Lift the shutter and remove the Mylars (front and rear)

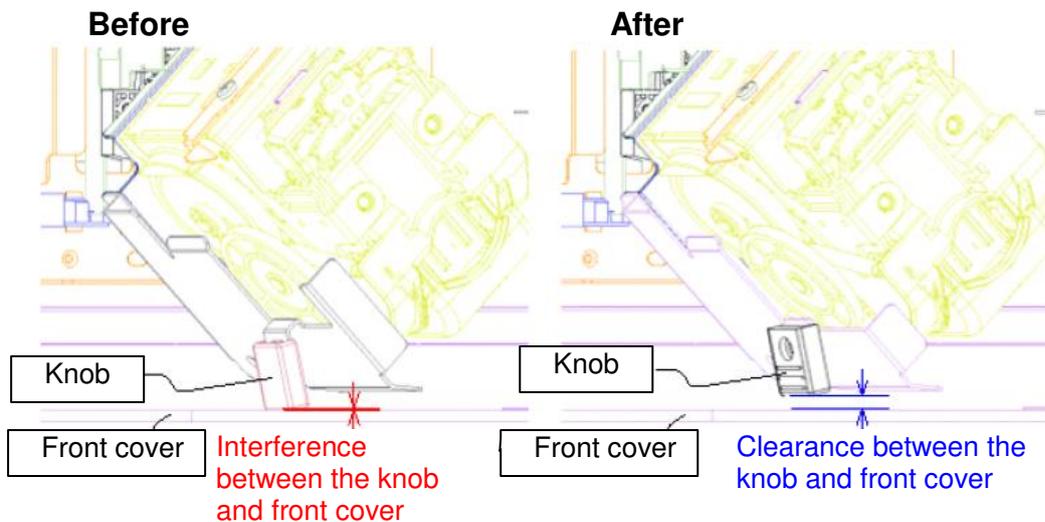
1. Countermeasure against SC720 [2K/3K sheet finisher error]
The stapler bracket contacts the front cover and deforms, resulting in the above SC.
2. For improved production process

1. Knob on the stapler cover (snap-to-fit → screw)
