Model: Finisher_SR4090_SR4100	Date: 7-Oct-13	No.: RD703002
-------------------------------	----------------	---------------

Subject: SR4100: Troubleshooting Creases and Jam in stapler unit		Prepared by: Hiroaki H Matsui	
From: 1st PP Tech Service Sec., PP Tech Service Dept.			
Classification:	<input checked="" type="checkbox"/> Troubleshooting	<input type="checkbox"/> Part information	<input type="checkbox"/> Action required
	<input type="checkbox"/> Mechanical	<input type="checkbox"/> Electrical	<input type="checkbox"/> Service manual revision
	<input type="checkbox"/> Paper path	<input type="checkbox"/> Transmit/receive	<input type="checkbox"/> Retrofit information
	<input type="checkbox"/> Product Safety	<input type="checkbox"/> Other ()	<input type="checkbox"/> Tier 2

Model: Finisher_SR4090_SR4100		Date: 11-Oct-13	No.: RD703004
Subject: SR4090/SR4100: Shift tray stalls causing paper jam		Prepared by: H. Matsui	
From: PP Tech Service Dept., 1st PP Tech Service Sect.			
Classification:	<input checked="" type="checkbox"/> Troubleshooting	<input type="checkbox"/> Part information	<input type="checkbox"/> Action required
	<input type="checkbox"/> Mechanical	<input type="checkbox"/

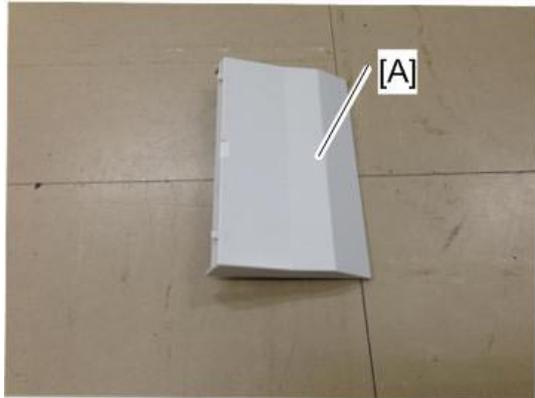
d135a0068

The problem occurs if the Shift Auxiliary Tray [A] included with the finisher is set incorrectly. In this condition, the feeler gets caught between the auxiliary tray and shift tray when the shift tray moves up and is displaced.

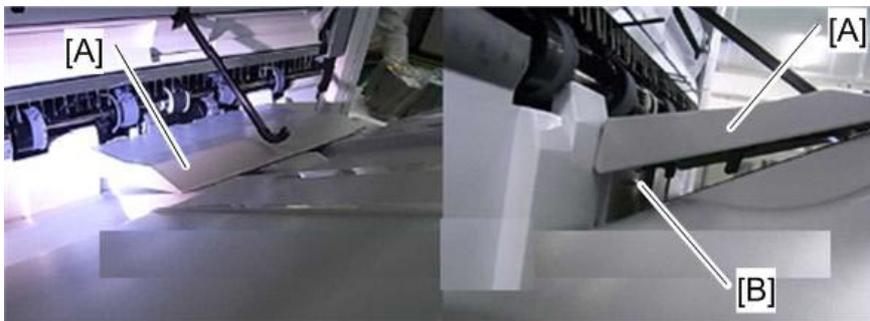
d135a0069

- The Shift Auxiliary Tray [A] is to be used only when the configuration contains the Multi-Folding Unit FD4000. This auxiliary tray increases the stacking capacity of z-folded paper.
- If the Multi-Folding Unit FD4000 is not installed, do not attach the Shift Auxiliary Tray as it may cause the shift tray to malfunction.

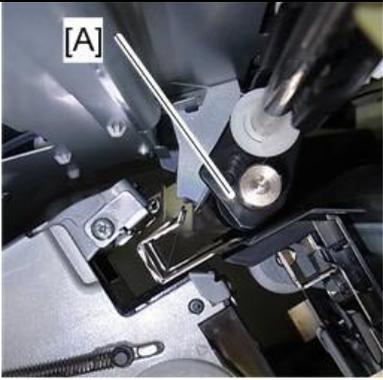
<p style="text-align: center;">d135a0052</p>

Drag roller - FRONT	
[A]: Correct position	[B]: Incorrect position Drag roller is stuck on top of the staple tray.

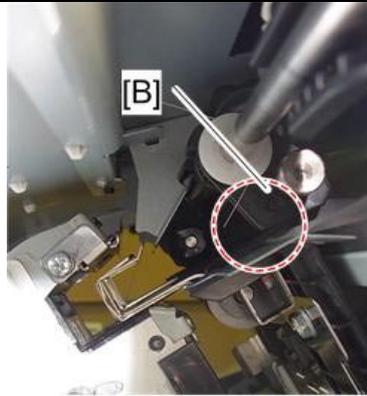
<p style="text-align: center;">d135a0053</p>

Drag roller - REAR	
[A]: Correct position	[B]: Incorrect position Drag roller is stuck on top of the staple tray.

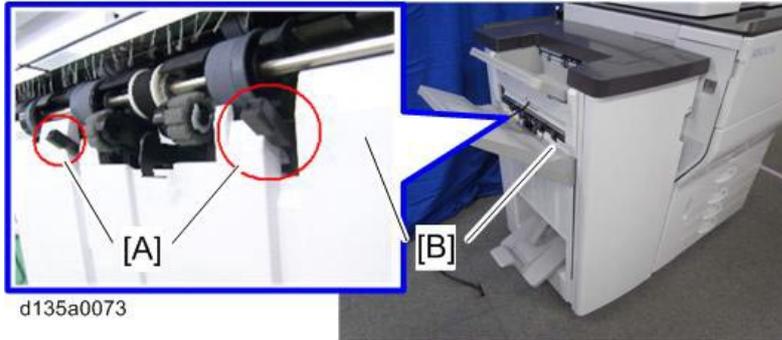
Incorrect position of the paper stacking holders

The paper stacking holders [A] are incorrectly positioned and protruding from the end fence [B], causing the paper to get caught on top of these holders.

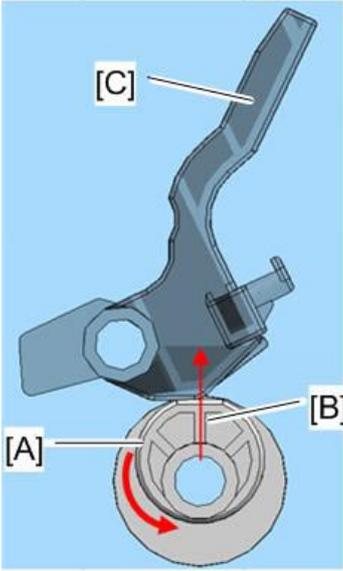
<p>d135a0076</p>

Correct	Incorrect
<p>The center rib [B] of the cam [A] is facing straight up and the paper stacking holder [C] is in contact with the flat surface of the cam [A].</p>	<p>The center rib [B] of the cam [A] is slanted and the paper stacking holder [C] is not in contact with the flat surface of the cam [A].</p>

- 4. If the paper stacking holder is positioned incorrectly, replace the paper stacking holder unit [A] with a new one (screw x7). See field service manual for the procedure.

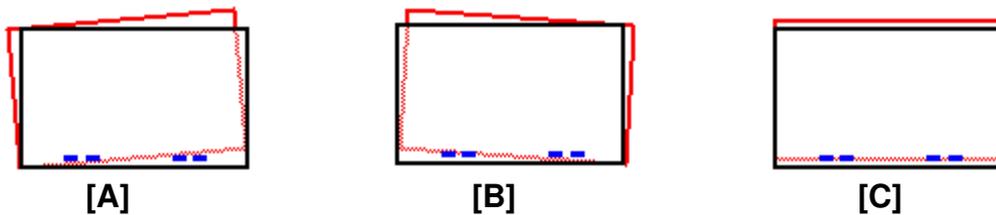
1. The first sheet of the stapled set is misaligned with respect to the paper feed direction (**[A]** and **[B]** below), or shifted along the paper feed direction (**[C]**). As a result, one or both of the staples passes partially through the paper or misses the paper altogether.

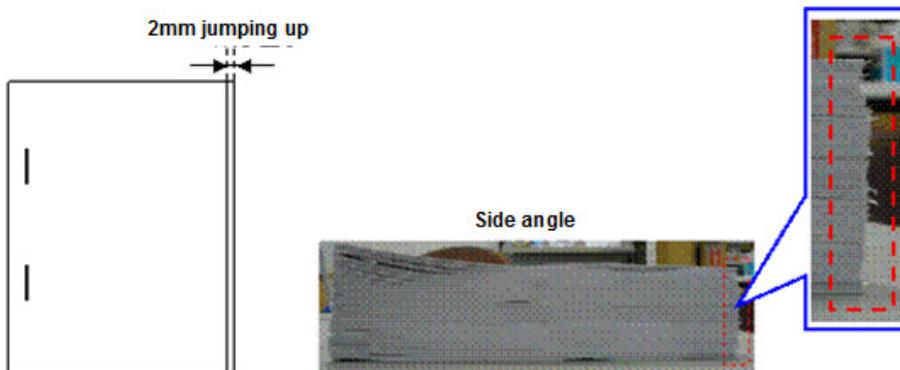
2. One or more sheets in a stapled set is shifted up to 2mm along the paper feed direction with respect to the other sheets in the set.

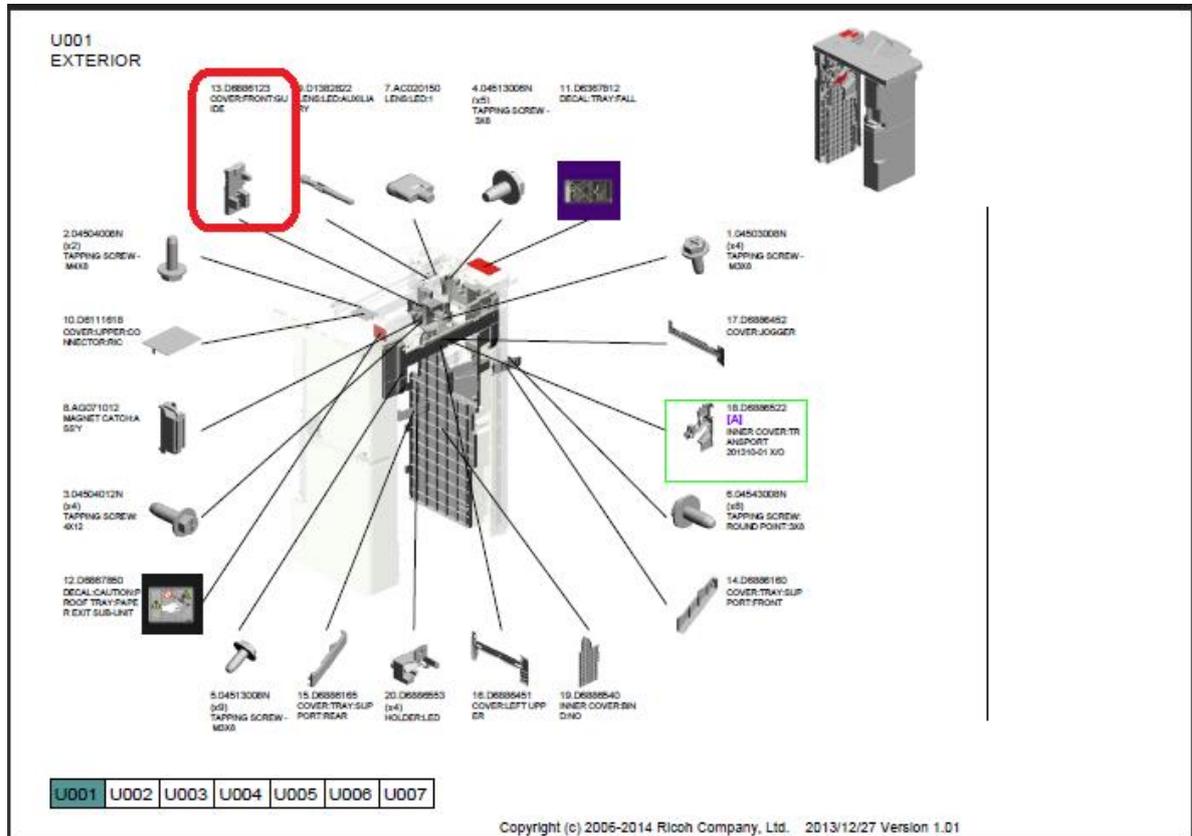
The magnet attached to the magnetic door catch is loose and the front cover does not completely close, displaying a front cover open error message on the operation panel.

Cause

- 1) If the magnet is loose, reattach it.
If the magnet cannot be reattached properly, procure the modified magnetic door catch (p/n: D6886124).
- 2) A check procedure to confirm proper attachment of the magnet was added at the factory.

Old P/N	New P/N	Description	Q'ty	Int	Page	Index
D6886123	D6886124	COVER:FRONT:GUIDE	1	-	4	13

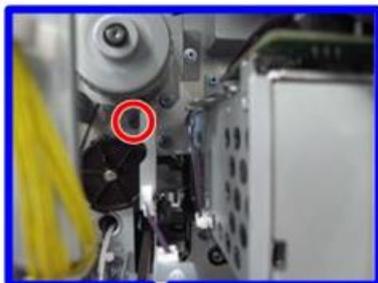
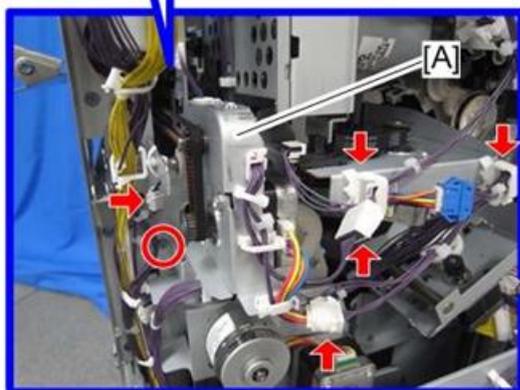
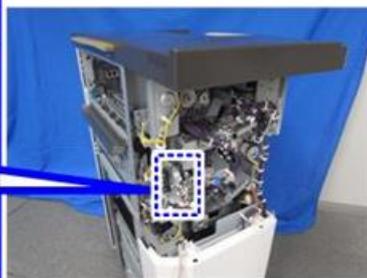
The paper contacts the Mylar on the punch unit (circled in red below).

1. Remove the rear upper cover and lower cover.
2. Remove the registration sensor bracket [A] (screws x2, connectors x3).

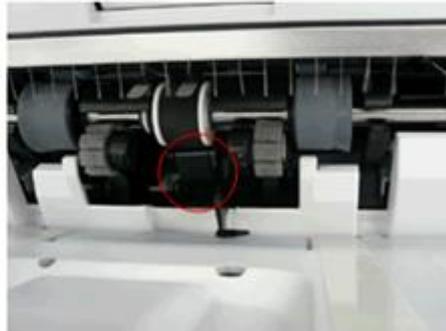
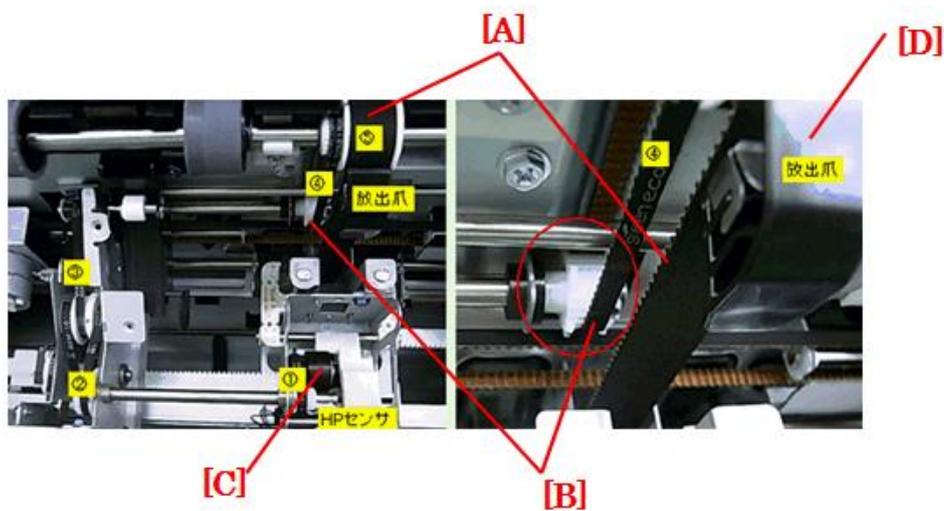
Correct Condition

A previous jam or other force places a load on the exit pawls [A], causing the timing belt [B] to slip along the gear teeth. As a result, the home position [C] of the exit pawl is shifted and the pawl blocks part of the paper path [D].

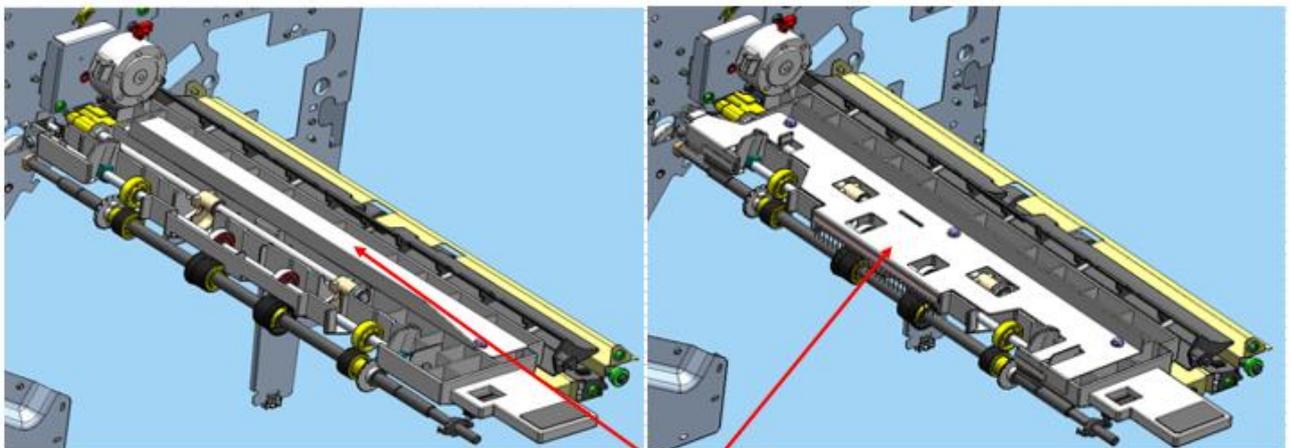
Change 1 : Shape of the supporting plate in the straight-path

Change 2 : Addition of discharge brushes in the straight-path

Reason : Higher tolerance against static electricity

D6882268 → D6882267
SUPPORTING PLATE:GUIDE PLATE:SHIFT:OPEN AND CLOSE:ASS'Y

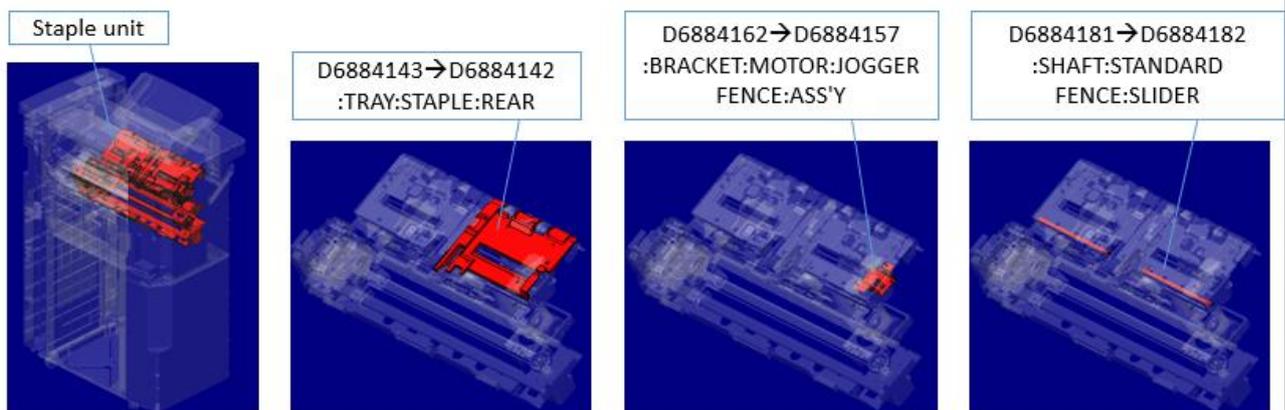
Change : Design modification of the stapler unit components

Reason : Higher stack alignment accuracy

NOTE: The above parts must be replaced as a set.

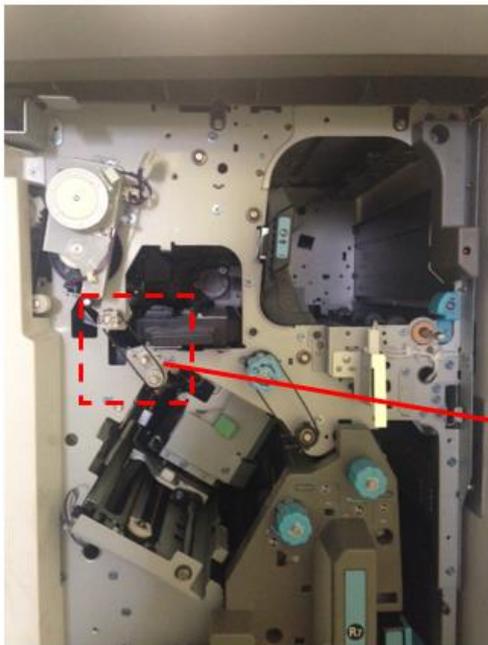
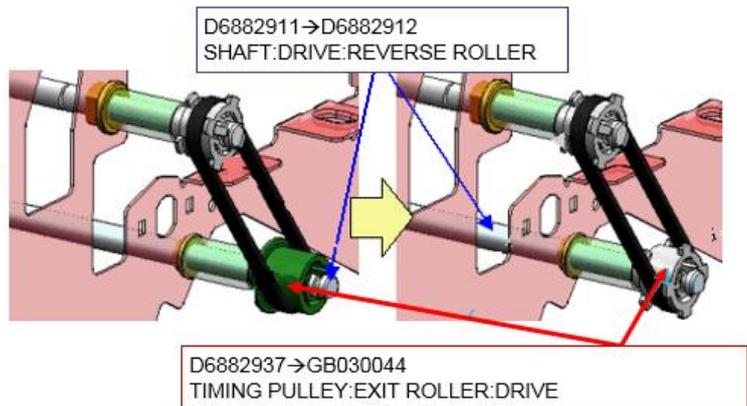
Change : Modification of the pulley on the paper exit drive shaft

Reason : For better engagement of the pulley with the belt

NOTE: The above parts must be replaced as a set.

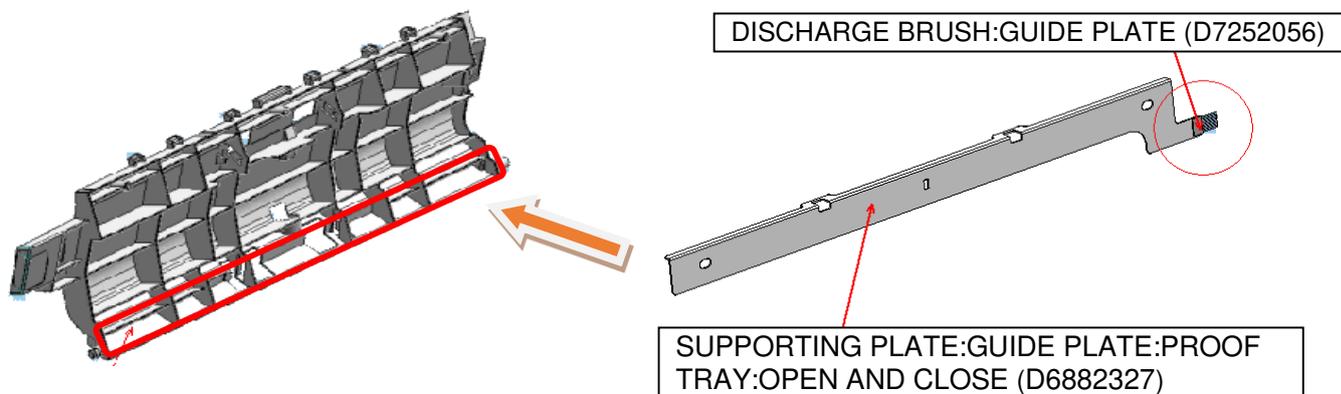
Change Reason : Guide plate of the proof tray
: For higher reliability

A supporting plate attached with a discharge brush (p/n: D7252056) was added to the modified guide plate.
