| Model: Katana | | Date:14-Jul-06 | No.: RB234015 |
| Subject: Service Manual Revision | | Prepared by: S. Ishizu | |

| Model: Katana (Bellini-C3) | | Date: 2-Aug-07 | No.: RB234036 |
| Subject: SR5000 Staple Rear Fence Broken | | Prepared by: M. Matsuda | |

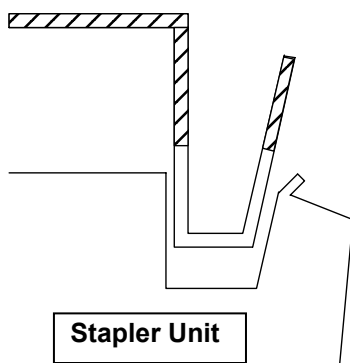
### Normal rear fence:

The bending angle of the rear fence was incorrect from the time of production. As a result, the stapler head may hit the rear fence repeatedly during stapling.

Check the rear fence at the next service visit, and replace the rear fence with a inspected rear fence (P/N **B2349905**, FOC) under these conditions:
