Subject: Firmware Release Note: Finisher_COLUMBIA		Prepared by: T. Tadokoro	
From: PPBG QA/Service Planning Dept.			
Classification:	<input type="checkbox"/> Troubleshooting <input type="checkbox"/> Mechanical <input type="checkbox"/> Paper path <input type="checkbox"/> Product Safety	<input type="checkbox"/> Part information <input type="checkbox"/> Electrical <input type="checkbox"/> Transmit/receive <input checked="" type="checkbox"/> Other (     )	<input type="checkbox"/> Action required <input type="checkbox"/> Service manual revision <input type="checkbox"/> Retrofit information <input type="checkbox"/> Tier 2

Model: B-C4		Date: 06-Apr-09	No.: RD059019
Subject: Booklet Finisher SR5020 staple position adjustment		Prepared by: T.Tadokoro	
From: PPBG QA/Service Planning Dept.			
Classification:	<input type="checkbox"/> Troubleshooting <input type="checkbox"/> Mechanical <input type="checkbox"/> Paper path <input type="checkbox"/> Product Safety	<input type="checkbox"/> Part information <input type="checkbox"/> Electrical <input type="checkbox"/> Transmit/receive <input type="checkbox"/> Other (     )	<input checked="" type="checkbox"/> Action required <input type="checkbox"/> S

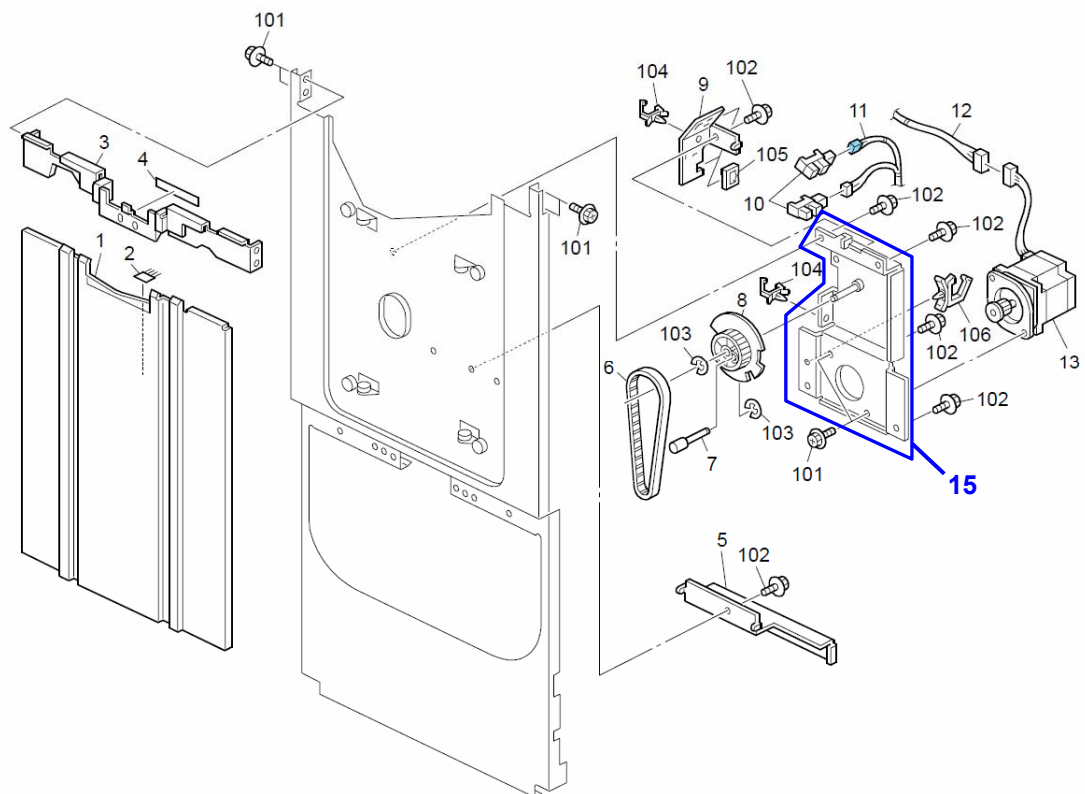
### 33.Shift Tray 3 (D434)

**Change:** A new service part has been added.

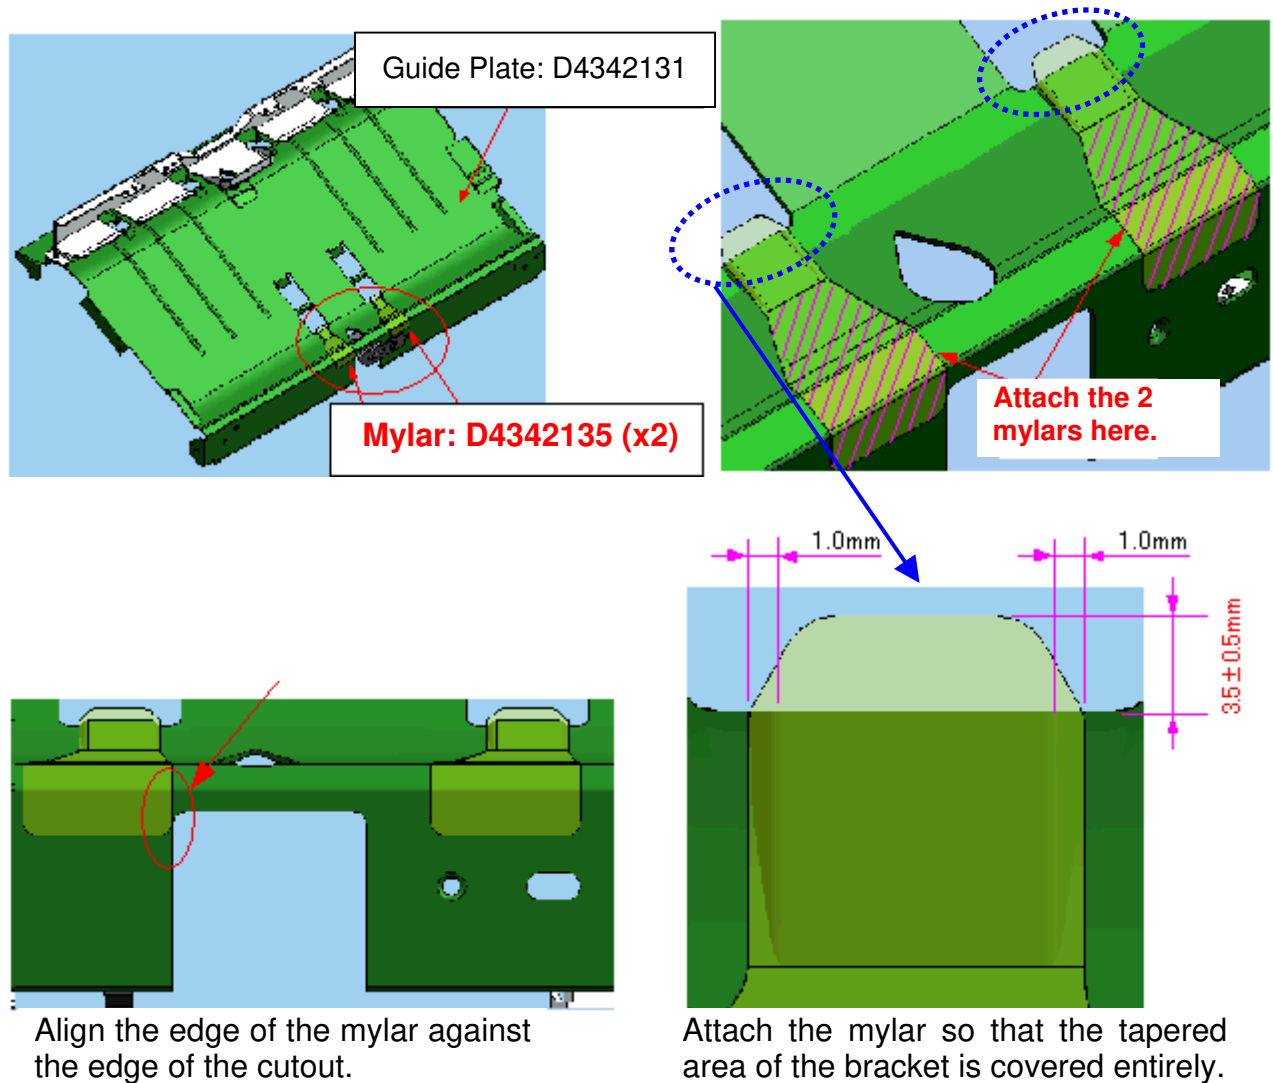
The diagrams below describe how and where to attach the mylars.

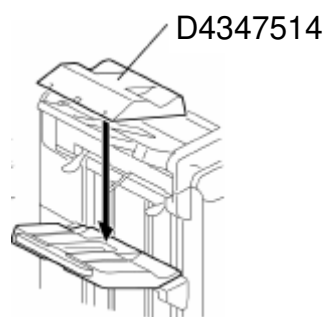
This tray should be used when stacking coated thin paper (less than 90gsm). It prevents sheets sticking together because a space is generated between the stacked sheets. Also, when not using this tray, it can be stored as shown below.

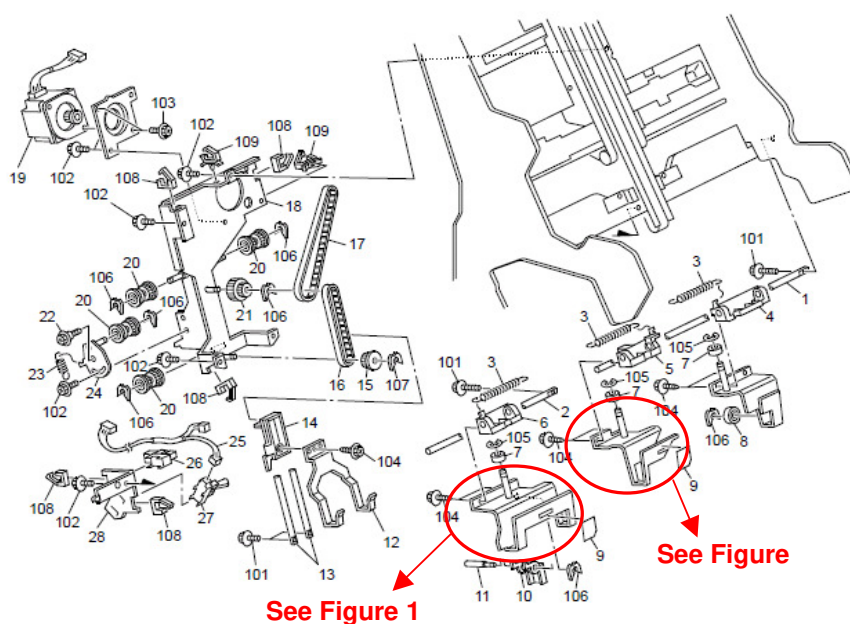
16. Staple Unit 6 (D434)

Mylars have been added to the bottom fences (front and rear) to prevent the stacks from bending, which could result in inaccurate stapling.

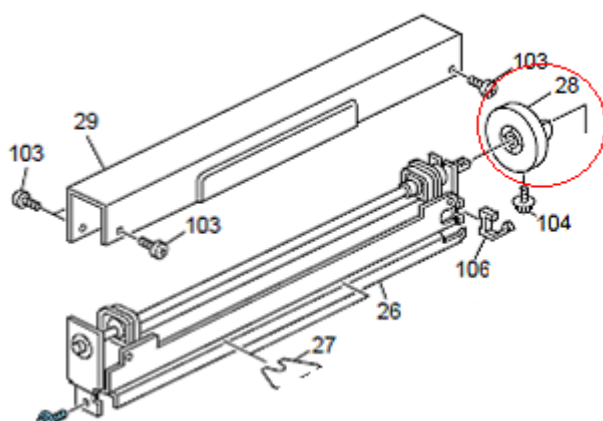
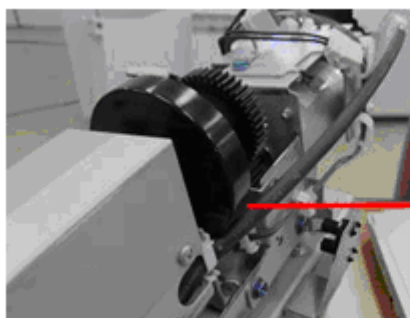
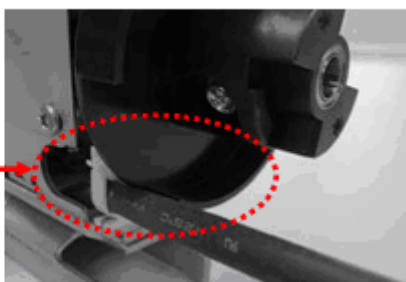
Harness cable of the punch unit is set incorrectly and is interfering with the ratchet (indexed 28), preventing the ratchet from retrieving its home position.

Route the harness cable correctly as described in the following section of the field service manual:

Installation > Booklet Finisher SR5020 (D434-17) > Punch Unit PU5020 NA, EU, SC (D449-17, -27, -28)

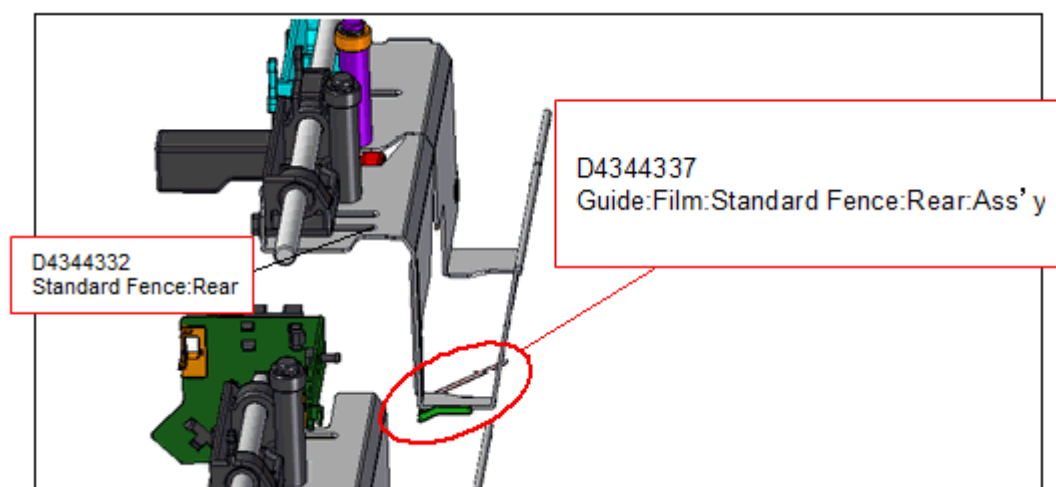
- The staple fence will be installed with the Stand and the Mylar from April 2012 mass production. If poor stapling occurs in the original units (which are installed with staple guides that appear as shown in the diagram below) due to slack in the staple stack, ~~procure the newly registered assembly parts D5124371 and D5124370.~~ **procure D5124372, D5124373, and D5124374.**

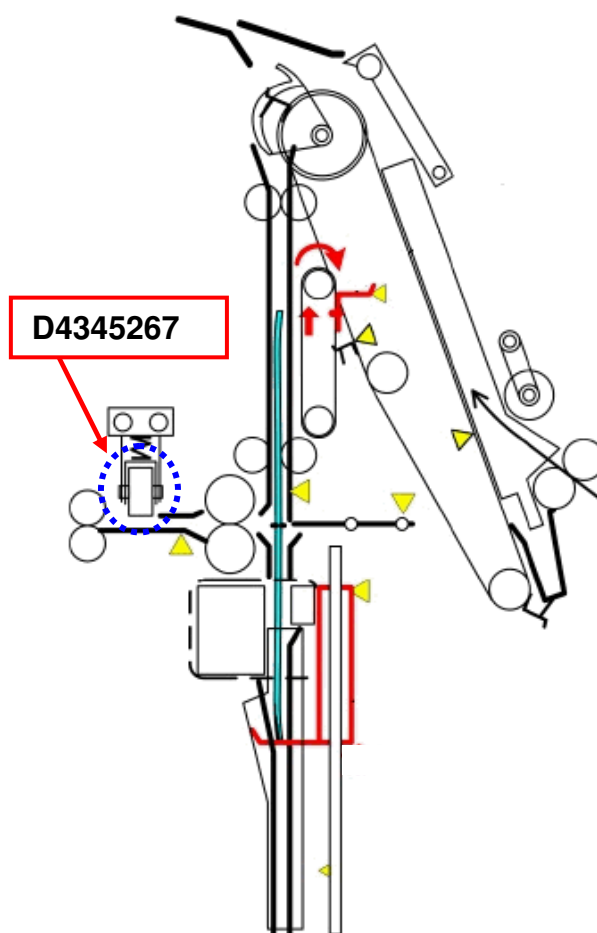
The Crease Roller circled in blue in the diagram below was registered with the p/n D4345267.

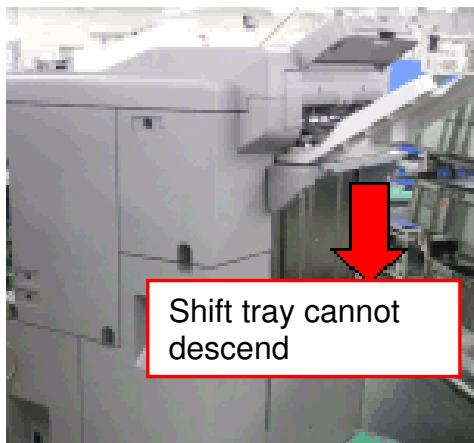
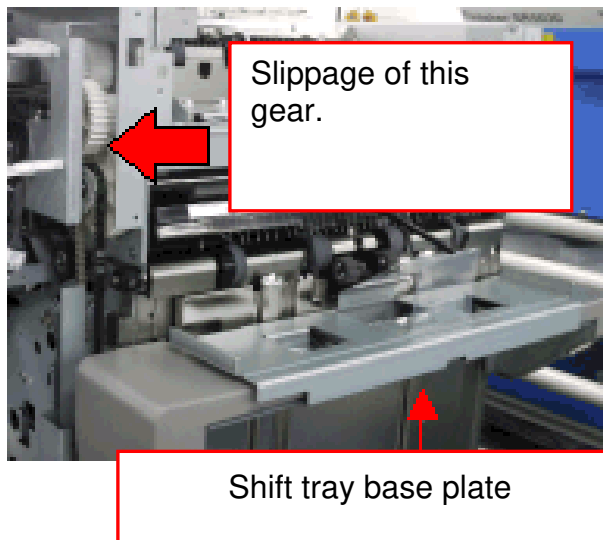
- SC750
- Shift tray cannot descend
- Slippage of the shift tray gear

The front and rear supporting plates, which are bent and welded to the base plate, were bent in incorrect dimensions due to a fault in the manufacturing process. This causes the washer installed on the side plate to interfere with the side plate rail, preventing the shift tray from descending.

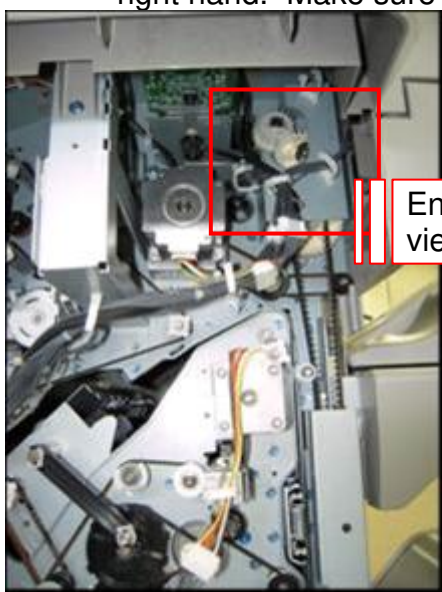
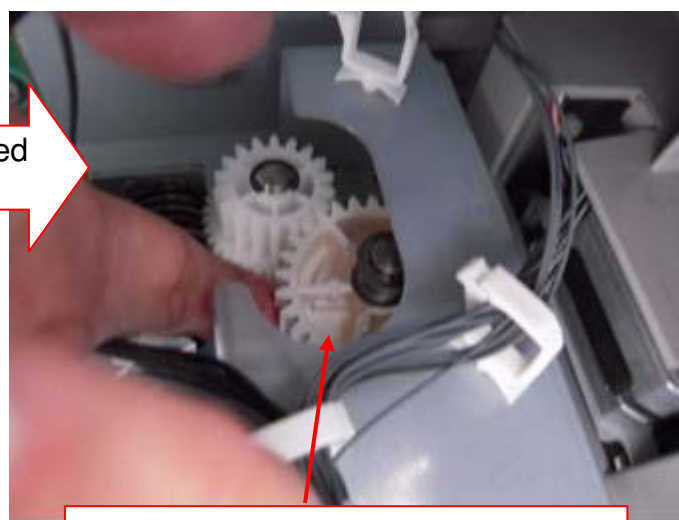
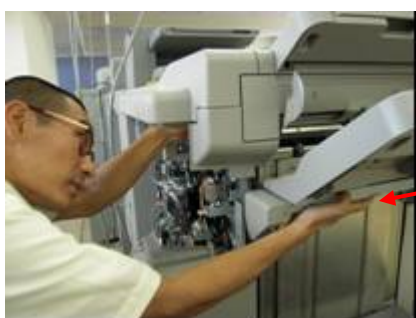
Disengage this gear by pulling it toward yourself with your left hand.

Support the tray with your right hand to prevent free-fall.

1. Turn off the machine power and disconnect the power cable from the Booklet Finisher.
2. Remove the rear cover. (Refer to the procedure in the field service manual.)
3. Support the shift tray with your right hand.
4. Disengage the gear that lifts/lowers the shift tray by pulling it with your left hand. (See the photos below.)

**CAUTION:** The shift tray could free-fall and result in damage if not supported with your right hand. Make sure to support the tray when disengaging the gear.
