Model: Finisher SR5040/SR5030 (D512/D513)	Date: 20-Jun-11	No.:RD512001a
---	-----------------	---------------

Model: Finisher SR5040/SR5030 (D512/D513)		Date: 16-Dec-11	No.: RD512002
Subject: Finisher SR5030 Exit Roller damage by End Fence.		Prepared by: Hiroaki H Matsui	
From: PP Service Planning Department 1G			
Classification:	<input checked="" type="checkbox"/> Troubleshooting <input type="checkbox"/> Mechanical <input type="checkbox"/> Paper path <input type="checkbox"/> Product Safety	<input type="checkbox"/> Part information <input type="checkbox"/> Electrical <input type="checkbox"/> Transmit/receive <input type="checkbox"/> Other ()	<input type="checkbox"/> Action required <input type="checkbox"/> Service manual revision <input type="checkbox"/> Retrofit information <input type="checkbox"/> Tier 2

Subject: Modification for smooth Shift Tray motion		Prepared by: K. Tsutsui	
From: 1 st PP Tech Service Sec., PP Tech Service Dept.			
Classification:	<input type="checkbox"/> Troubleshooting <input type="checkbox"/> Mechanical <input type="checkbox"/> Paper path <input type="checkbox"/> Product Safety	<input type="checkbox"/> Part information <input type="checkbox"/> Electrica

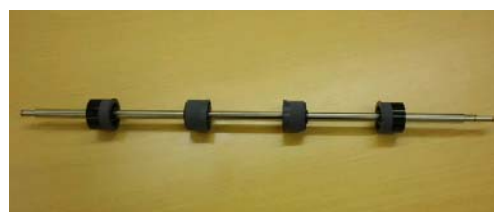
Countermeasure End Fence
(Length of the end fence edges has been shortened to prevent contact with the roller.)

Exit Roller Assembly

P/N D0749902 (End Fence Kit) consists of the above two parts.

NOTE: P/N D0749902 is supplied as a temporary countermeasure part.

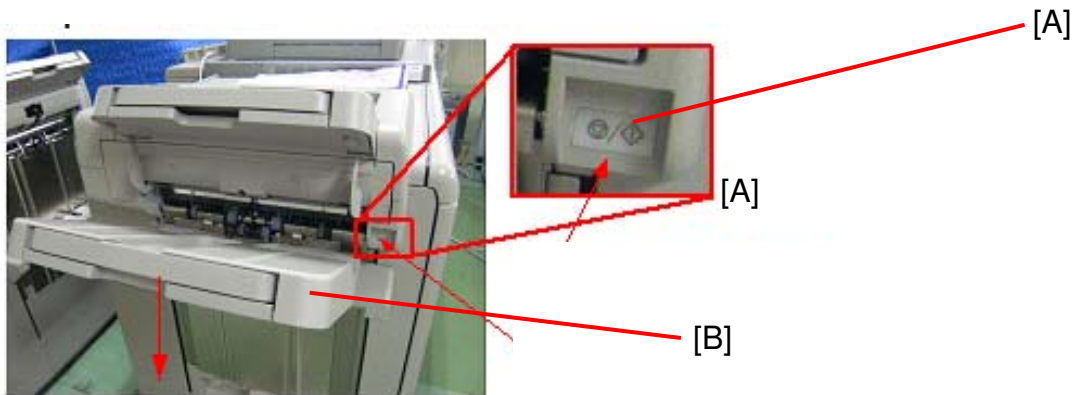
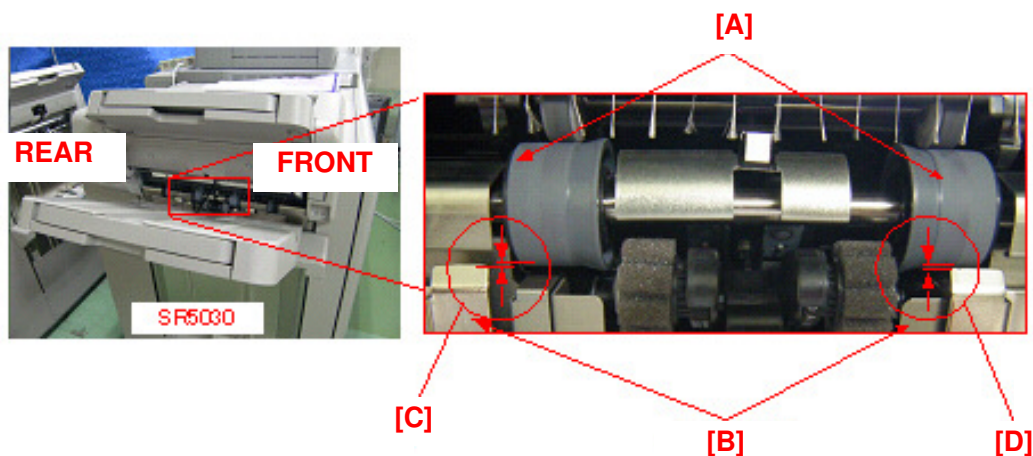
How to measure the gap

The photos above show the location of the related parts and the measurement locations.

[A]: Exit Rollers

[B]: End Fences

[C]: Gap at Rear Side (Measurement Points)

[D]: Gap at Front Side (Measurement Points)

2. If the measurements of the 2 locations [C] and [D] are 2.5 mm (approximately 0.1 inch) or smaller, replace the End Fence and the Exit Rollers with the countermeasure parts as a set.

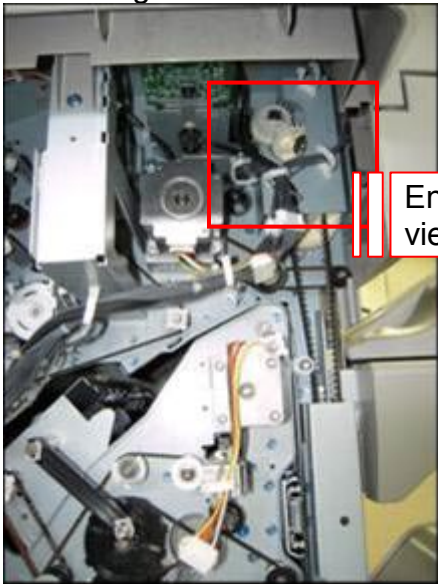
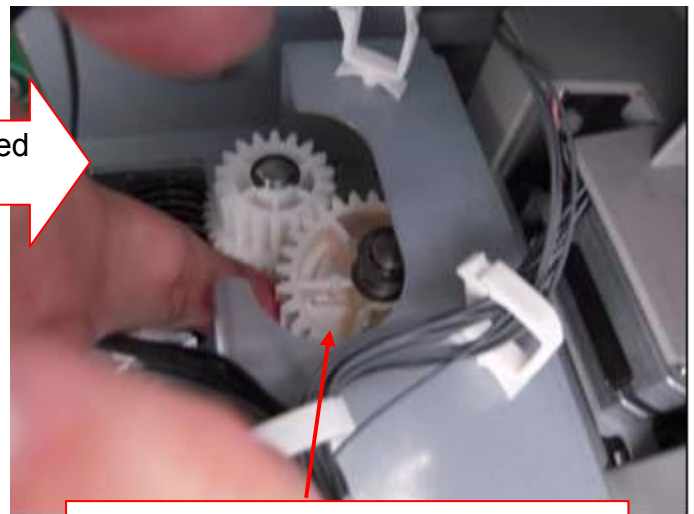
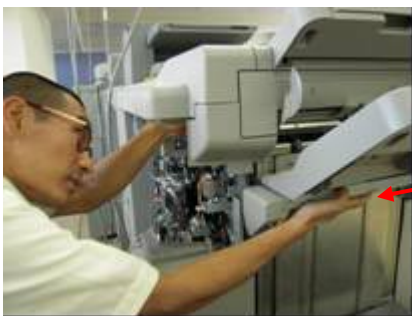
The front and rear supporting plates, which are bent and welded to the base plate, were bent in incorrect dimensions due to a fault in the manufacturing process. This causes the washer installed on the side plate to interfere with the side plate rail, stopping the shift tray from descending.

1. Turn off the machine power and disconnect the power cable from the Booklet Finisher.
2. Remove the rear cover. (Refer to the procedure in the field service manual.)
3. Support the shift tray with your right hand.
4. Disengage the gear that ascends/descends the shift tray by pulling it with your left hand.
(See the photos below.)

Disengage this gear by pulling it
toward yourself with your left hand.

Support the tray with your right
hand to prevent free-fall.

5. With the gear disengaged, check if the shift tray supported with your right hand can smoothly descend and ascend.
