| Model: Booklet Finisher SR5060 (D734) | Date: 7-May-15 | No.: RD734001 |

| Subject: Part change – Modified exit roller to prevent roller marks in saddle-stitched booklets | | Prepared by: T. Suzuki | |

| Subject: Request for rework to prevent Jam109 | | Prepared by: Shinnosuke Sasaki | |

| Subject: Booklet Finisher SR5060: Creases on the Leading Edges of Saddle-Stitched Sheets | | Prepared by: Hiroaki H Matsui | |

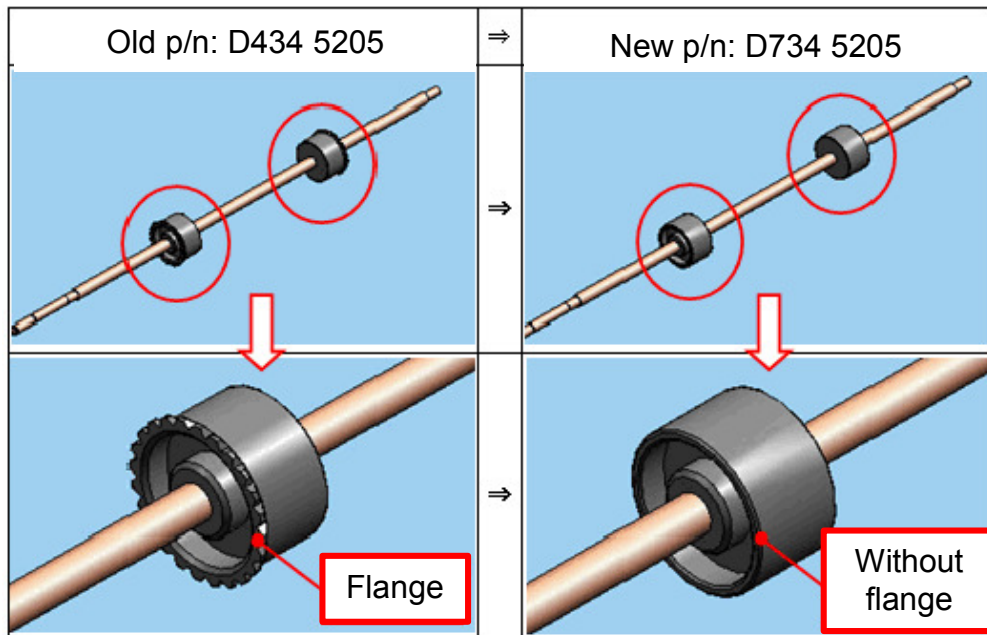
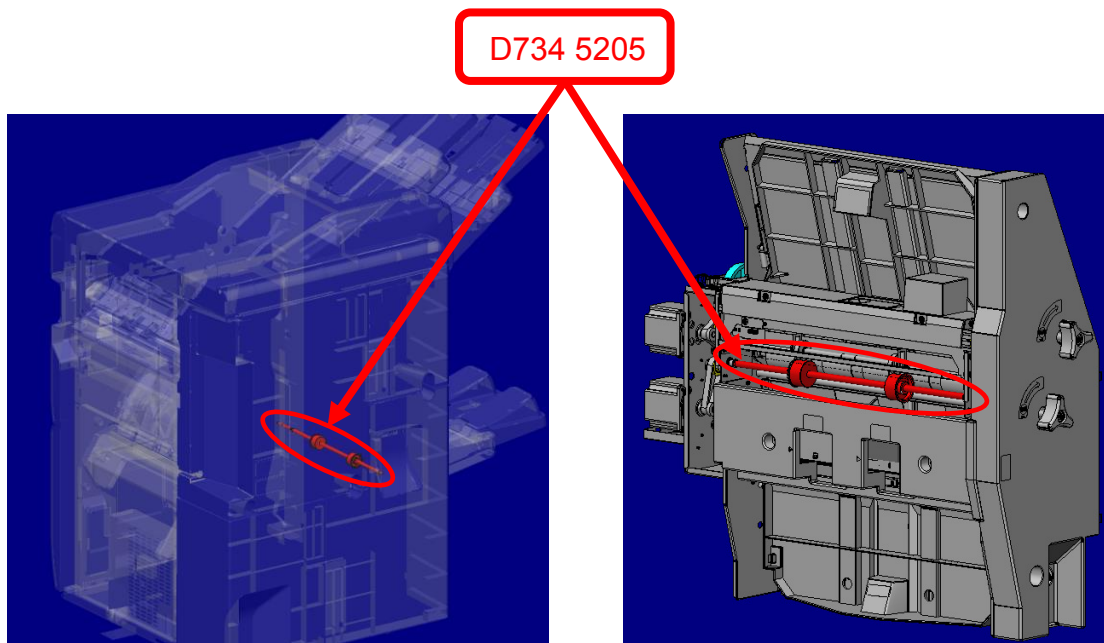
Roller marks appear along the feed direction until about halfway down from the leading edge in saddle-stitched booklets.

The flanges of the exit roller press the paper.

The exit roller was modified. The new exit roller does not have the flange.

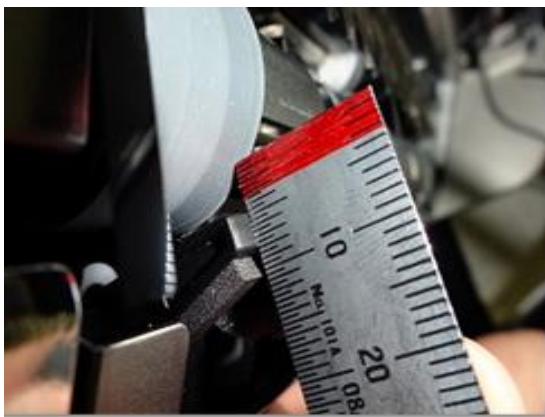
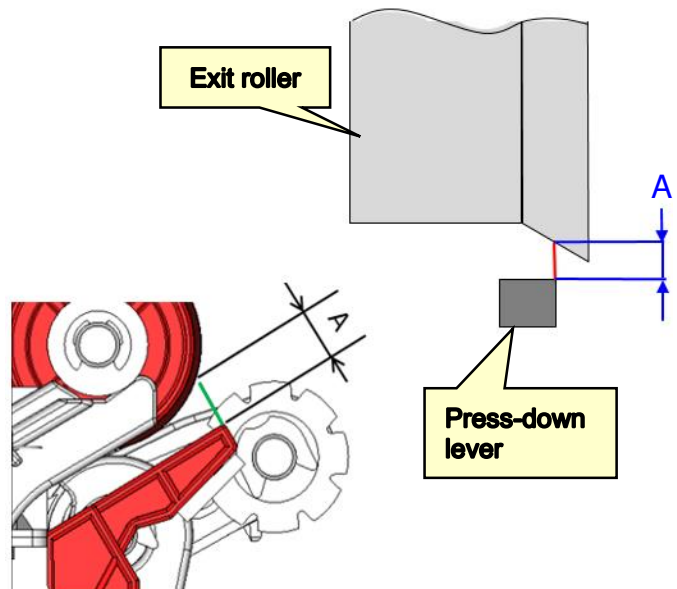
There are two rollers and levers; one at the operator side and another at the non-operator side. Make measurements at both sides.

**If the distance is 3.5mm or longer:**

→ No action required.

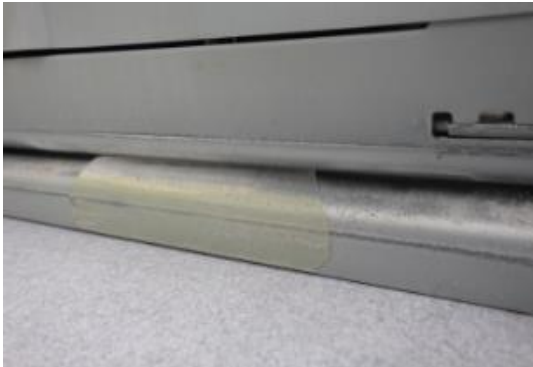
Printing frequently on paper containing abundant calcium carbonate abrasives and eventually damages the Mylar sheets attached to the guide plate of the punch unit, and causes Jam 125 and SC720-25.

5. Check the condition of the Mylar sheets.  
Good

6. If the Mylar sheets are worn or damaged, remove the sheets and clean the surface of the guide plate to where the sheets attach with alcohol and attach the new sheets by taking note of the following points.

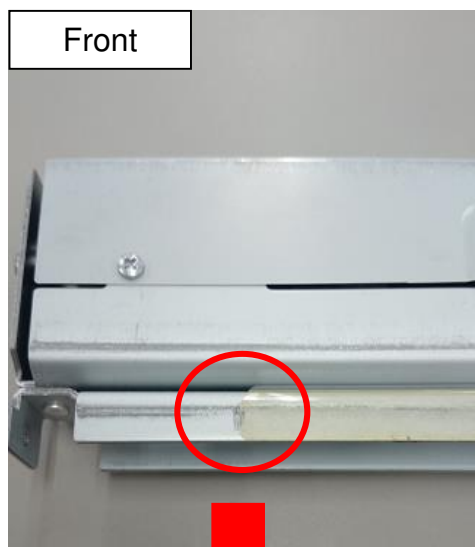
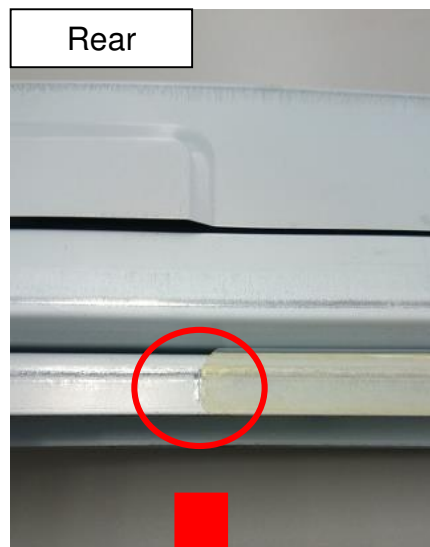
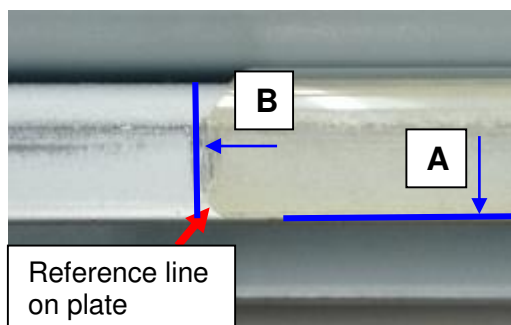
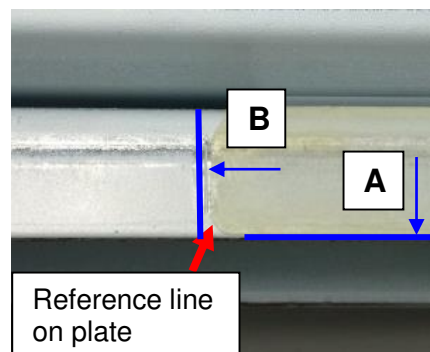
Vertical direction [A]: 1mm or less against the edge of the plate  
Mylar must not protrude from the edge.

Horizontal direction [B]: 1mm or less from the reference line on the plate

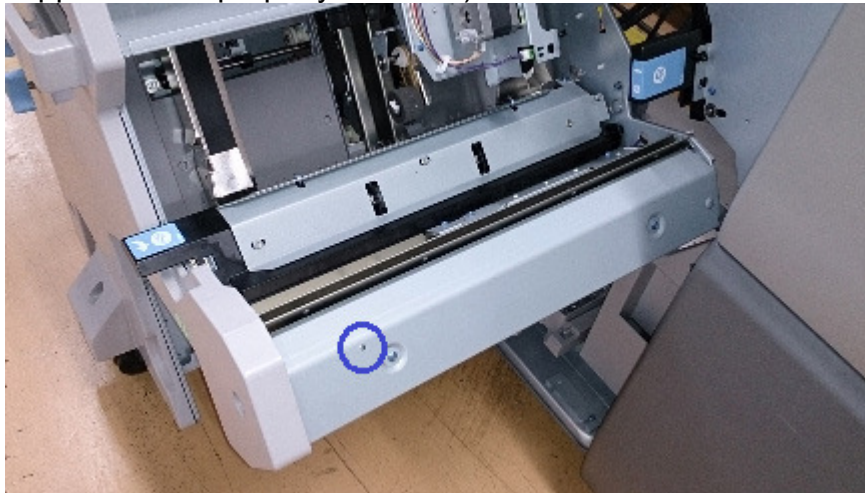
1. Pull out the stack/staple unit and confirm that the screw has been removed from the screw hole circled in blue. (This screw should be removed at installation. Running the machine with this screw fastened will cause SC720-35, because the trailing edge stopper will not properly function.)

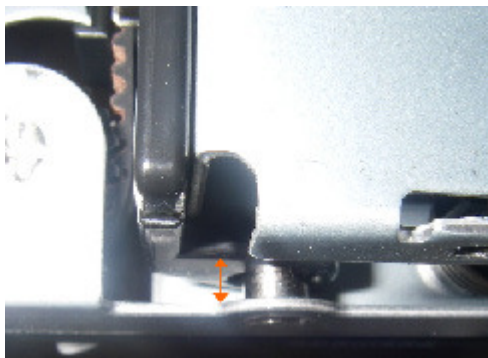
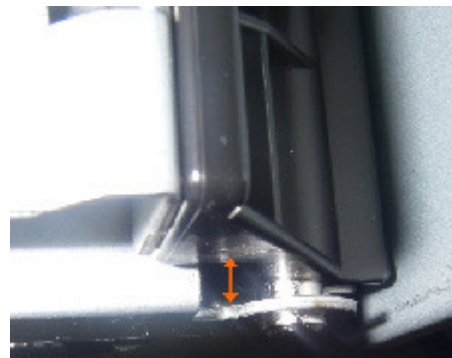
1. Measure the gap between the top piece of the corner stapler stack unit and its supporting plate at both the front and rear sides with a scale.

\* The gap should be approximately 2.6mm +/- 0.8mm at both the front and rear sides.

**Note:** If the difference in the gap between the front and rear is larger than 2.0mm, an excess load could be put on the corner stapler stack unit, causing the SC.

Do 'Adjustment **A**' if the gap **at the front is larger** than at the rear.  
Do 'Adjustment **B**' if the gap **at the rear is larger** than at the front.

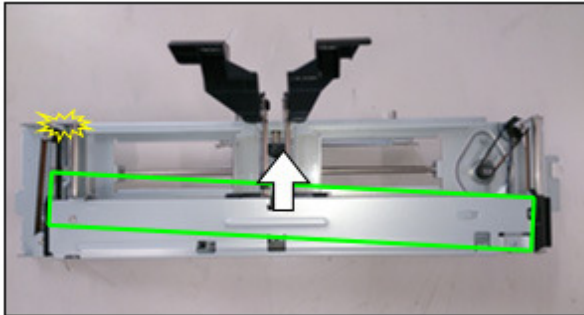
**A: Gap is larger at front**

- Larger gap at front: Moving part collides with the frame during operation, causing a motor overload.
- Larger gap at rear: Moving part collides with the frame when returning to home position, causing a motor overload.

Adjustment A: *If the gap **at the front** is larger than at the rear.*

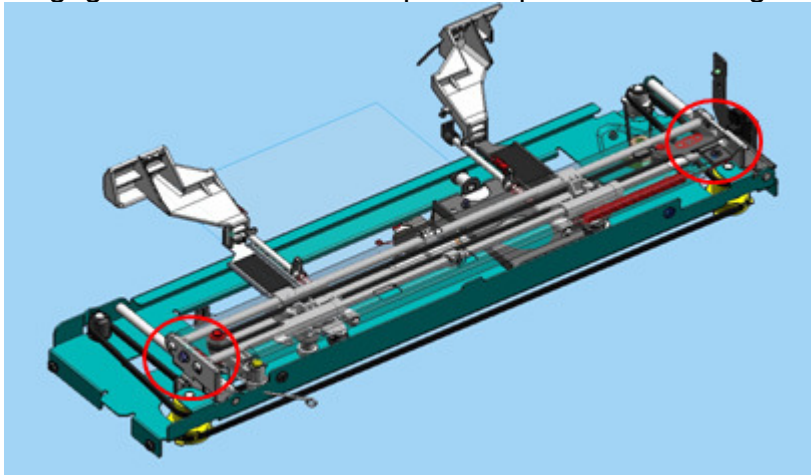
- B-1. Remove the corner stapler stack unit. (See 'Adjustment A' above for the procedure.)
- B-2. The timing belt could be fixed on the wrong groove at either of the two locations circled in red, causing an uneven tension. If so, slide the timing belt so that its engagement with the black piece slips to a different groove on the belt.

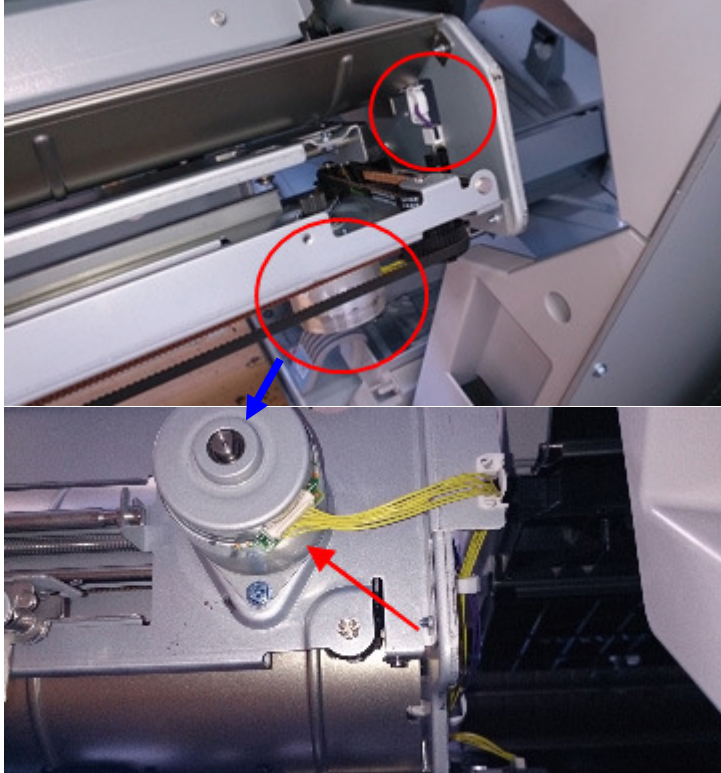
**Note:** Incomplete connection or damaged cables will cause Jam126 and SC720-35.

1. Confirm a secure connection of the cables connected to the corner stapler stack unit motor and the home position sensor.

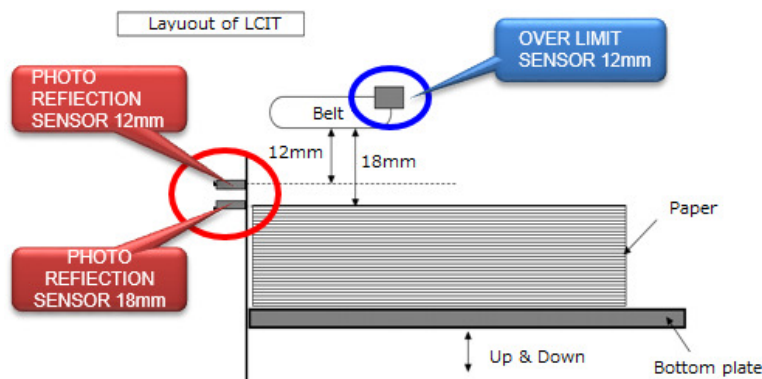
SC50X-05 Paper Feed Tray Error (Bottom plate ascending too much) may occur.  
This SC shows when the over limit sensor turns ON.

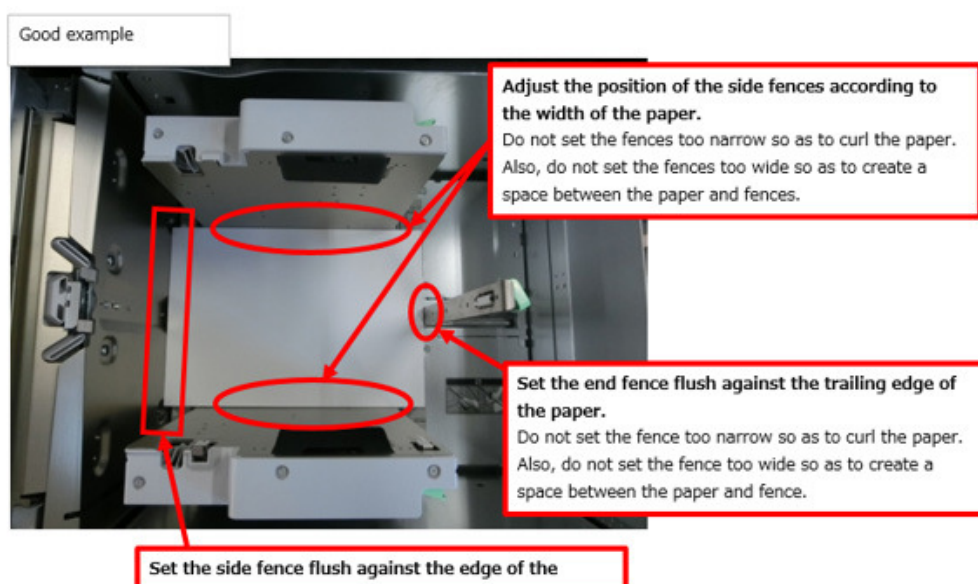
Adjust the side or end fence at the appropriate position according to the paper size.  
If there is deformation of side or end fence, modify that. Shown below are good and bad examples of paper set on the tray. Refer to the "Good" example to make the tray adjustments.

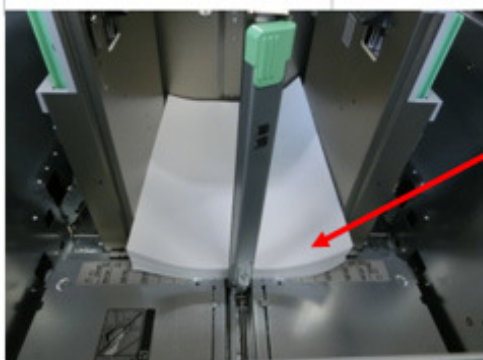
Bad example 4

Side fence is too narrow, curling up the paper.

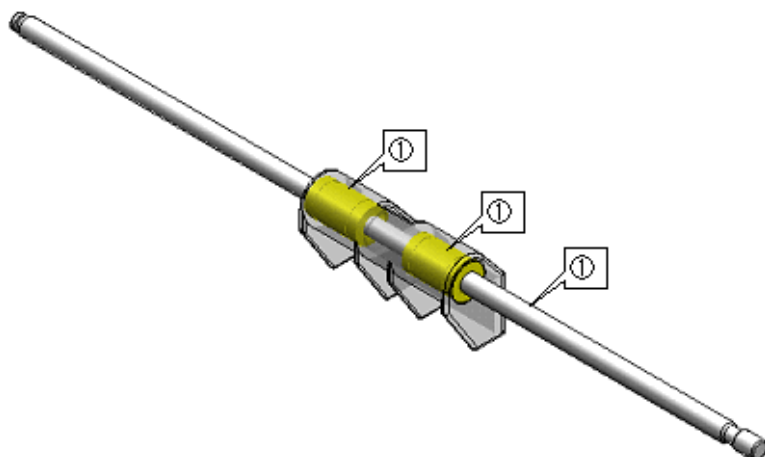
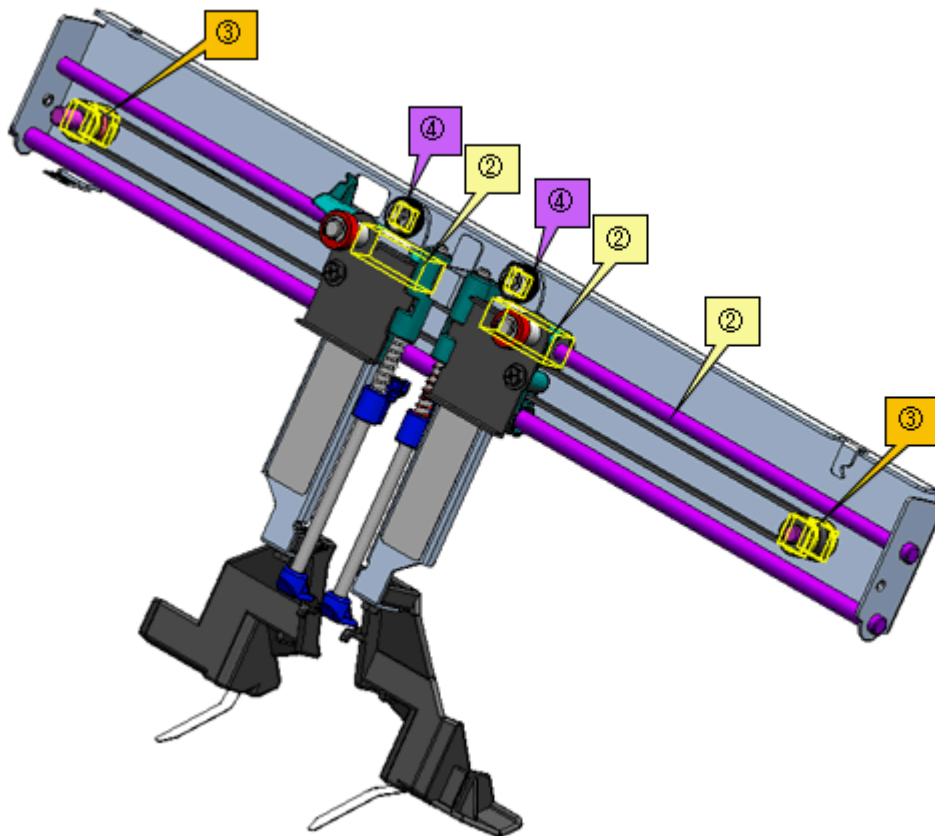
- ① The bearings on the slider shaft were replaced with bushings.
- ② The bearings in the slide plate were replaced with bushings.
- ③ The pulleys for the belt drive were replaced with ball bearings.
- ④ The vibrating plate rollers were replaced with ball bearings.

**Reason:** For smooth movement of the vibrating plate, to prevent SC720-35 (Finisher: Stack plate motor 1 error)

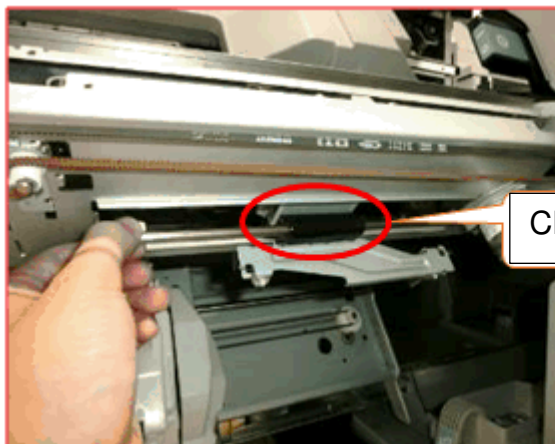
Check the slider shaft.

Old: The outer race of the bearing touches the shaft.

New: A black bushing touches the shaft.

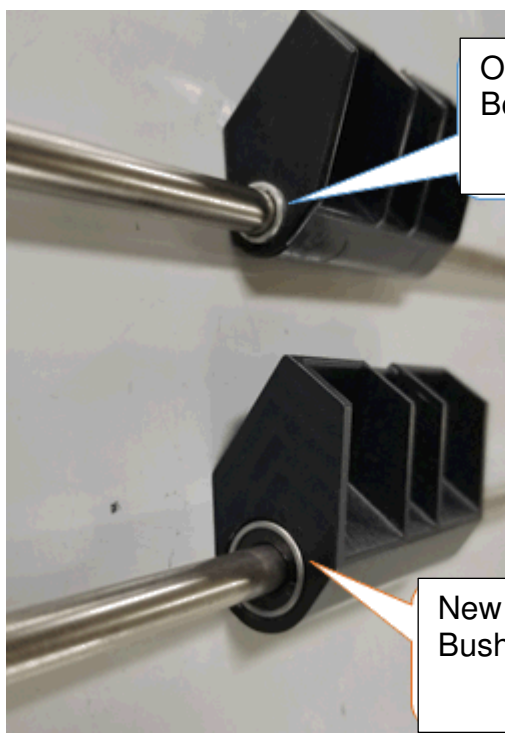
Old  
Bearing

New  
Bushing

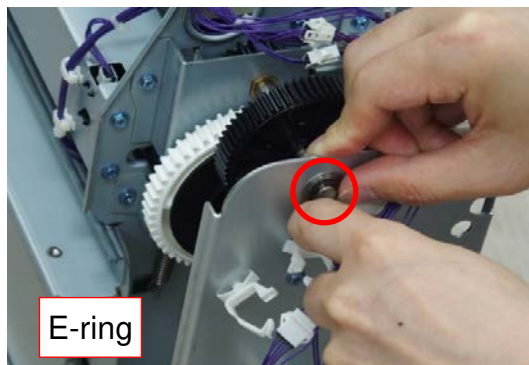
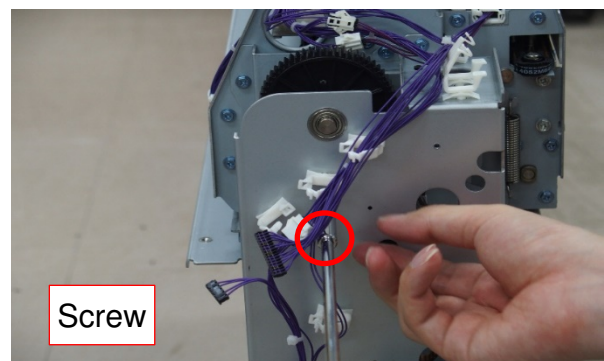
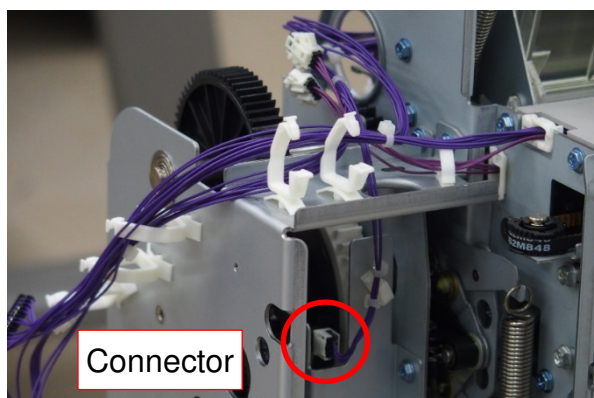
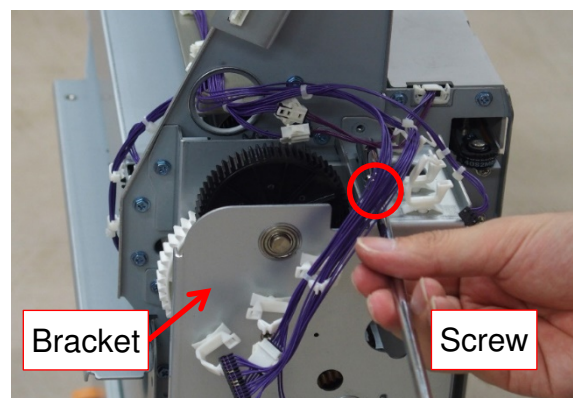
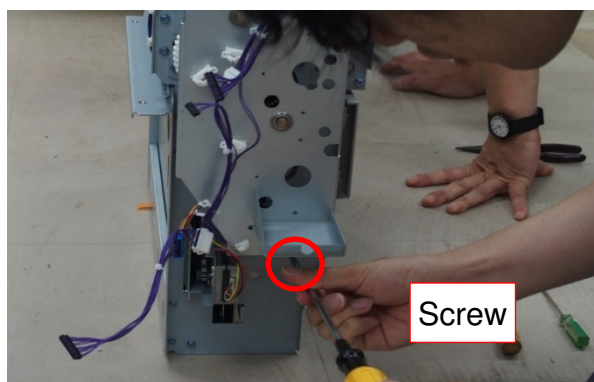
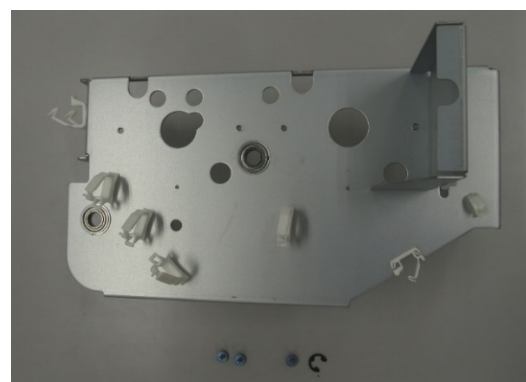
3-4. E-ring (x1), Screw (x3), Connector (x1), Bracket (x1)

**NOTE:** Work carefully not to catch the connector when removing the bracket.

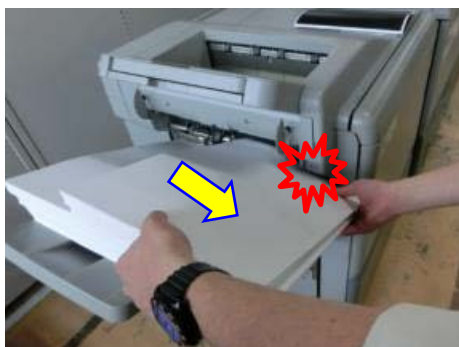
Excess load is put on the shift tray motor for the following reasons.

- 1) The media is dense and heavy.
- 2) A portion of the stack is removed from the shift tray toward the front (operator side) without pressing the Emergency Shift Tray Stop switch and causes the following:
  - The operator is unable to remove the stack smoothly and places it on the shift tray again.
  - The removed portion of the stack gets caught in between the top of the remaining stack and the cover.

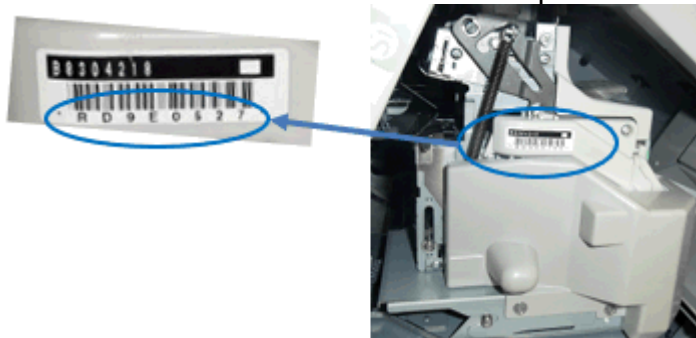
How to check the serial number of staple unit

Note: The Staple unit serial number in Finisher is the factory default number.

If there is a Staple unit replacement history, service parts are installed, so please verify the service part serial number as well!

Check the serial number of the Staple unit, and if the number is target, then replace the unit to the following part number.
