Model: Martini-C1

Subject: Jogger Fence Adjustment		Prepared by: Y.Urushihara	
From: 1st Tech. Support Sec. Service Support Dept.			
Classification:	<input type="checkbox"/> Troubleshooting <input type="checkbox"/> Mechanical <input type="checkbox"/> Paper path <input type="checkbox"/> Other ()	<input type="checkbox"/> Part information <input type="checkbox"/> Electrical <input type="checkbox"/> Transmit/receive	<input type="checkbox"/> Action required <input checked="" type="checkbox"/> Service manual revision <input type="checkbox"/> Retrofit information

Model: Martini-C1		Date: 4-Oct-02	No.: RB064005
Subject: Finisher screw detaches from slide rail bracket		Prepared by: K. Miura	
From: Technical Services sec. Service Planning Dept.			
Classification:	<input checked="" type="checkbox"/> Troubleshooting <input type="checkbox"/> Mechanical <input type="checkbox"/> Paper path <input type="checkbox"/> Other ()	<input type="checkbox"/> Part information <input type="checkbox"/> Electrical <input type="checkbox"/> Transmit/receive	<input type="checkbox"/> Action required <input type="checkbox"/> Service manual revision <input type="checkbox"/> Retrofit information

Model: Martini-C1

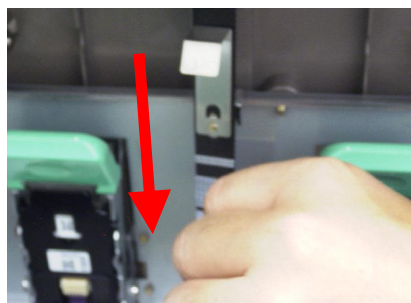
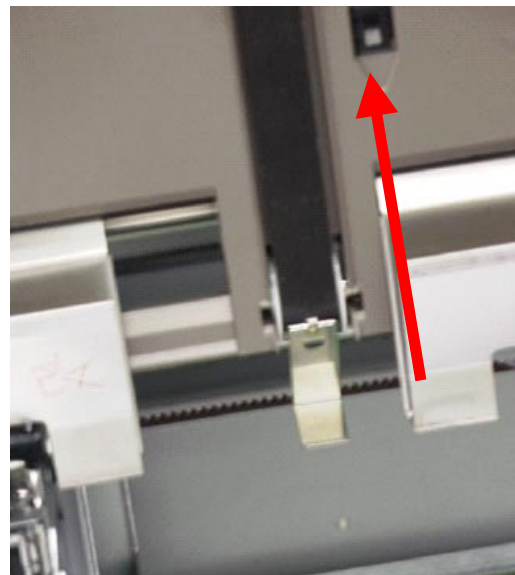
1. Move the belt hook down to the position shown in the photograph to the right by moving the stack feed out belt on the rear side of the unit by hand.

Important: Do not move the belt by the hook itself. Also, be sure to move the belt in the correct direction, shown by the arrow in the photograph below.

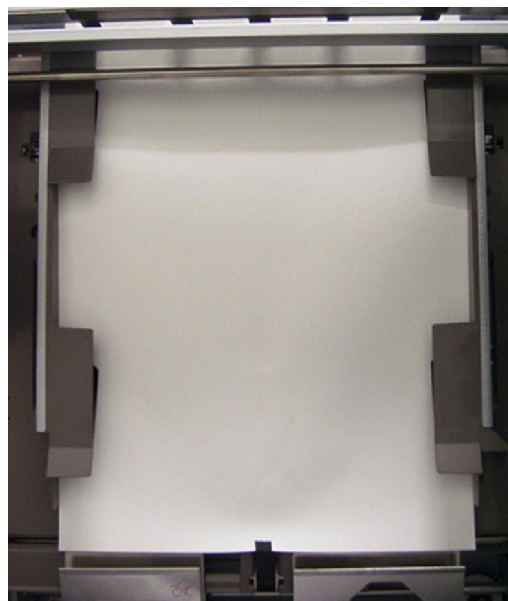
2. Insert the adjustment board (B4689003) between the jogger fences.

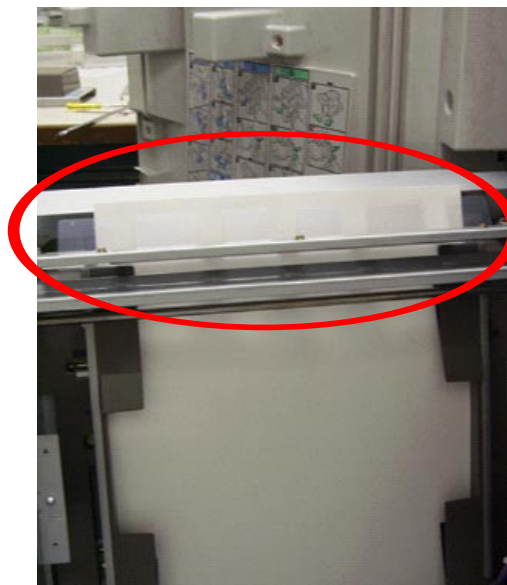
3. By manually moving the stack-feed out belt on the rear side of the unit, bring the adjustment board up until its edge is about at the top edge of the upper stay.

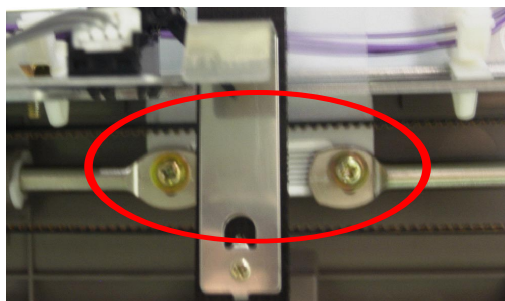
4. Loosen the 2 screws for the lower jogger shafts.

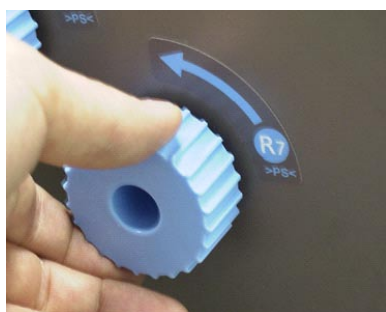
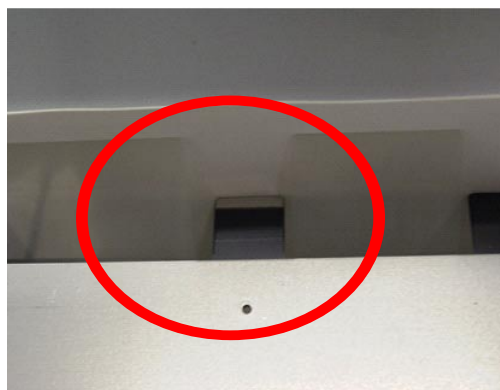
5. Rotate the R7 knob until the upper stay lightly contacts the adjustment board.

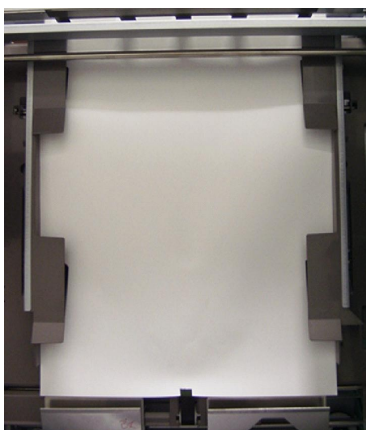
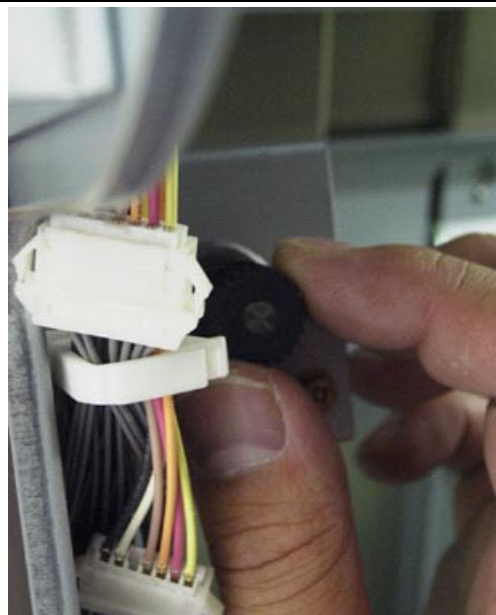
6. By turning the motor pulley (black knob), bring the fences together until they are roughly parallel to one another.

Note: At this point, the fences should not be tight against the board's edges.

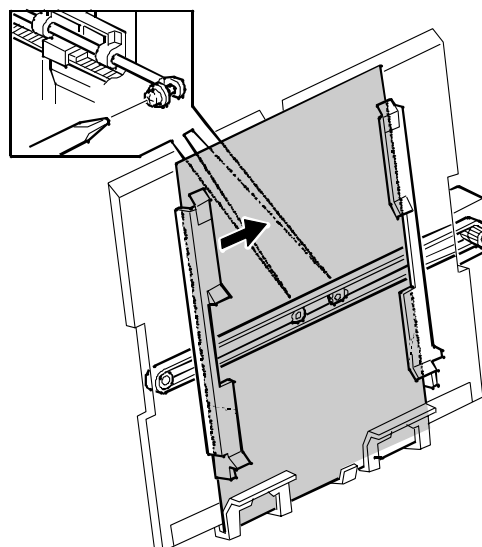
7. Bring the board flush against the rear jogger fence.

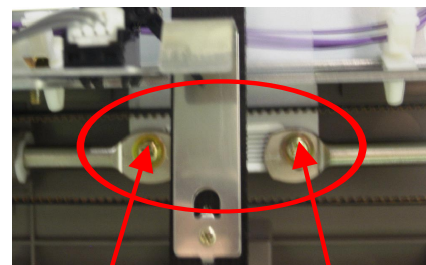
8. Adjust the **rear** jogger shaft position until the top edge of the upper stay and upper edge of the board are parallel to one another.

Left edge height + Right edge height = **0.5mm or less.**

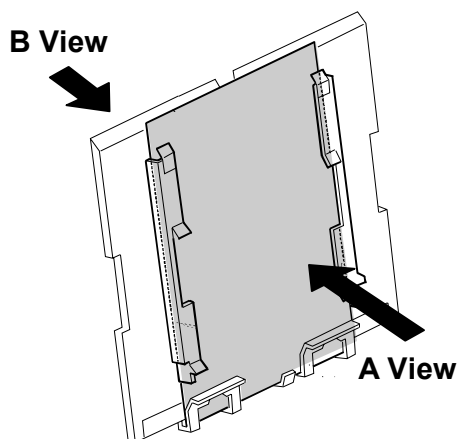
9. Tighten the screw for the rear jogger shaft all the way

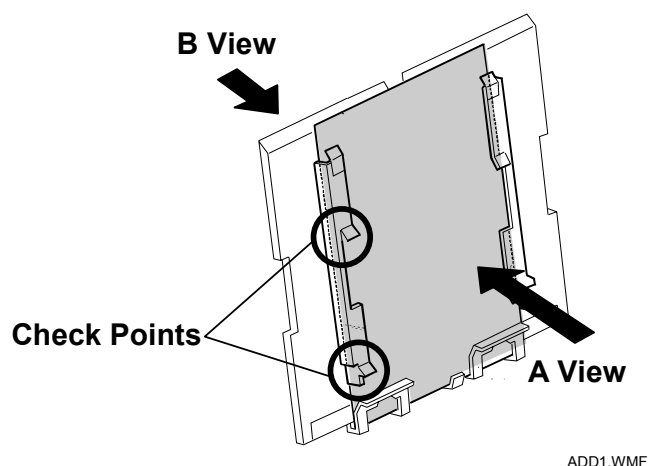
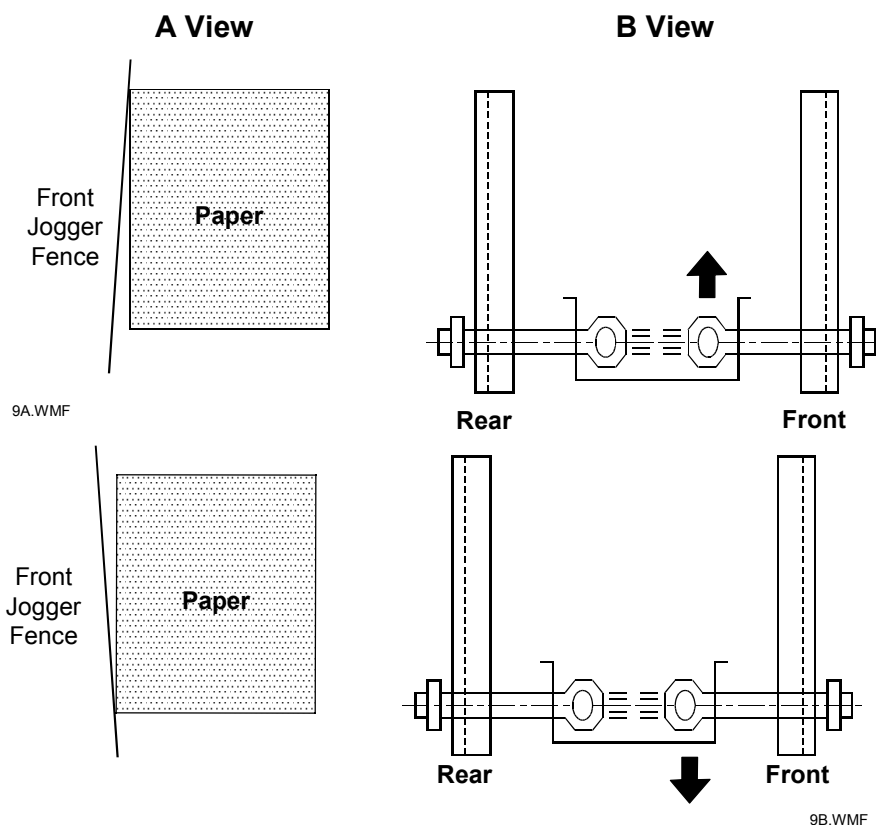
10. Bring the **front** jogger fence flush against the edge of the board, then adjust the front fence shaft until the board/fence gaps on both sides are:
Board/fence gap (top + bottom) = **0 - 0.5mm**.

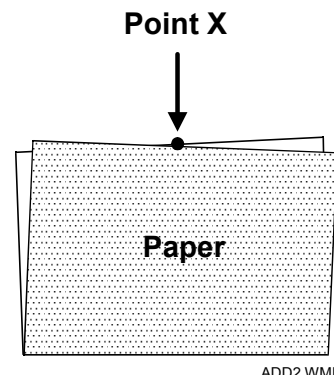
15. Adjust the folding position using **SP6902** until the two edges intersect in the middle (point X). This will minimize vertical folding skew, i.e. bring the leading/trailing edges of the sheets closer together.

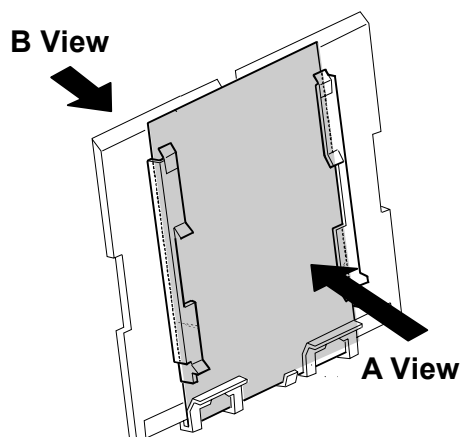
- 1) If A/B are over 2mm, **raise** the rear jogger fence shaft and re-secure the shaft in place. Then, loosen the screw for the front jogger fence shaft, **lower** the shaft to bring the front jogger fence flush against the paper, and re-secure the shaft in place.

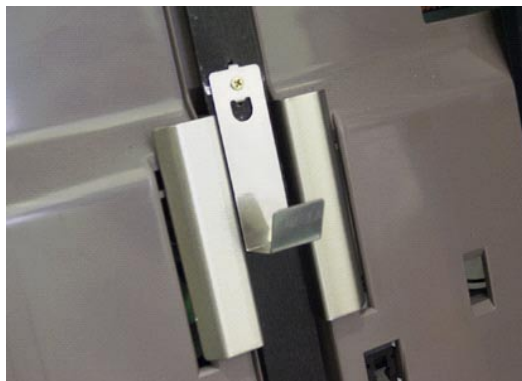
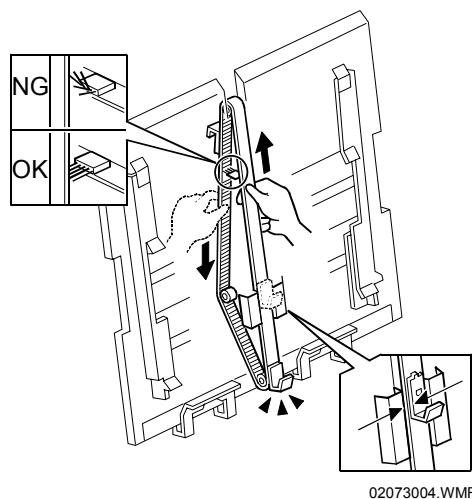
19. Bring the belt hook to the position shown in the photograph below then adjust the hook until it is parallel to the belt itself.

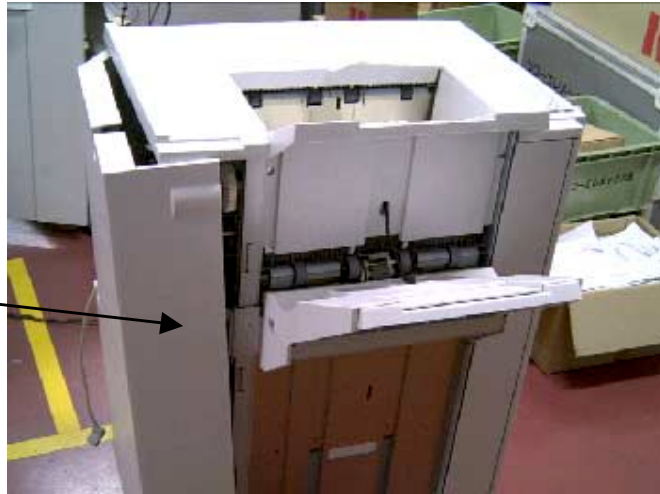
[A]

1. Remove the rear cover [A].

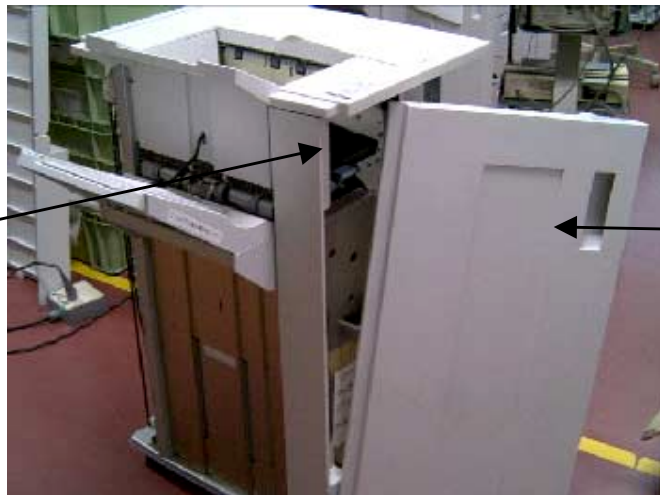
[C]**[B]**

2. Remove the front door [B] by lifting up the upper hinge area [C], then removing the door shaft from its pivoting hole.

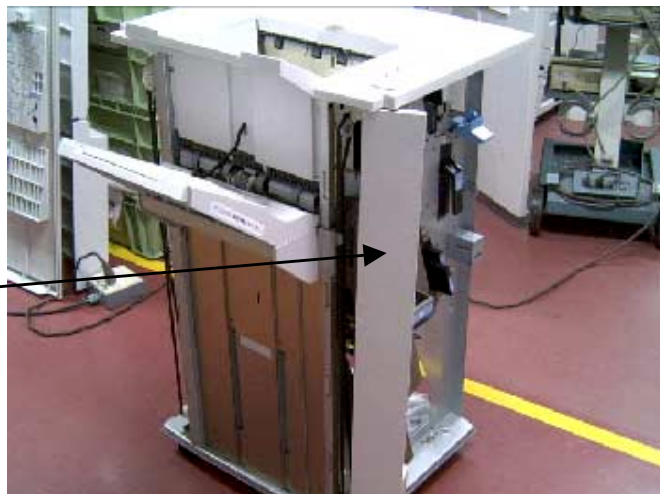
[D]

3. Remove the front right cover [D].

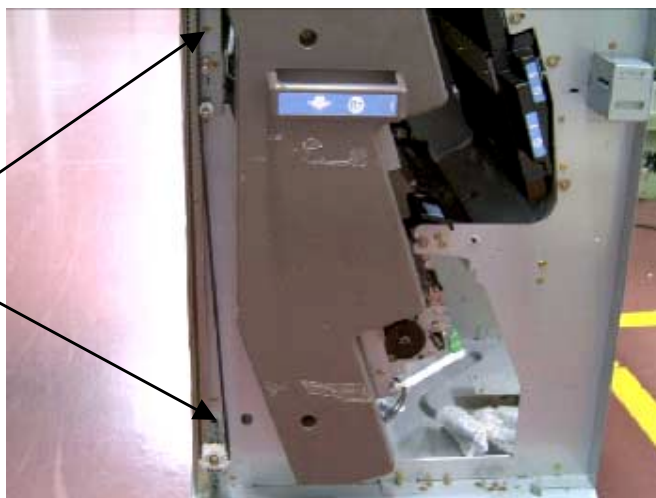
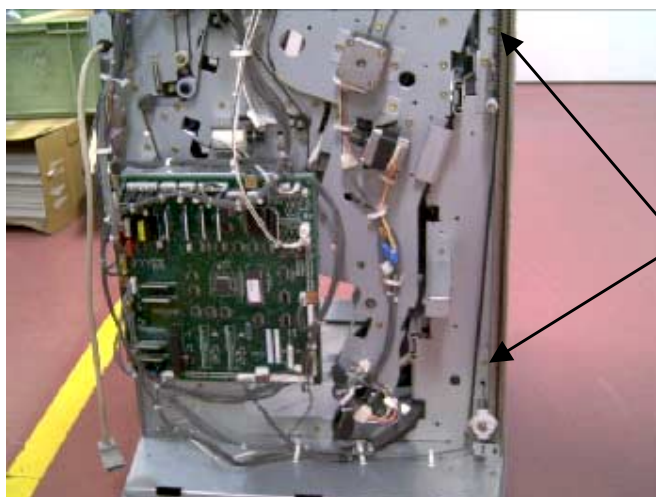
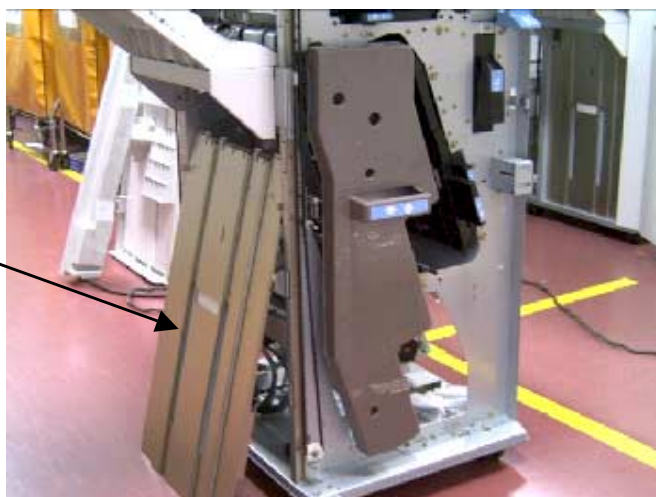
4. Remove the end fence [E] by first removing the 2 screws [F] on the front and rear plates (2 screws [G]), then pulling the lower portion of the fence outward to disconnect it from the machine.
