Model: Model Sh-MF1 PFU option		Date: 24-Feb-12	No.: RM375001
Subject: Part catalog correction		Prepared by: T.Hirai	
From: 3rd Tech Service Sect., MFP/P Tech Service Dept.			
Classification:	<input type="checkbox"/> Troubleshooting <input type="checkbox"/> Mechanical <input type="checkbox"/> Paper path <input type="checkbox"/> Product Safety	<input checked="" type="checkbox"/> Part information <input type="checkbox"/> Electrical <input type="checkbox"/> Transmit/receive <input type="checkbox"/> Other ()	<input type="checkbox"/> Action required <input type="checkbox"/> Service manual revision <input type="checkbox"/> Retrofit information <input type="checkbox"/> Tier 2

Model: Model Sh-MF1 (PFU)		Date: 28-Mar-12	No.: RM375002
Subject: Check points at installation (Tray side fences or Paper end sensor were detached)			Prepared by: T.Hirai
From: 3rd Tech Service Sect., MFP/P Tech Service Dept.			
Classification:	<input type="checkbox"/> Troubleshooting <input type="checkbox"/> Mechanical <input type="checkbox"/> Paper path <input type="checkbox"/> Product Safety	<input type="checkbox"/> Part information <input type="checkbox"/> Electrical <input type="checkbox"/> Transmit/receive <in

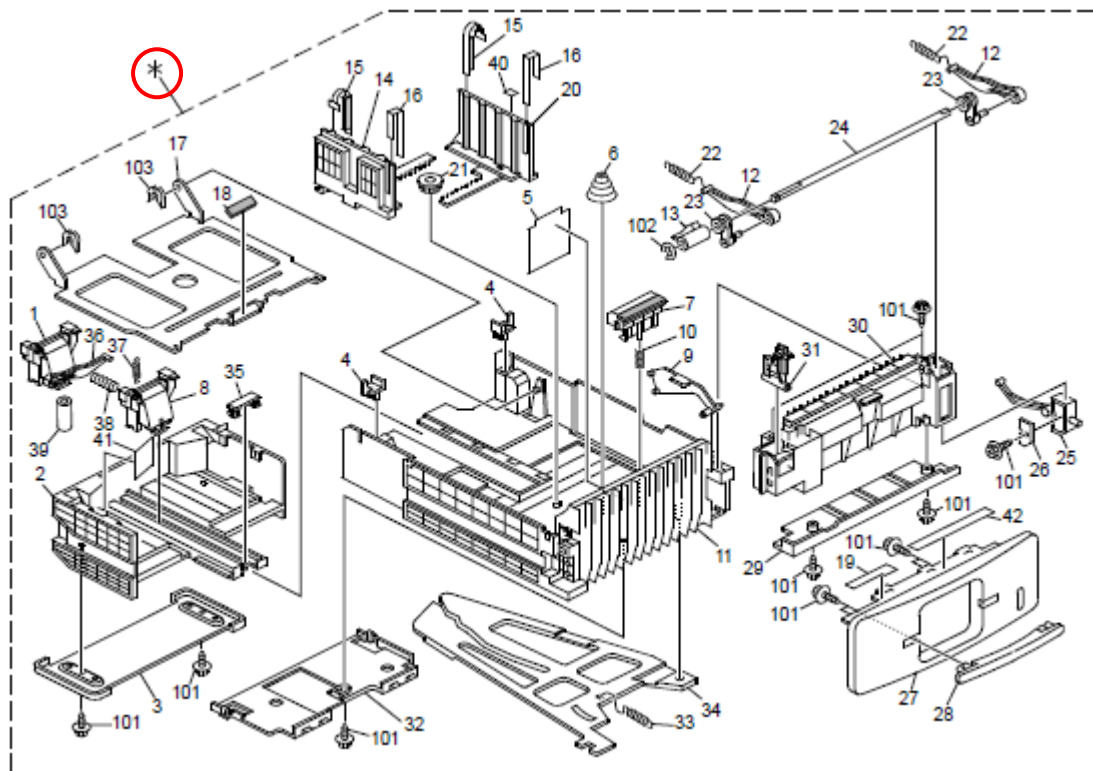
Part Number	Description	Q'ty	Int	Page	Index	Note
M3752550	PAPER TRAY:ASS'Y	1	-	5	*

Change/ Reason: This part number was missing from the parts catalog.

Important: *If there is no available screw hole in the user's tray, replace the tray with the following new part (which contains the required screw holes).*

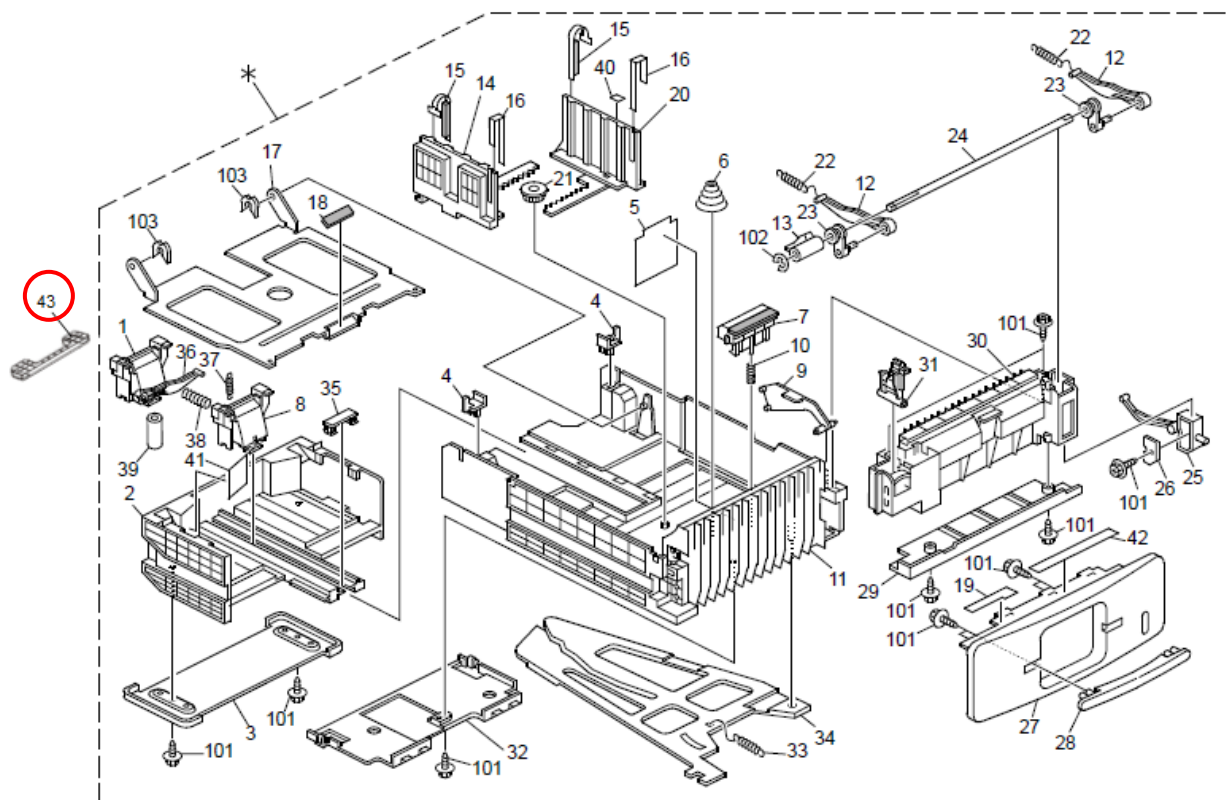
2.Paper Feed Unit 2 (M375/M376)

Old part number	New part number	Description	Q'ty	Int	Page	Index	Note
	M0212564	END FENCE:SPACER	0-1	-	5	43

Change: A spacer was added.

Reason: To make sure that the operator sets the end fence in the correct position.

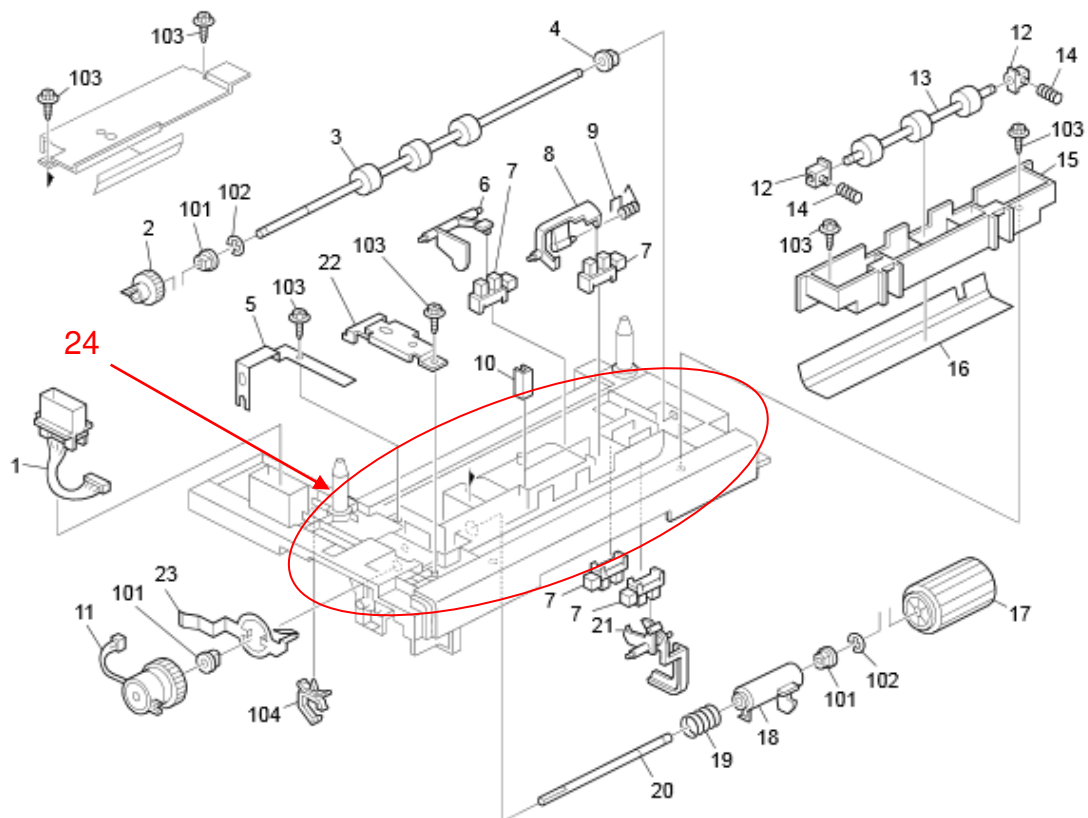
3.Paper Feed Unit 3 (M375/M376)

Old part number	New part number	Description	Q'ty	Int	Page	Index	Note
	M3752556	HOUSING:PAPER FEED UNIT:UPPER	0-1	-	6	24

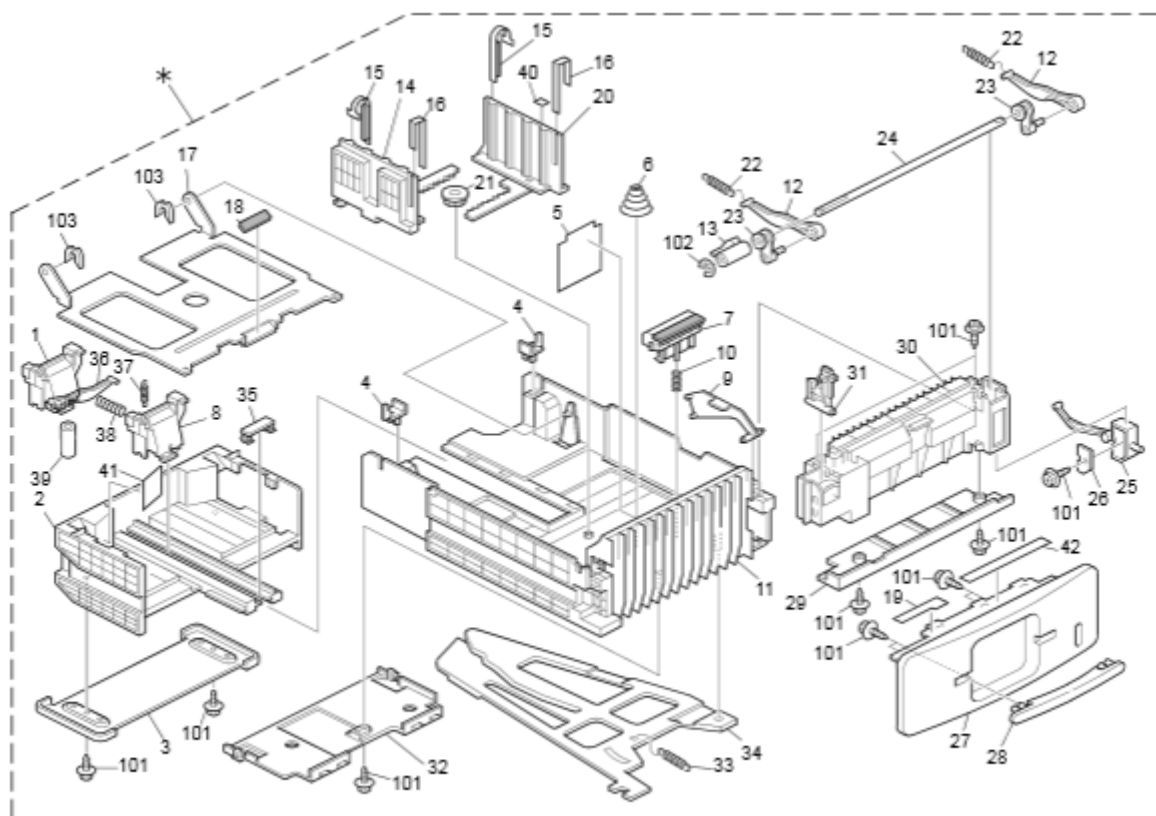
2.Paper Feed Unit 2 (M386/M389)

Change/Reason: The following part number and index number were changed.

Old part number	New part number	Description	Q'ty	Int	Page	Index
M0212659	M0522670	TRAY BOTTOM PLATE	1	-	5	17

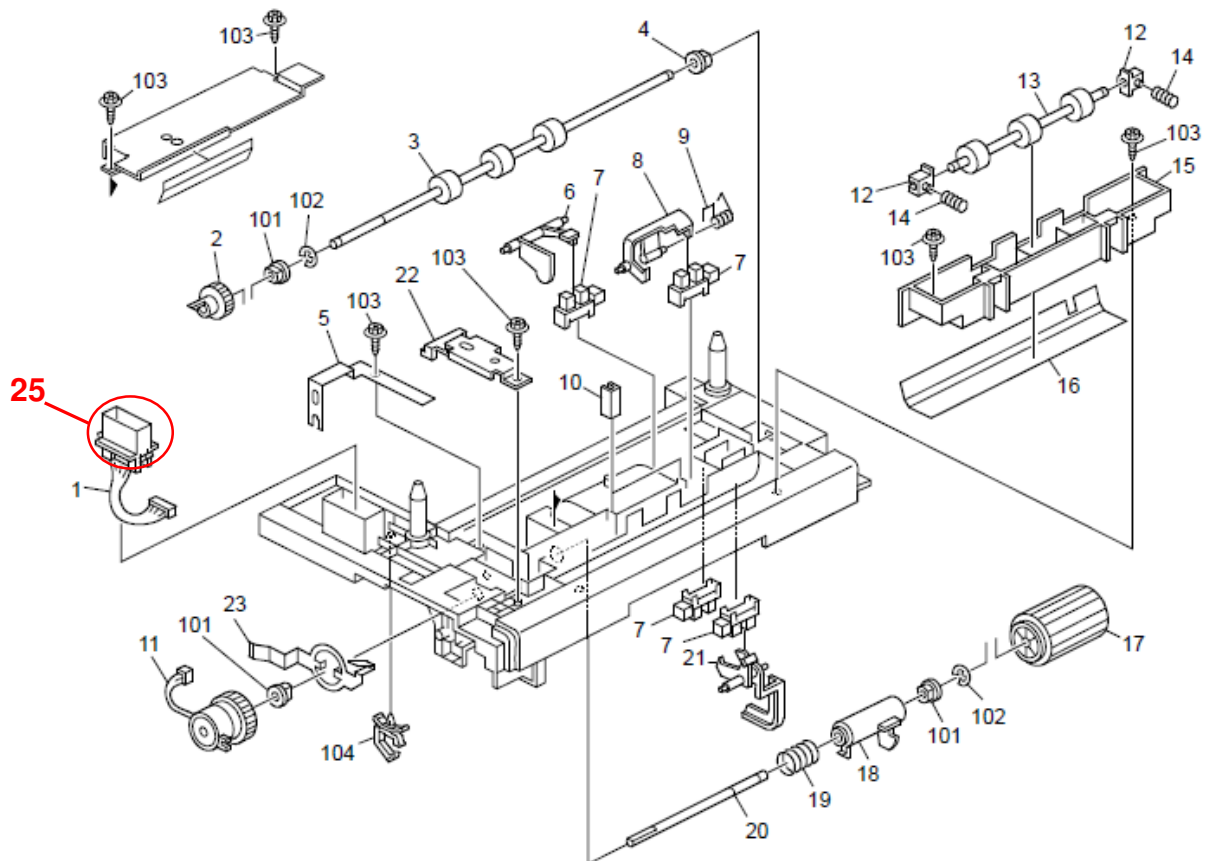
3.Paper Feed Unit 3 (M375/M376)

Change/Reason: This part number was missing from the parts catalog.

Part number	Description	Q'ty	Int	Page	Index	Note
11029811	CONNECTOR:1-1612256-4	1	-	7	25

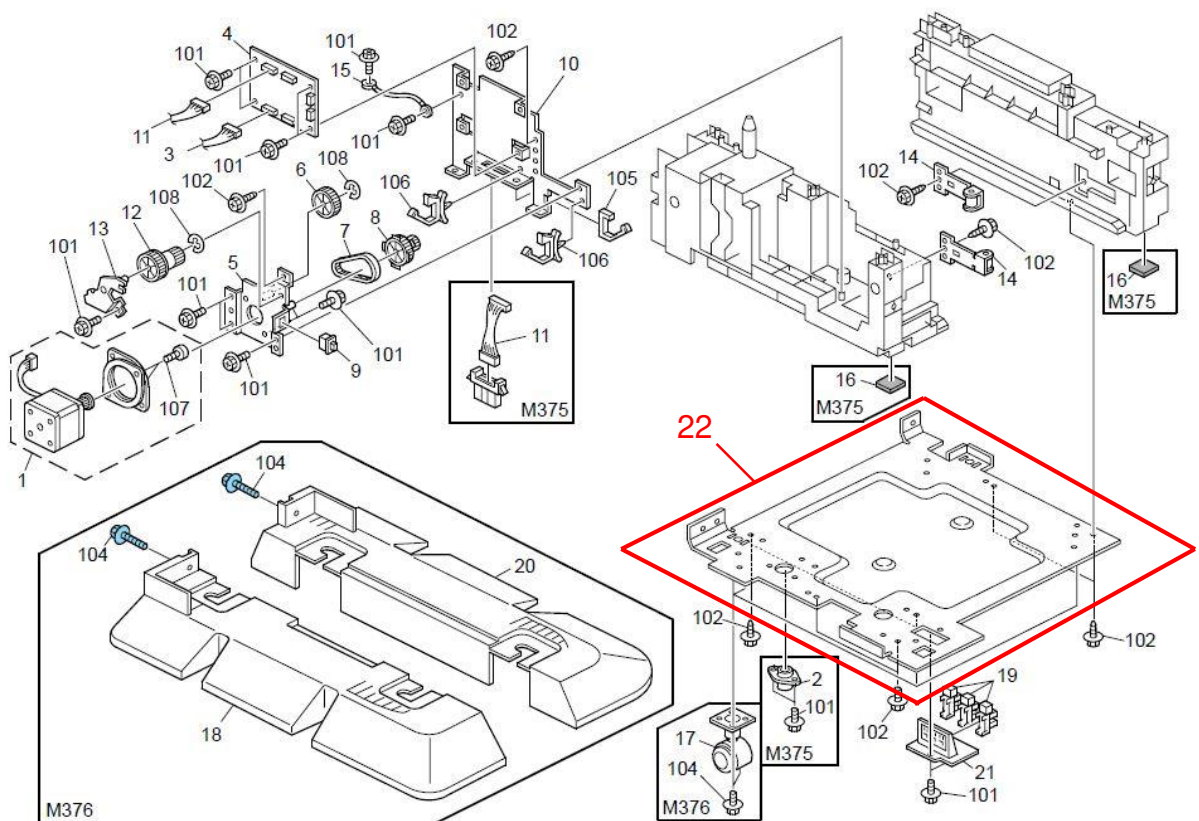
4.Paper Feed Unit 4 (M375/M376)

Change: The following part was newly added as a service part.

Reason: To meet requests received from the field.

Old part number	New part number	Description	Q'ty	Int	Page	Index	Note
-	M3751051	FRAME:LOWER:HELENA-MF	1	-	9	22	M375 only

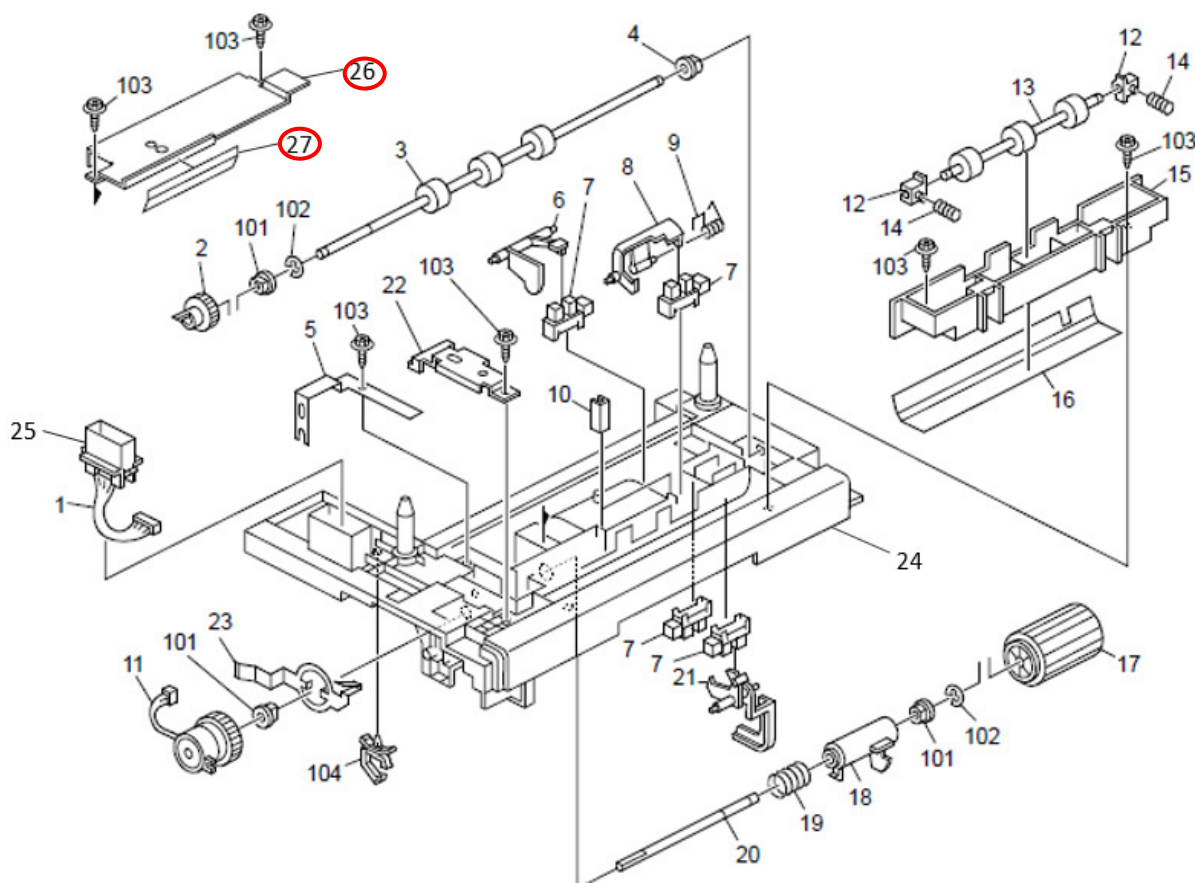
3.Paper Feed Unit 3 (M375/M376)

Change: These parts are newly added.

Reason: To meet requests received from the field.

Part number	Description	Q'ty	Int	Page	Index	Note
M3752559	BRACKET:HOUSING:FEED:HELENA	1		7	26	
M3752562	GUIDE:STAY:FEED:HELENA	1		7	27
