Technical Bulletin

Model: Model Sh-P1 (PFU)			Date: 08-May-1	12	No.: RM386002
Subject: Check	Prepai	red by: T.Hirai			
(Tray side fenc					
From: 3rd Tech S					
Classification:	Troubleshooting	☐ Part info	rmation	Action	required
	☐ Mechanical	☐ Electrica	al [] Service	e manual revision
	☐ Paper path	Transmi	t/receive	Retrofi	it information
	☐ Product Safety	Other () [Tier 2

Model: Sh-P1 PFU Option	Date: 15-Mar-13	No.: RM386004a

Subject: Breakage of Stoppers for Tray Extension				ed by: T. Nihei
From: 3rd Tech Service Sect., MFP/P Tech Service Dept.				
Classification:		☐ Part information	n	Action required
	☐ Mechanical	☐ Electrical		☐ Service manual revision
	☐ Paper path	☐ Transmit/recei	ve	☐ Retrofit information
	☐ Product Safety	☐ Other ()		⊠ Tier 2

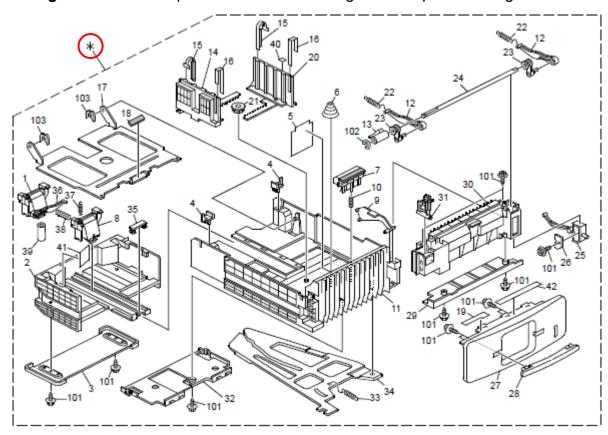
Change/ Reason: This part number was missing from the parts catalog.

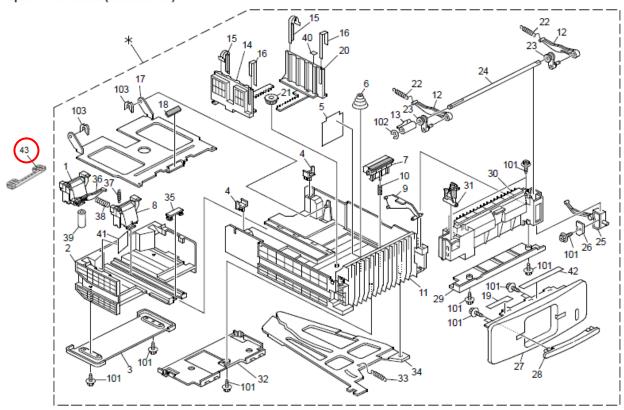
2.Paper Feed Unit 2 (M386/M389)

Change: A spacer was added.

Reason: To make sure that the operator sets the end fence in the correct position.

Old part number	New part number	Description	Q'ty	Int	Page	Index	Note
	M0212564	END FENCE:SPACER	0-1	-	5	43

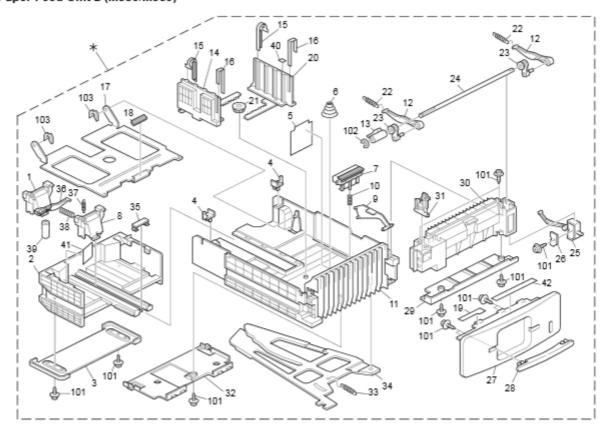
2.Paper Feed Unit 2 (M386/M389)

Change/Reason: The following part number and index number were changed.

Old part	New part	Description	Q'ty	Int	Page	Index
number	number					
M0212659	M0522670	TRAY BOTTOM PLATE	1	_	5	17

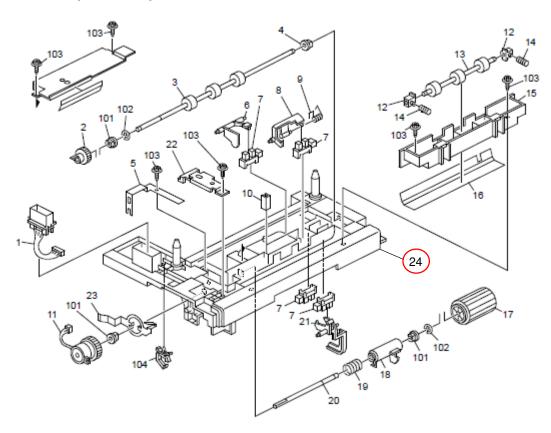
3.Paper Feed Unit 3 (M386/M389)

Change: The following part was newly added as a service part.

Reason: To meet requests received from the field.

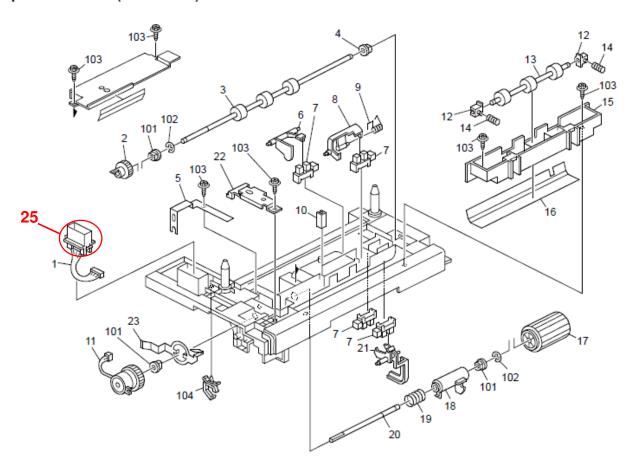
3.Paper Feed Unit 3 (M386/M389)

Change/Reason: This part number was missing from the parts catalog.

Part number	Description	Q'ty	Int	Page	Index	Note
11029811	CONNECTOR:1-1612256-4	1	-	7	25

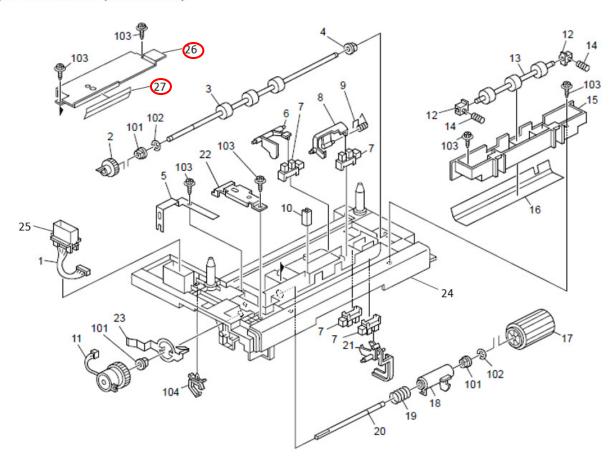
3.Paper Feed Unit 3 (M386/M389)

Change: These parts are newly added.

Part number	Description	Q'ty	Int	Page	Index	Note
M3752559	BRACKET:HOUSING:FEED:HELENA	1		7	26	
M3752562	GUIDE:STAY:FEED:HELENA	1		7	27
