Model: Paper Feed Unit for Model Ti-P1		Date: 05-Sep-13	No.: RM406001
Subject: Upper Left Cover & Frame		Prepared by: H.K.	
From: 3rd Tech Service Sect., MFP/P Tech Service Dept.			
Classification:	<input type="checkbox"/> Troubleshooting <input type="checkbox"/> Mechanical <input type="checkbox"/> Paper path <input type="checkbox"/> Product Safety	<input checked="" type="checkbox"/> Part information <input type="checkbox"/> Electrical <input type="checkbox"/> Transmit/receive <input type="checkbox"/> Other ()	<input type="checkbox"/> Action required <input type="checkbox"/> Service manual revision <input type="checkbox"/> Retrofit information <input type="checkbox"/> Tier 2

Model: Paper Feed Unit for Model Ti-P1		Date: 18-Oct-13	No.: RM406002
Subject: RUBBER FOOT		Prepared by: H.K.	
From: 3rd Tech Service Sect., MFP/P Tech Service Dept.			
Classification:	<input type="checkbox"/> Troubleshooting <input type="checkbox"/> Mechanical <input type="checkbox"/> Paper path <input type="checkbox"/> Product Safety	<input checked="" type="checkbox"/> Part information <input type="checkbox"/> Electrical <input type="checkbox"/> Transmit/receive <input type="checkbox"/> Other ()	<input type=

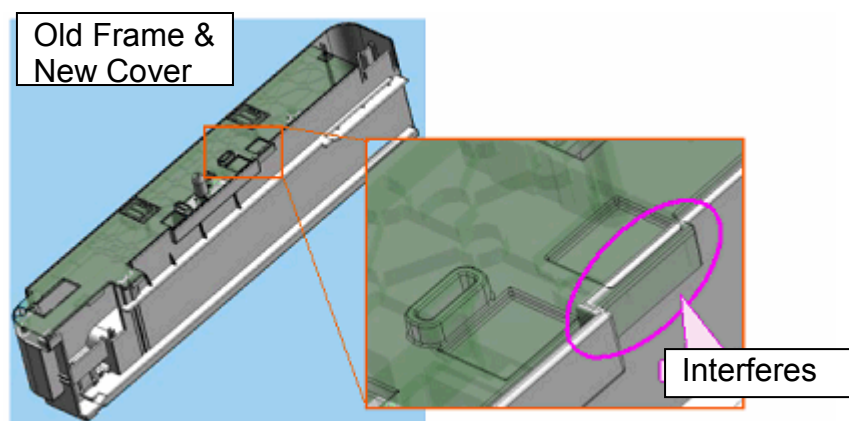
- Interchangeability of production machines:
 - M4061003 → M4081003 = X/X
- Interchangeability of old machines in the field:
 - M4061003 → M4069500 = O/O
- The M4081003 cover cannot be installed on old machines in the field due to physical incompatibility with the new frame.
 - M4081003: For attachment to new machines in the field
 - M4061003 and M4069500: For attachment on old machines in the field.

Note: M4069500 has been specially modified so that it is compatible with the frame on old machines.
