Technical Bulletin

Model: Shepherd-P1

No.: RJ093003

Subject: Changed the installation procedure for installing the proximity sensors.			Prepared by: Y.Kurohashi		
From: 1st System Business Promotion Section, System Business Department					
Classification:	 Troubleshooting Mechanical Paper path Product Safety 	Part informat Electrical Transmit/rec Other (tion eive)	 Action required Service manual revision Retrofit information Tier 2

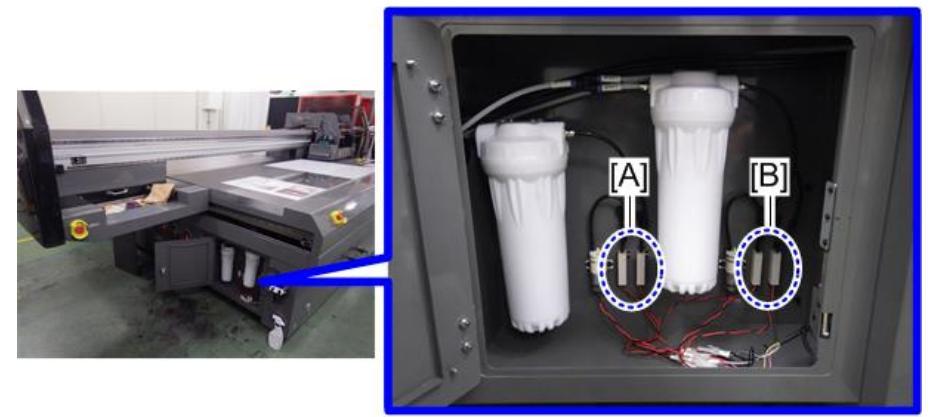
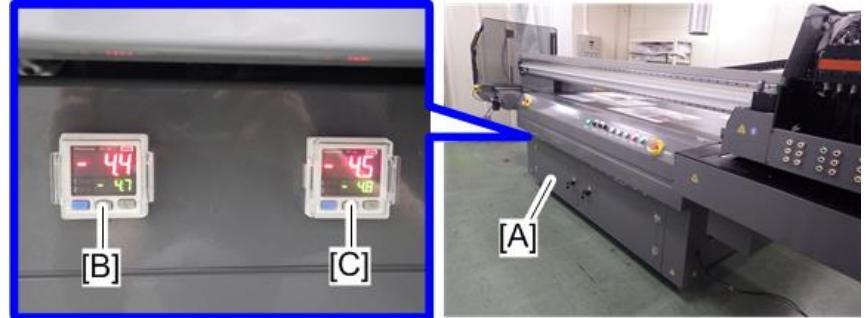
Please explain the intermittent ticking sound from negative pressure valve is normal work of the machine.

To keep negative pressure at the print heads all times, the electrical valves open and close intermittently.

Therefore, there is the sound not only at printing but also at standby-mode.

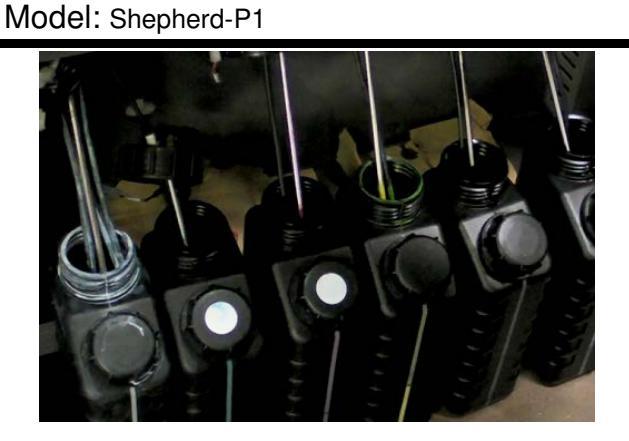
If ink tube is not correct position, the air will be supplied instead of ink or ink is not supplied correctly. The air will be supplied instead of ink when ink surface is below the end of ink supplying tube. When air is in the ink supplying tube, the air may cause nozzle clogged or flowing inks into the air tube by negative pressure broken. The following cases are not good.

- 1. Check the points from ink filling port after removing caps.
- 2. Straighten out the kink of tube, or cut it to the correct length, or replace it with correct length one.

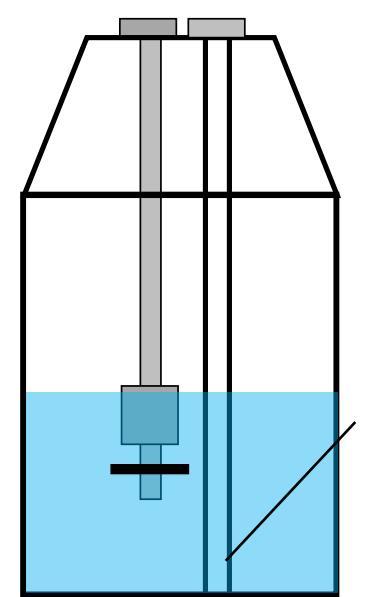
The end of tube touches the bottom of the bottle because the length of tube is too long. As a result, enough ink may not be supplied.

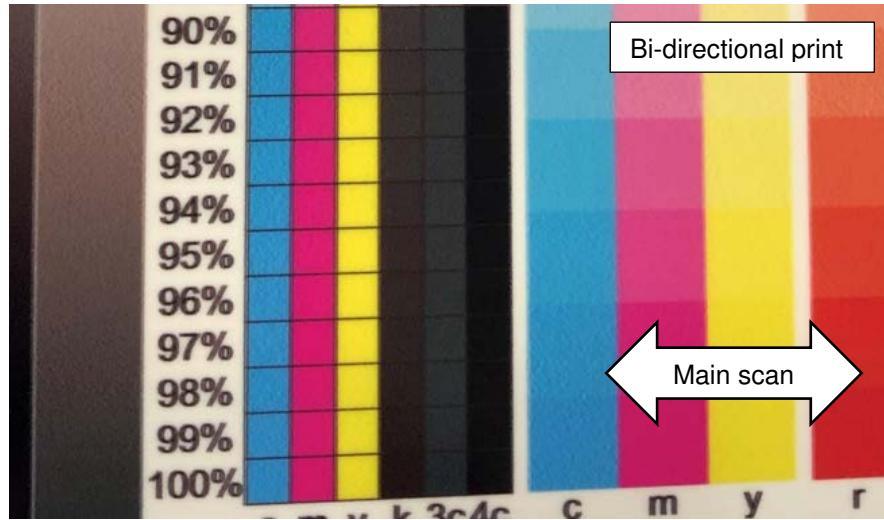
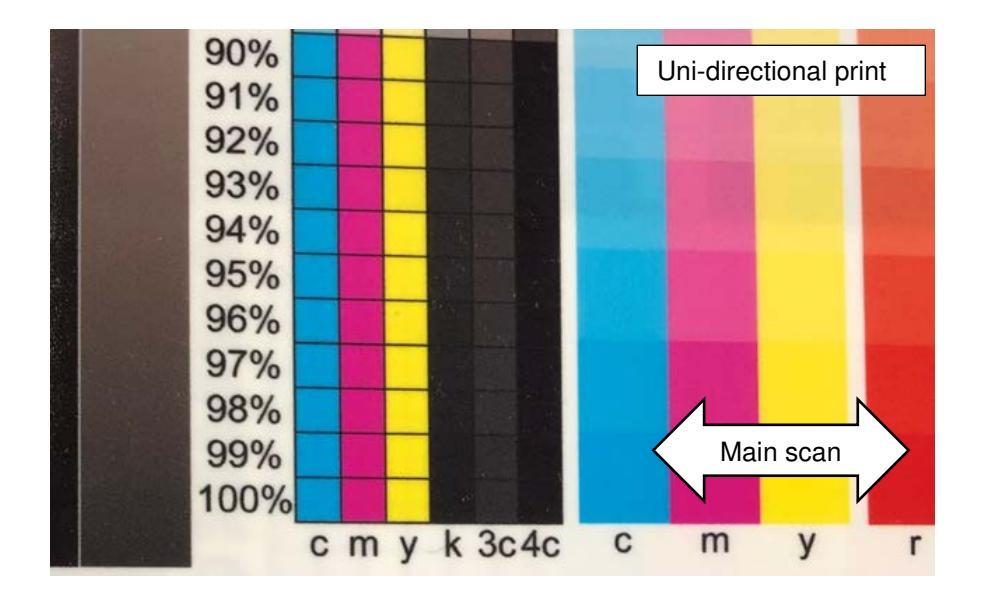
A little image shift in main scan direction may occur like the photo below when bidirectional printing at Print Control Software v.1.0.1.2.

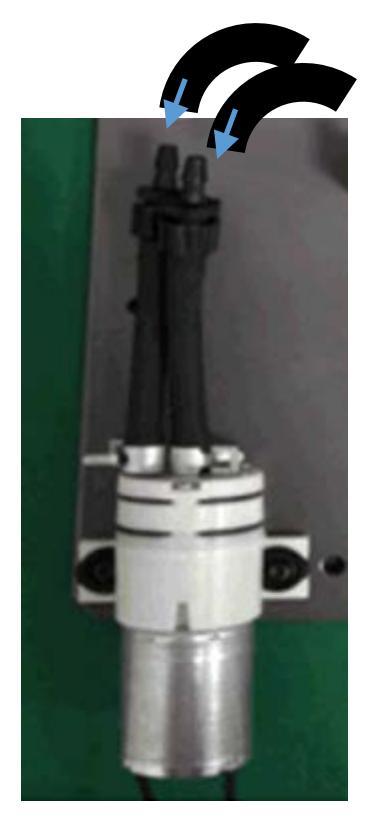
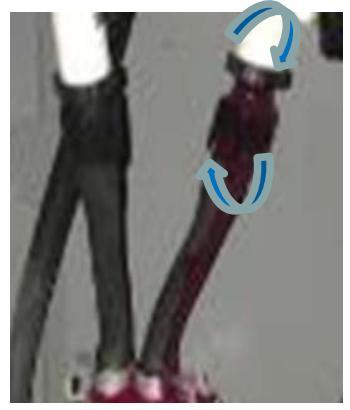
If the tube and the fitting are assembled after attached to the printer frame, ink may leak from the connection because it is loose by the elasticity of kinked tube at connecting them.

Insert the opposite side tube after assembled the tube, fitting and pump.

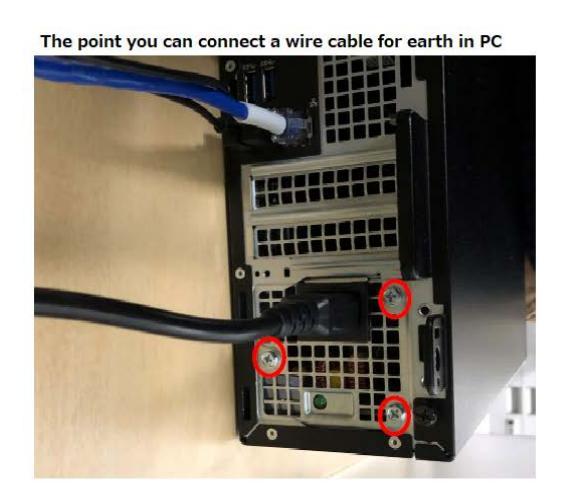
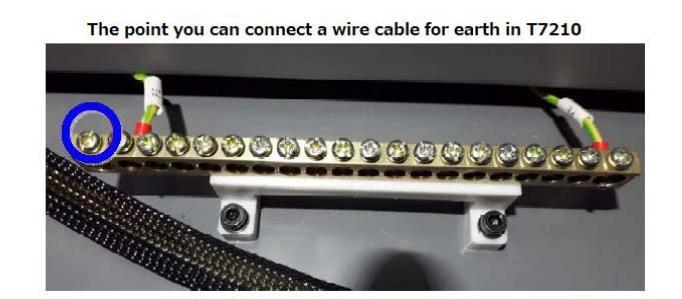
The same error has also occurred in Ricoh Deutschland so far, and this measure worked, too.

So if USB error during vacuuming is reported, it may be caused by the unstable earth potential in the environment where T7210 is installed. So please prepare a wire cable and connect the PC's GND(any one of below \bigcirc) and T7210's GND(any one of below \bigcirc) directly.

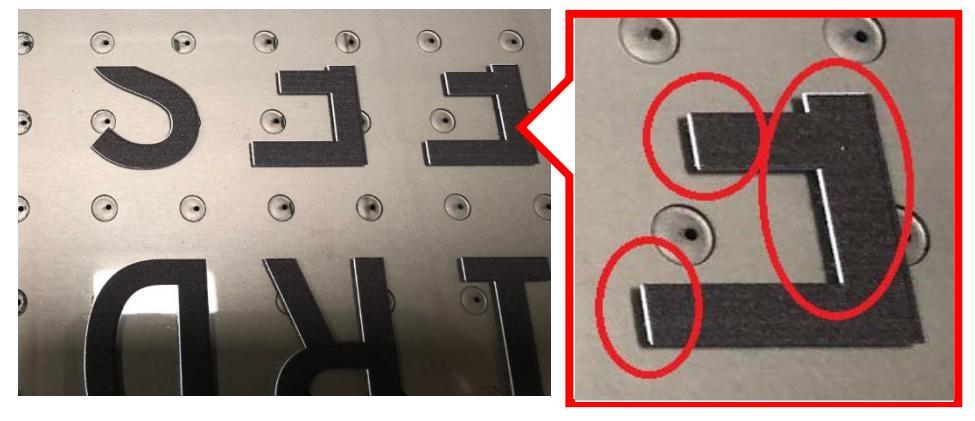
White image misalignment is occurred when Black image is overprinted on the white ink.

Adhesive material on X-axis encoder sheet, after cleaning the encoder sheet, then this problem is solved.

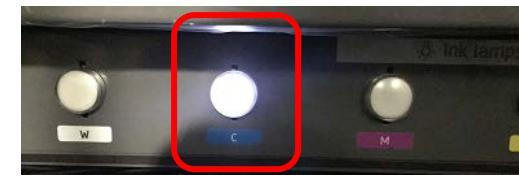
Only Cyan is empty

Ink end lamps lit darker or do not lit when more than 2 ink tanks empty occurring at the same time.

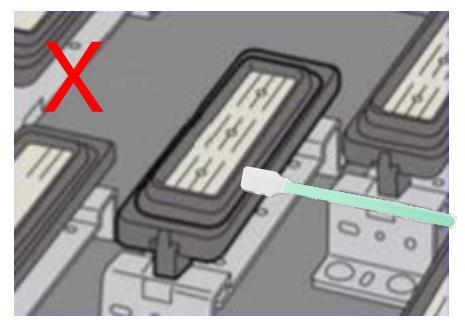
Wiping from side of the cap(no good)

Check whether the caps are not out from capping unit and reseat them if they are out. Instruct to customer that wipe around the cap from above not side the cap when cleaning. And instruct to the customer that reseat the caps if they are out from capping unit.

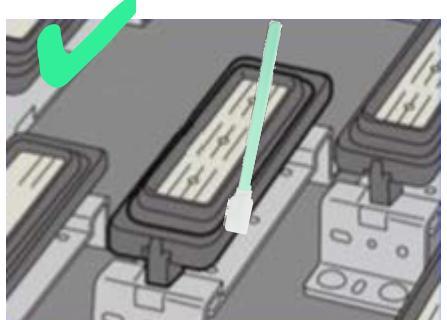
Wiping from above the cap(good)

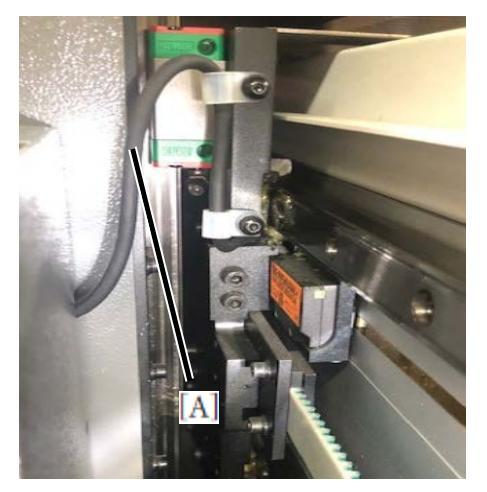
Good

- j093a2865
- Take care the wiring route as follow below and fix the sensor cable by cable tie with the ionizer cable inside the UV lamp cover, when installing the Encoder sensor cable.
 - Take care the wiring route[A] as without kink or without touch the X-axis frame. Result of kink, the cable is touched and rubbed with the frame. (Red circle [B])

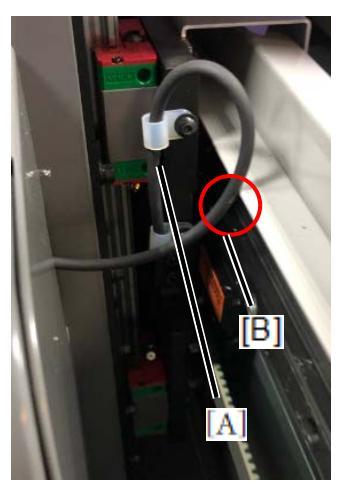
Not Good (wire kinked)

Take care not to rub the sensor cable[A].

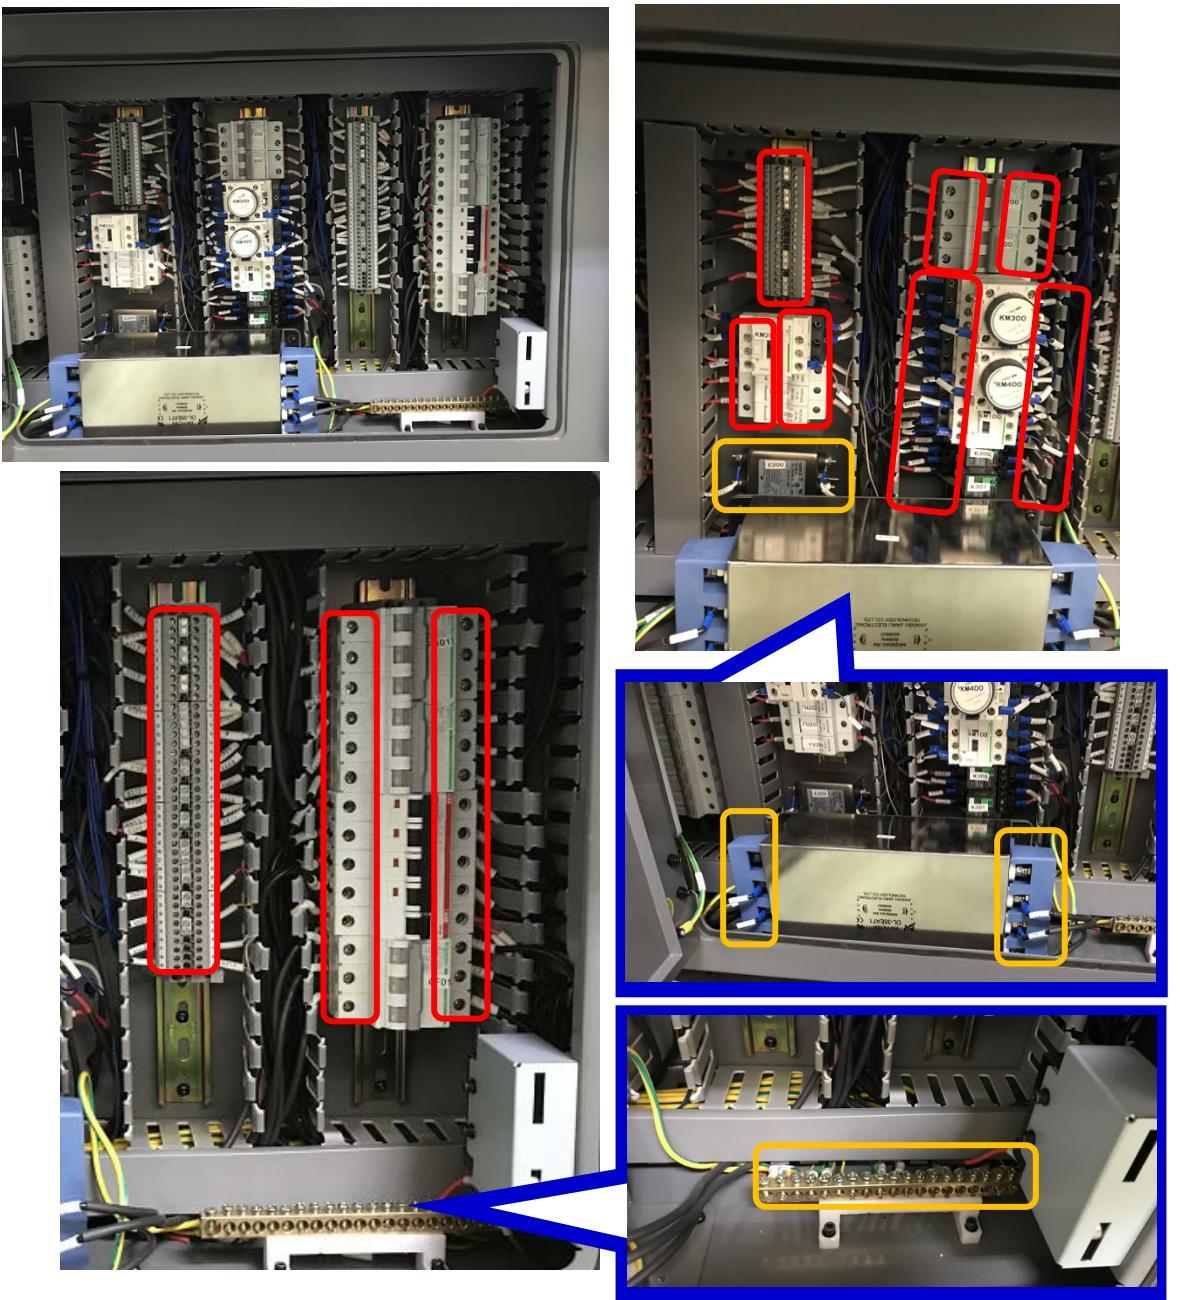
2. Retighten the screws on the wire terminal and any electric devices regarding view of [E]

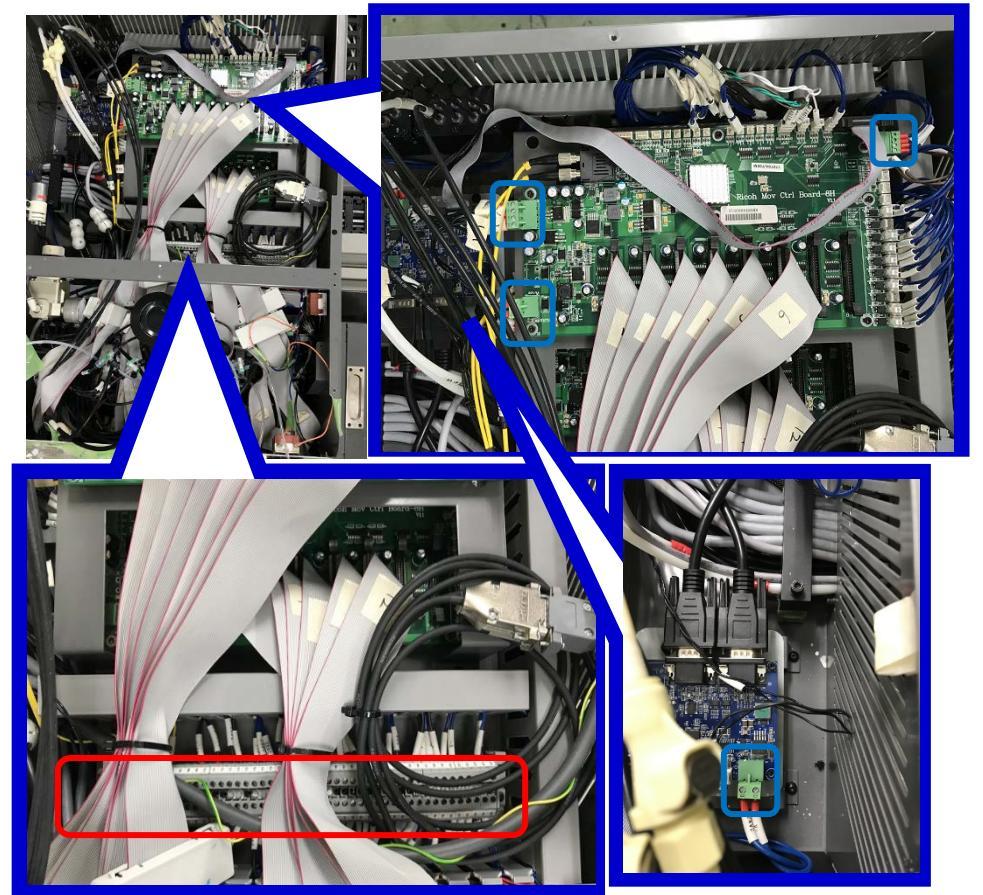
3. Retighten the screws on the wire terminal regarding view of [F]

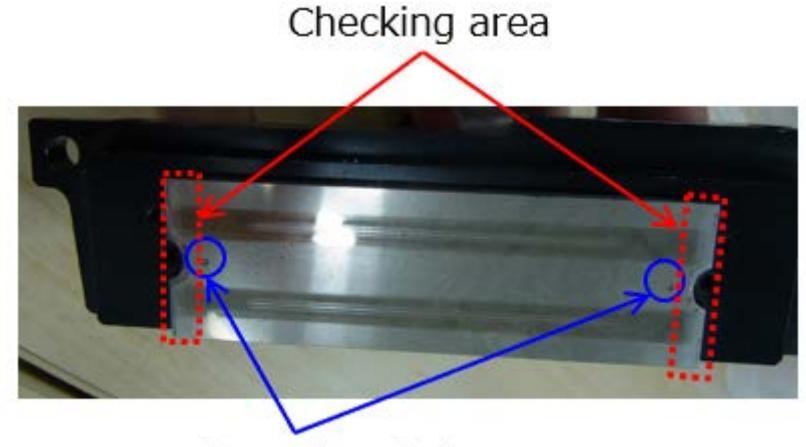
Fig.2

Notes: Confirmation work is performed in the following area to avoid damaging the nozzle surface at the time of measurement. Please see the picture below.

Nozzle surface hole

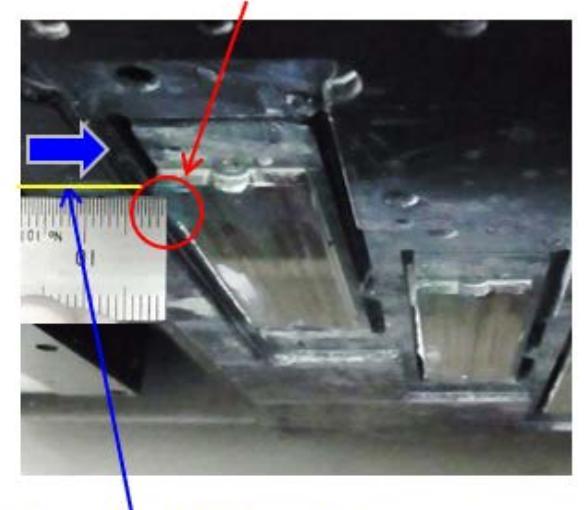
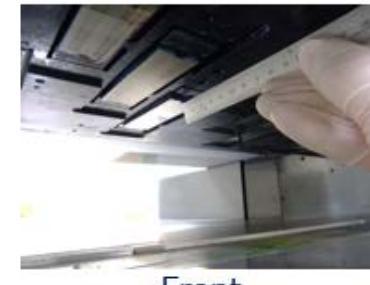
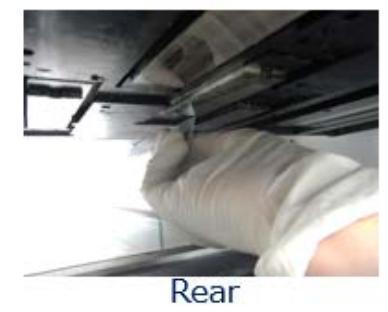
Fig.3

Interference check with the head

Contact the scale with the plate

The scale is used vertically depending on the location of the head.

- 1. Apply the spacer parts J0939903 to the head where the nozzle surface is convex from the head plate.
- 2. It is necessary to add 2 sheets of spacer for 1 head. Turn over the same part and use it.

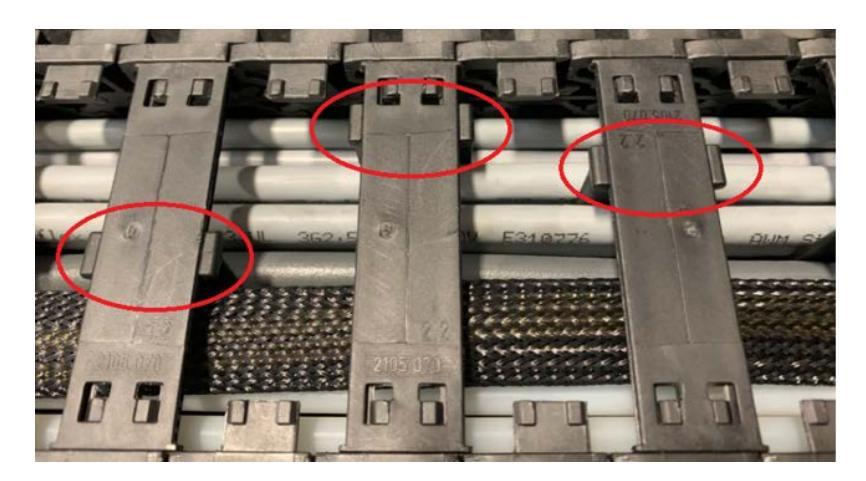
So one of the cables which length was too long was bent, and contacted the edges of parts in the cable bearer, which caused the cable to be damaged.

To prevent it more thoroughly, "strain relief separators" have been inserted as shown in the following photo in Ricoh Pro T7210 machines which S/N of the table is R869X900001 or larger.
