Model: Model K-P1		Date: 18-Jan-01	No.: RG058001
Subject: Printer Controller Firmware History		Prepared by: K. Misugi	
From: Technical Services Dept., GTS Division			
Classification:	<input type="checkbox"/> Troubleshooting <input type="checkbox"/> Mechanical <input type="checkbox"/> Paper path <input type="checkbox"/> Other ()	<input type="checkbox"/> Part information <input type="checkbox"/> Electrical <input type="checkbox"/> Transmit/receive	<input checked="" type="checkbox"/> Action required <input type="checkbox"/> Service manual revision <input type="checkbox"/> Retrofit information

Printer controller firmware history for the Kir-P1 (G058/G056 model).

Model: Model K-P1		Date: 09-Apr-01	No.: RG058003
Subject: Dirty Background on Printouts		Prepared by: K. Misugi	
From: Technical Services Dept., GTS Division			
Classification:	<input checked="" type="checkbox"/> Troubleshooting	<input type="checkbox"/> Part information	<input type="checkbox"/> Action required
	<input type="checkbox"/> Mechanical	<input type="checkbox"/> Electrical	<input type="checkbox"/> Service manual revision
	<input type="checkbox"/> Paper path	<input type="checkbox"/> Transmit/receive	<input type="check

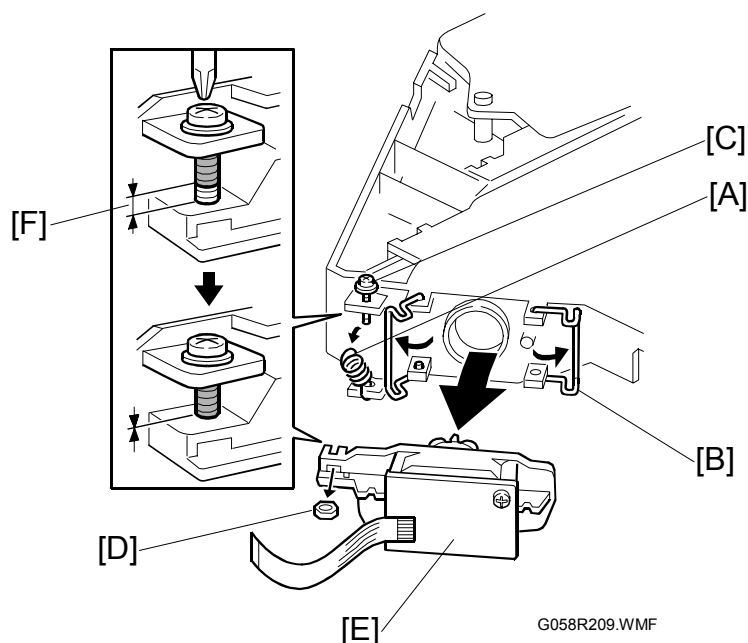
3.3.5 Laser Diode Unit

The Service Manual procedure for the LD unit position adjustment has been changed from the first machine of mass production. The new procedure is as follows:
