Model: K-P1, A-C2, J-P1		Date: 03-Jul-01	No.: RB003008
Subject: Slow Printing from Macintosh		Prepared by: K. Misugi	
From: Technical Services Dept., GTS Division			
Classification:	<input checked="" type="checkbox"/> Troubleshooting <input type="checkbox"/> Part information <input type="checkbox"/> Action required <input type="checkbox"/> Mechanical <input type="checkbox"/> Electrical <input type="checkbox"/> Service manual revision <input type="checkbox"/> Paper path <input type="checkbox"/> Transmit/receive <input type="checkbox"/> Retrofit information <input type="checkbox"/> Other (      )

Model: General (GW Models)		Date: 20-Dec-01	No.: RGene010
Subject: Series Print Mode		Prepared by: K. Misugi	
From: Technical Services Dept., GTS Division			
Classification:	<input checked="" type="checkbox"/> Troubleshooting <input type="checkbox"/> Part information <input type="checkbox"/> Action required <input type="checkbox"/> Mechanical <input type="checkbox"/> Electrical <input type="checkbox"/> Service manual revision <input type="checkbox"/> Paper path <input type="checkbox"/> Transmit/receive <input type="checkbox"/> Retrofit information <input type="checkbox"/> Other (      )

Mo

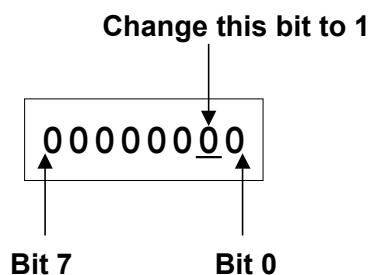
Enter the printer controller service mode, access the bit switch settings display, then change bit 1 of bit switch 2 to "1."

**Important:** Do not change any other settings. (The default setting is "0.")

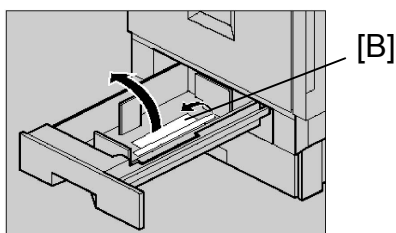
1. Remove the toner cartridges to prevent toner from flowing into the toner supply tube due to vibrations experienced during transport. This may cause the tube to be clogged with toner.
2. Put bubble wrap into the toner cartridge holder to shield the toner supply entrance. This prevents toner from flowing out to the toner cartridge holder.
3. Put the lock pin [A] (which comes with the machine) in the transfer belt unit.
4. Make sure there is no paper left in the paper trays and fix down the bottom plates with a sheet of paper and tape [B].
5. Empty out the waste toner bottle and attach securing tape to prevent the bottle from coming out.
6. Attach shipping tape to the covers and doors as shown, or shrink-wrap the machine tightly.

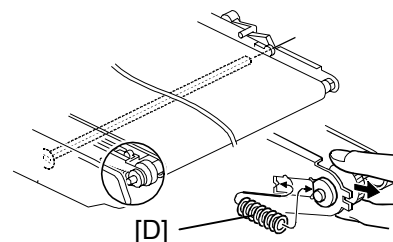
6. Remove the 4 transfer charge brushes (2 screws each).
7. Use a screwdriver to remove excess toner/dust from the brush fibers, being sure to stroke the fibers in the direction that they lean. Then, clean off the fibers with a dry cloth.

**NOTE:** If the fibers are stroked in the opposite direction, this may lead to vertical white lines on the outputs.

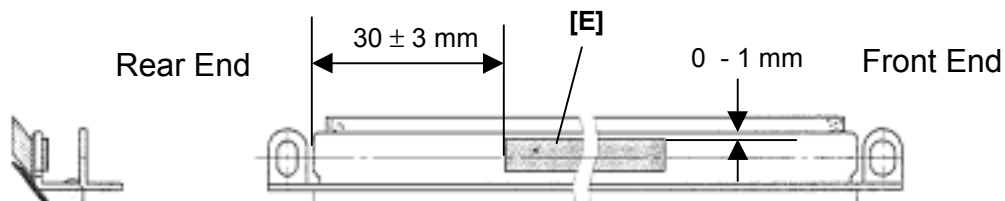
8. Clean the cushion attachment areas on the surfaces of the metal plates with alcohol.
9. Mark a line  $30 \pm 3\text{mm}$  from the rear edge of the brush.
10. Place the brush onto a few sheets of clean paper and attach the cushion [E] onto the metal plate of each brush, aligning the edge of the cushion with the edge of the brush.

**NOTE:** When attaching the cushions, be careful not to push down on the brush too strongly. This is because doing so can damage the Mylar and/or flatten out the brush fibers, which can prevent contact between the fibers and transfer belt and lead to vertical white lines.

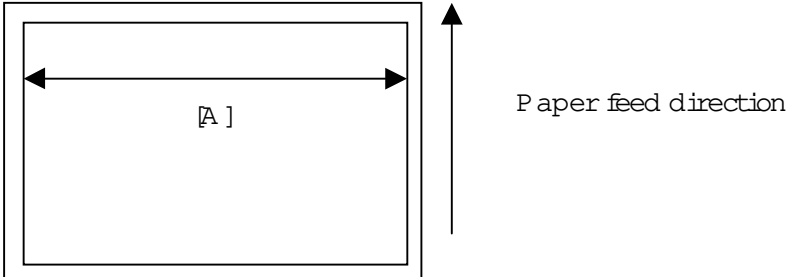
(2)	Measure distance [A] (along the main scan direction) and check to see if it is within the adjustment standard. - Main scan magnification adjustment standard [B]: Inch: 10.84" +/- 0.03" Metric: 293 mm +/- 0.9 mm  <div style="display: flex; align-items: center; justify-content: center;">

</div> <ul style="list-style-type: none"> <li>If [A] is not within adjustment standards:</li> </ul> <ol style="list-style-type: none"> <li>Calculate value [C]:              Metric: <math>[C] = ([B] - [A]) \times 1200 / 25.4</math>              Inch: <math>[C] = ([B] - [A]) \times 1200</math> </li> <li>If <math>[A] &lt; [B]</math>, input: [current value in SP2-103-55 or 59] - [C]              If <math>[A] &gt; [B]</math>, input: [current value in SP2-103-55 or 59] + [C]   <b>Example:</b> SP2-103-55              If [A] is 1 mm (0.04") shorter than [B]:              → <math>[C] = 1 \text{ mm} \times 1200 / 25.4 = 47.2 = 47</math> (rounded off to nearest whole number).              → If the current setting is 140, input <math>140 - 47 = 93</math>.           </li> </ol>

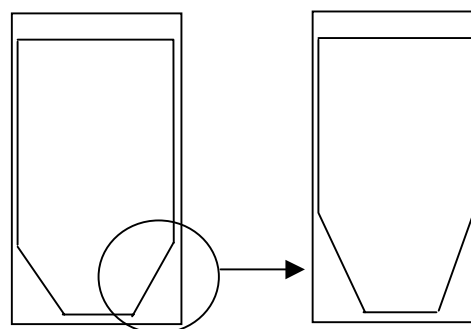
Modification	Cut-in
Strips of Mylar have been attached to the inner package to prevent the package from bending or becoming dented. <b>Note:</b> Applied to all toner colors.	August, '01
The shape of the black toner package has been changed to create a steeper slope in the area circled in the illustration, allowing the toner to flow more easily. <b>Note:</b> Applied only to Black toner, since this change would reduce the package capacity too much for the color toners.	April, '02

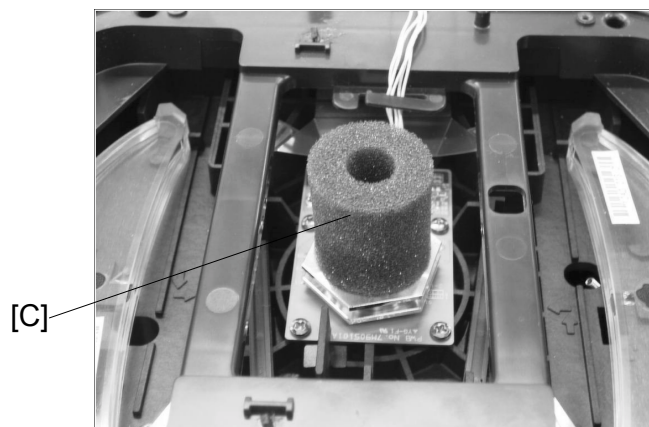
**Caution:** If the sponge is not removed, the polygon mirror motor can be damaged and/or the printer may not function correctly.

3. Remove the sponge [C].
