Model: Model C-P2c	Date: 17-Feb-05	No.: RG112001a
--------------------	-----------------	----------------

Subject: Controller Firmware Release History (System)		Prepared by: A. Ishiyama	
From: 1st Tech. Support Sec. Service Support Dept.			
Classification:	<input type="checkbox"/> Troubleshooting	<input type="checkbox"/> Part information	<input type="checkbox"/> Action required
	<input type="checkbox"/> Mechanical	<input type="checkbox"/> Electrical	<input type="checkbox"/> Service manual revision
	<input type="checkbox"/> Paper path	<input type="checkbox"/> Transmit/receive	<input type="checkbox"/> Retrofit information
	<input checked="" type="checkbox"/> Other ()

This RTB has been issued to announce the firmware history for the System of the Model C-P2c (G113 model).

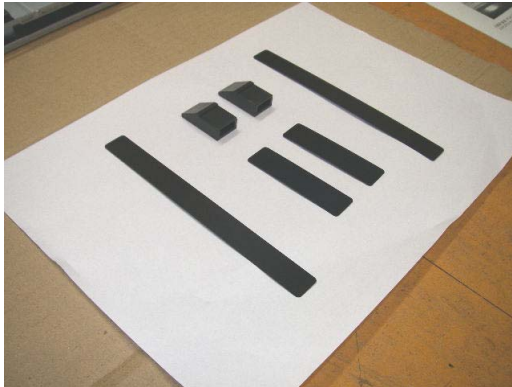
The bent metal plates in the paper feed section press the feed rollers insufficiently. Under these conditions, the paper cannot be fed smoothly at the exit of the duplex unit.

1. Make sure that you have all the necessary parts included in G3619505 (3 types, total 6pcs, this sheet).
