Model: Model A-P3		Date: 27-Nov-01	No.: RG065001
Subject: Service Manual Correction		Prepared by: E. Fukuyama	
From: Technical Services Dept., GTS Division			
Classification:	<input type="checkbox"/> Troubleshooting <input type="checkbox"/> Part information <input type="checkbox"/> Action required <input type="checkbox"/> Mechanical <input type="checkbox"/> Electrical <input checked="" type="checkbox"/> Service manual revision <input type="checkbox"/> Paper path <input type="checkbox"/> Transmit/receive <input type="checkbox"/> Retrofit information <input type="checkbox"/> Other ()

Model: General (GW Models)		Date: 20-Dec-01	No.: RGene010
Subject: Series Print Mode		Prepared by: K. Misugi	
From: Technical Services Dept., GTS Division			
Classification:	<input checked="" type="checkbox"/> Troubleshooting <input type="checkbox"/> Part information <input type="checkbox"/> Action required <input type="checkbox"/> Mechanical <input type="checkbox"/> Electrical <input type="checkbox"/> Service manual revision <input type="checkbox"/> Paper path <input type="checkbox"/> Transmit/receive <input type="checkbox"/> Retrofit information <input type="checkbox"/> Other ()

Model: Model A-P3		Da

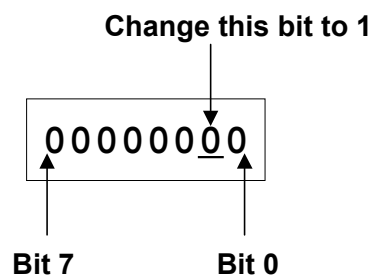
In response to complaints from customers that the intervals between jobs are too long when sent in series, a new service switch has been added to improve performance.

Enter the printer controller service mode, access the bit switch settings display, then change bit 1 of bit switch 2 to "1."

Important: Do not change any other settings. (The default setting is "0.")

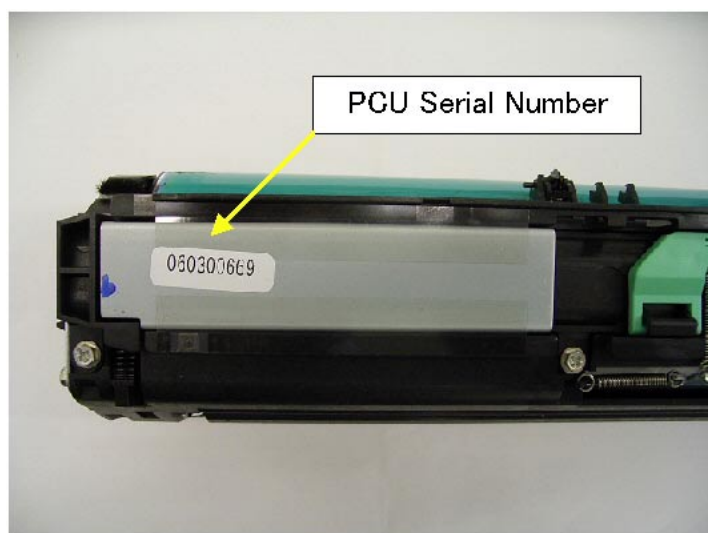
Service Parts P/N (PCU)	PCU Serial Number (PCU)	Model on which the PCU is used:
G0652204	051200001 - 060200200	Model A-P3
