Model: Model PL-MF	Date: 25-May-06	No.: RG157001a
--------------------	-----------------	----------------

Subject: Firmware History - Main Unit Controller		Prepared by: H.K.	
From: 1st Tech. Support Sec. Service Support Dept.			
Classification:	<input type="checkbox"/> Troubleshooting	<input type="checkbox"/> Part information	<input type="checkbox"/> Action required
	<input type="checkbox"/> Mechanical	<input type="checkbox"/> Electrical	<input type="checkbox"/> Service manual revision
	<input type="checkbox"/> Paper path	<input type="checkbox"/> Transmit/receive	<input type="checkbox"/> Retrofit information
	<input checked="" type="checkbox"/> Other (Firmware History)

Model: Model PL-MF		Date: 22-Dec-06	No.: RG157003
Subject: ADF Jam or skew (US & European versions only)		Prepared by: H.K.	
From: 1st Tech. Support Sec. Service Support Dept.			
Classification:	<input checked="" type="checkbox"/> Troubleshooting	<input type="checkbox"/> Part information	<input checked="" type="checkbox"/> Action required
	<input type="checkbox"/> Mechanical	<input type="checkbox"/> Electrical	<input type="checkbox"/> Service manual revision
	<input type="checkbox"/> Paper path	<input type="checkbo

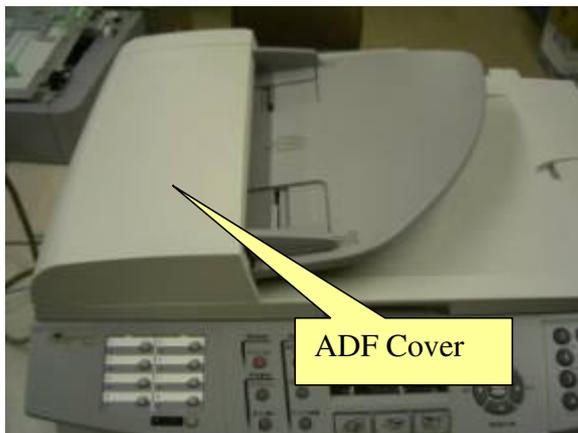
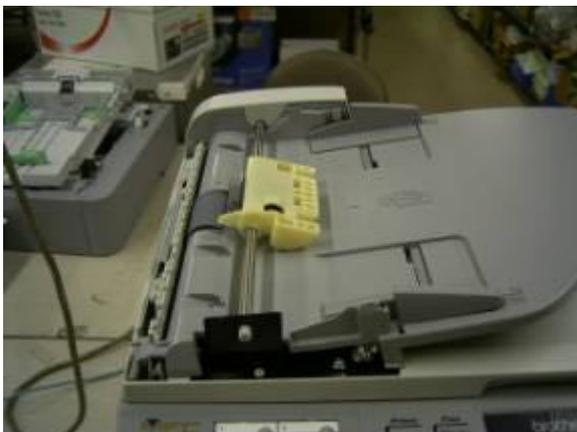
When the ribs near the pins are NG (No Good or defective), the ADF should be replaced.
When the ribs are OK, add the reinforcement plate to ensure the function of the pin.

1. Remove the ADF cover.

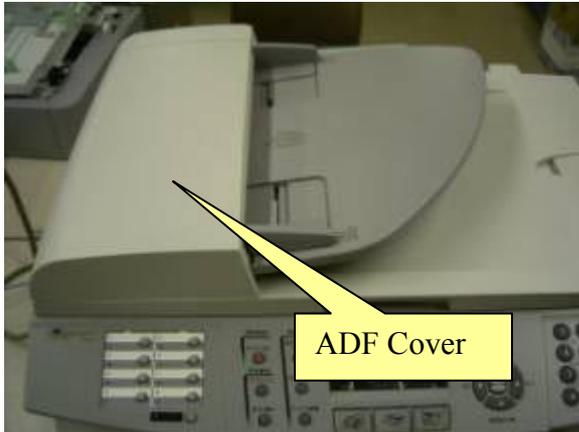
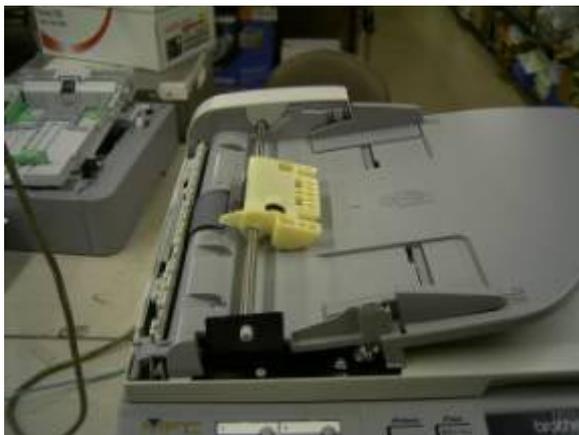
- **The previous RTB recommended replacing the ADF, but it was found that this symptom can be solved by installing the reinforcement plate alone.**
- **The reinforcement plate supports the spring directly, so that the pin does not have to.**

1. Remove the ADF cover.

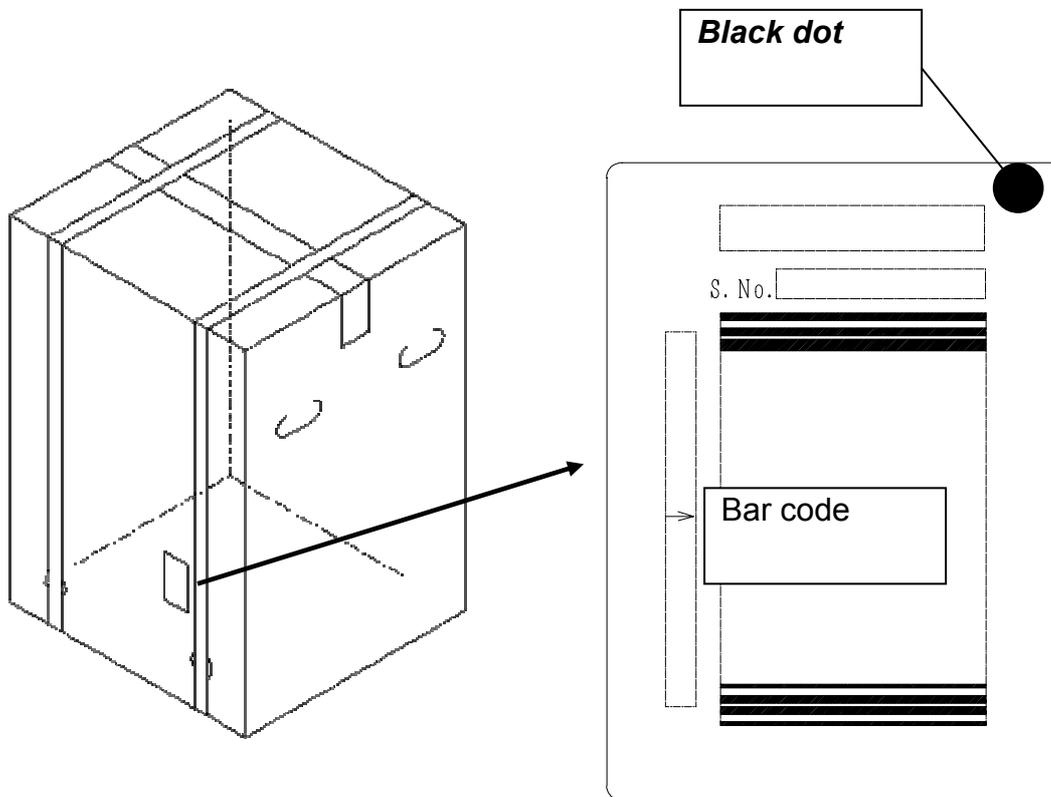
Note: The production line solution has already been applied to some units produced before the cut-in serial numbers. On these units, there is a black dot at the top **right**-hand corner of the barcode label.
