Model: Model G-P2	Date: 18-May-06	No.: RG160001d
-------------------	-----------------	----------------

Subject: Firmware Release History (Printer)		Prepared by: S. Tomoe	
From: 1st Tech. Support Sec. Service Support Dept.			
Classification:	<input type="checkbox"/> Troubleshooting <input type="checkbox"/> Mechanical <input type="checkbox"/> Paper path <input checked="" type="checkbox"/> Other ()	<input type="checkbox"/> Part information <input type="checkbox"/> Electrical <input type="checkbox"/> Transmit/receive	<input type="checkbox"/> Action required <input type="checkbox"/> Service manual revision <input type="checkbox"/> Retrofit information

This RTB has been issued to announce the firmware release information for the Printer.

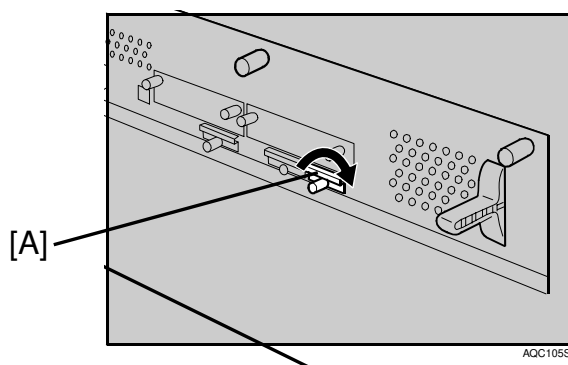
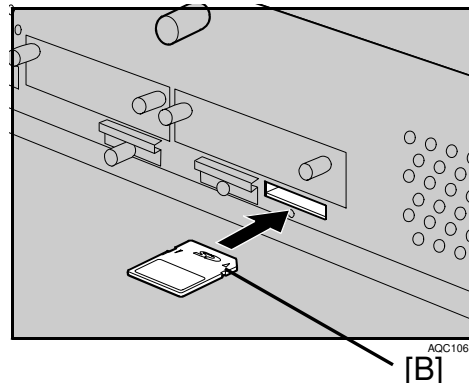
1. Turn off the main power switch if the machine is turned on.
2. Disconnect the network cable.
3. Remove the slot cover [A] of SD card slot 1 (⚙ x 1).
4. Turn the SD-card [B] label face up. Then push it slowly into slot 1 until you hear a click.
5. Turn on the main power switch.
6. Go into the SP mode and push "EXECUTE" with SP5-878.
7. Exit the SP mode and turn off the main power switch.
8. Connect the network cable.
9. Turn on the machine power.
10. Do SP5990-005 (SP print mode Diagnostic Report).
11. Make sure the ROM number and firmware version in area [C] of the diagnostic report are the same as those in area [D].

[A]: "ROM Number/Firmware Version" – "HDD Format Option"

[B]: "Loading Program" – "GW2a_zoffy"

- If this happens:
 - 1) Make sure the unit type is Type E.
 - 2) If the unit type is not Type E, do the installation procedure again using Type E.
 - 3) If the unit type is Type E, but the numbers still do not match:
 1. Replace the NV-RAM
 2. Do the installation procedure again
